REHABILITATION OF AN OLD CONCRETE GRAVITY DAM AND ITS COUNTERMEASURES FOR ENVIRONMENTAL PRESERVATION

Abstract: The Chugoku Electric Power Co., Inc. rehabilitated an old concrete gravity dam, which was completed in 1924, with the aim of improving flood discharge capacity and seismic stability, together with the re-development of existing hydropower station.

In this rehabilitation, an additional spillway was installed, and the new concrete was placed on the downstream face of existing dam body.

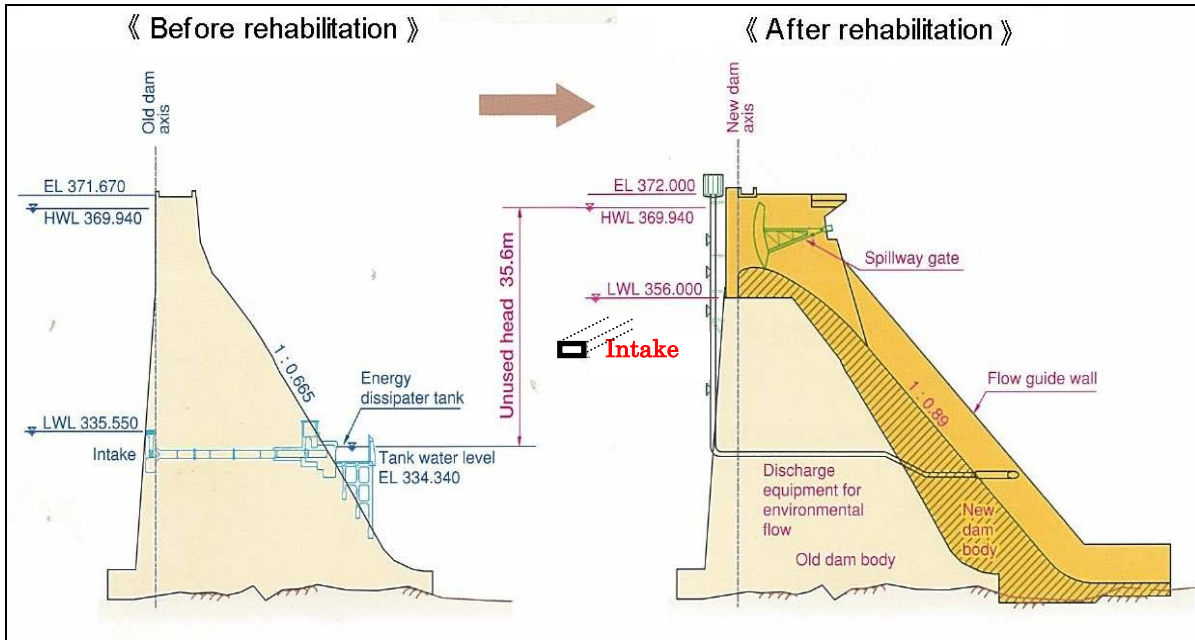
Fig. 3 Cross section of the dam rehabilitation work

The rehabilitation work of the Taishakugawa dam is outlined in Fig. 3. The upper part of the existing dam body was cut off so that the overflow type spillway was installed on the top of the dam for the improvement of flood discharge capability and new concrete was added on the downstream face of existing dam body for the improvement of seismic stability. Table 1 shows the dimensions of the Taishakugawa dam before and after rehabilitation.

The Taishakugawa dam was designed and constructed over 80 years ago and therefore does not satisfy the specific safety requirements (seismic stability) of the current design criteria in Japan. In order to satisfy the current safety level of the dam, it was planned that the new concrete was placed on the downstream face of existing dam body.
