PRELIMINARY INVESTIGATION OF DAMS STRICKEN BY THE IWATE-MIYAGI NAIRIKU EARTHQUAKE IN 2008

Yoshikazu YAMAGUCHI and Tomoya IWASHITA

Public Works Research Institute, Japan, e-mail: yamaguti@pwri.go.jp, iwashita@pwri.go.jp

ABSTRACT:

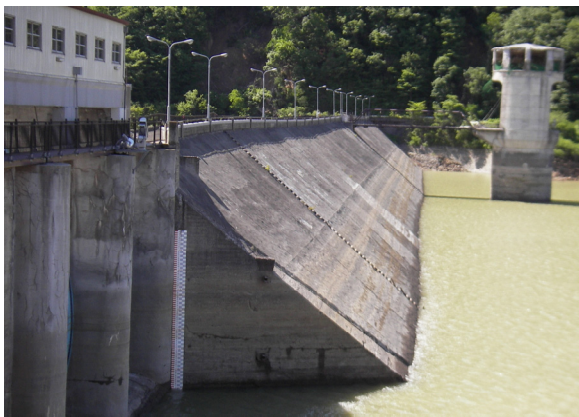
Ishibuchi Dam is a concrete faced rockfill dam (CFRD) with a dam height of 53m completed in 1953, and managed by Tohoku Regional Bureau, MLIT. Figure 3 is the cross section and longitudinal section of the dam. The upstream concrete face maintains the watertightness of dam body of this type of dam. No severe damage was found in the concrete face and its joints shown in Photo. 1.

Photo.1 Concrete faced upstream slope on which no damage was found (Ishibuchi Dam) (Photographed by Public Works Research Institute (PWRI) on June 15, 2008)

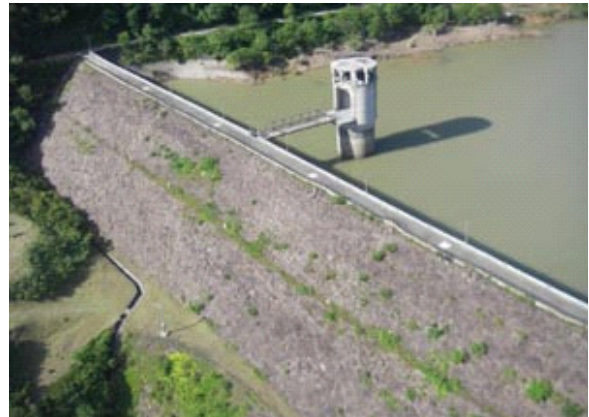
At the crest of the dam, the pavement was waved and cracked shown in Photos. 2 and 3. And gaps appeared on the boundary between the railing and pavement on the shoulder of the slope

Photo.2 Overview of the crest and downstream slope (Ishibuchi Dam) (Photographed by PWRI on June 15, 2008)

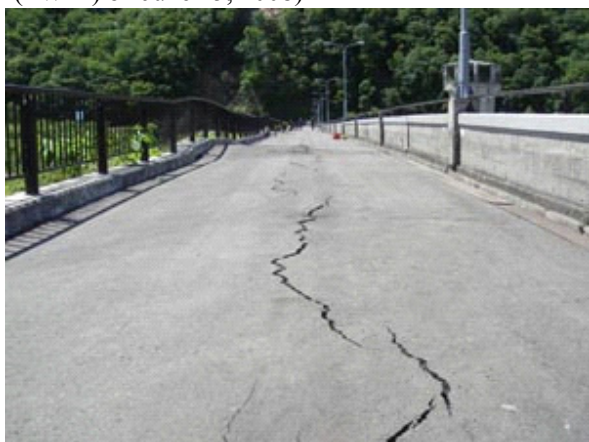
Photo.3 Cracks and waving of the crest pavement (Ishibuchi Dam) (Photographed by PWRI on June 15, 2008)

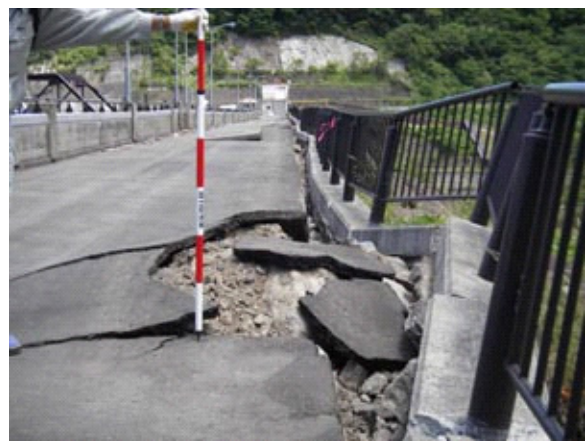
at the crest. On the downstream slope surface of the dam, projections were observed on the rock materials at the protruding parts of the wave on the crest pavement shown in Photos. 4 and 5, but damage of this kind was limited to high elevations. This dam was constructed by the dumped rock construction method as shown in Photo. 6 taken during construction. The piers for the railroad from where trucks dropped rock materials were left buried in the dam body. It is hypothesized that the whole dam body settled due to the earthquake, while the areas near the buried piers only settled a little. The maximum differential settlement is supposed to be about 50cm.

Photo.4 Gaps between the railing and pavement on the crest (Ishibuchi Dam) (Photographed by PWRI on June 15, 2008)

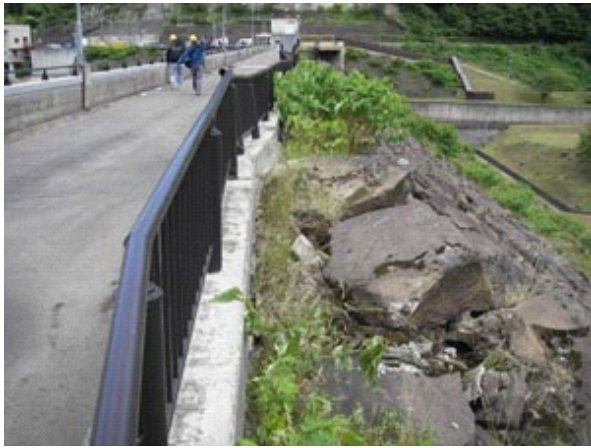
Photo.5 Projection of the riprap rocks around the top of the downstream slope (Ishibuchi Dam) (Photographed by PWRI on June 15, 2008)

Based on the results of emergency investigation, it was decided that no serious problems threatened the safety of the dam, but careful monitoring has been continued and the technical committee has been established to make a detailed survey to prepare for restoration of the dam.

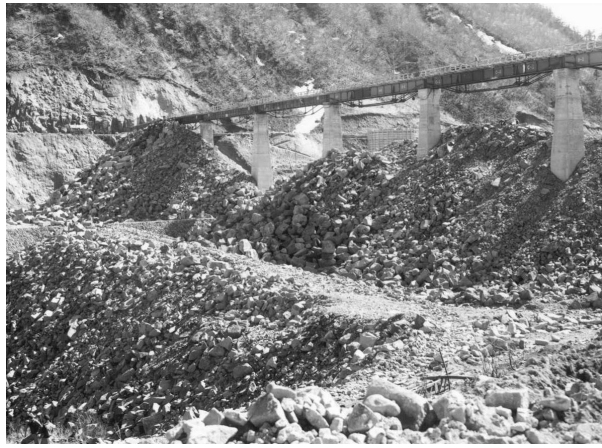
Photo.6 Ishibuchi Dam under construction by the dumped rock method in 1950's (The piers of tramway were buried.) (Courtesy by Kitakami River Integrated Dam Management Office, MLIT)

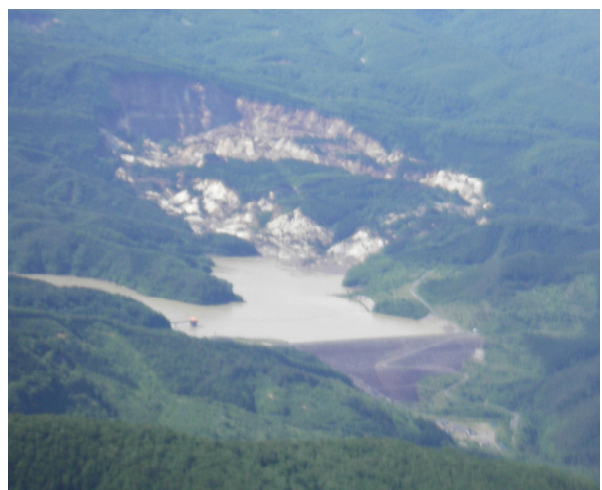
Huge landslides occurred around the reservoir on the left bank upstream from the dam. The largest landslide was 1.3km long, 0.8km wide, and approximately 67 million m³ in volume as shown in Photo. 7 of an aerial photograph. Approximately 1.5 million m³ of this landslide soil flowed into the reservoir. This corresponds to about 10% of the reservoir capacity of 14.13 million m³.

Photo.7 Huge landslides around the reservoir of Aratozawa Dam (Photographed by PWRI on June 15, 2008)

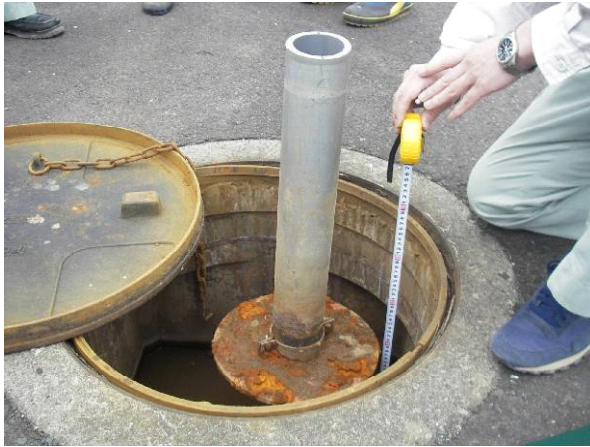
Maximum settlement of about 20cm was measured at the upstream slope shoulder of the dam crest. The surveying target was installed on the rock zone surface. Because the pipe of a crossarm gauge protruded about 40cm shown in Photo. 8, it is hypothesized that the large

settlement occurred at the core zone in the center of the crest rather than at the rock zone. Regardless of the large settlement, no conspicuous cracks were found on the crest pavement surface shown in Photo. 9. In addition, no deformation of the riprap on the upstream and downstream surfaces was found.

Photo.8 The pipe of a crossarm gauge protruded, as a result of the settlement of the dam body (Aratozawa Dam) (Photographed by PWRI on June 16, 2008)

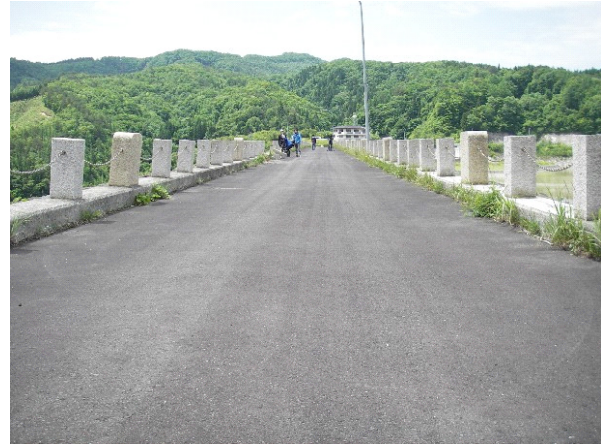
Photo.9 Few cracks in the crest pavement in spite of the dam body settlement (Aratozawa Dam) (Photographed by PWRI on June 16, 2008)

Based on the results of emergency investigation, it was judged that no serious problems threatened the safety of the dam at the time of our investigation. MAFF has established a technical committee and started a detailed survey to prepare for restoration of the dam.

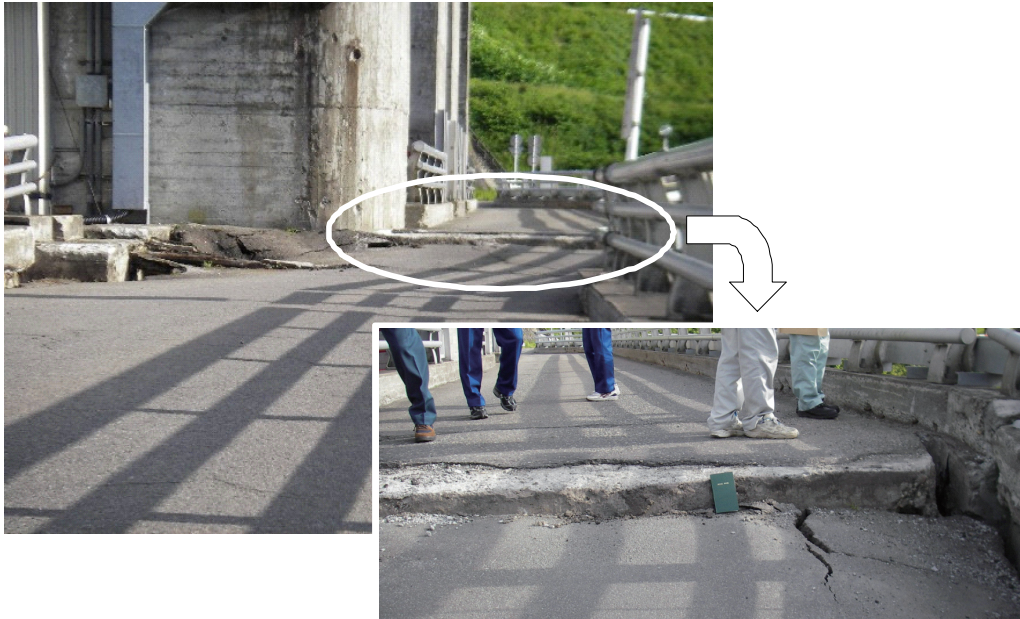
No cracks were confirmed on the pavement at the crest. Crest settlement of about maximum 14cm was observed, and at the connection of the spillway and the rockfill dam body, a level difference of about 15cm formed shown in Photo.

10. No deformation was confirmed on the upstream facing and the downstream rock slope surface.

Photo.10 Level difference occurred at the connection of the spillway concrete and the rockfill dam body as a result of the settlement of the dam body (Minase Dam) (Photographed by PWRI on June 15, 2008)

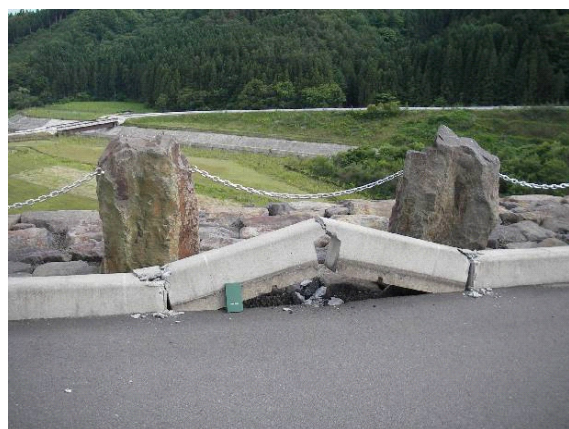
The settlement at the crest was a maximum of 3.8cm and the horizontal displacement in the stream direction was a maximum of 5 to 6cm, but the horizontal displacement in the dam axis direction was a little large at a maximum of about 13cm. And the curbstones on the crest were partially damaged by compression as shown in Photo. 11. No conspicuous cracks were, however, found on the crest pavement. And the riprap on the upstream and downstream sides was free of any deformation.

Photo.11 The damaged curbstone on the crest shoulder (Koda Dam) (Photographed by PWRI on June 16, 2008)
