Investigation and Repair on Deteriorated Transverse joint of Kasabori Dam

ABSTRACT:

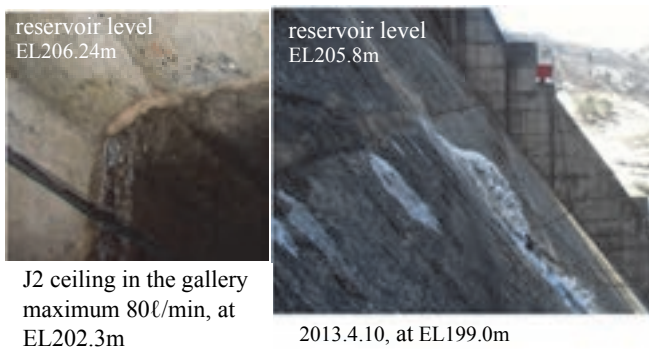
Figure 11. Water leakage situation through the J2 joint

- (1) When the reservoir level was about EL195.0m, the water leakage in the downstream was not confirmed.
- (2) When the reservoir level was EL201.5-203.5m, the water exuded from the joint of EL194-196 m.
- (3) When the reservoir level was EL204.5-206.5m, the water leaked from the joint of EL199.0m (See Fig. 11).

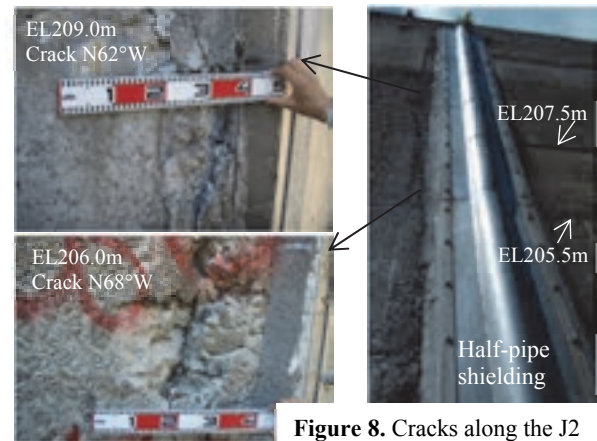
Figure 8. Cracks along the J2

The deterioration condition of J2 upstream face is shown in Fig. 8. Although the water stop work was carried out by installing half-pipe shielding of stainless steel during the first redevelopment (ended in 1979), at present, big cracks have extended to the left along the half-pipe shielding, which was the locations of the water passageways (Fig. 9).

Eventually, it was estimated that the water passageway is mainly "Open crack along J2 over EL200m => Estimated crack line through the dam body in Fig. 9 => J2 joint and inspection gallery => the J2 downstream end between EL199~196m". Thus, it was decided to thoroughly cut and remove the deteriorated concrete around J2, and to reconstruct the transverse joint.

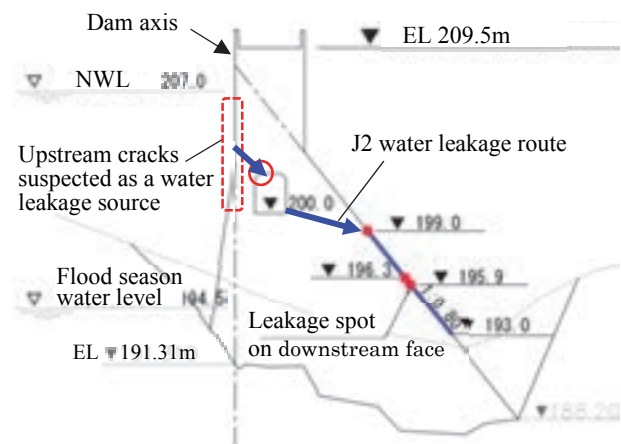
Figure 10. Cross-section of J2 and a water leakage route

In the downstream face of J2, water leakage at a maximum of 500 l/min was measured in April 2013 when the reservoir level rose. Then, coloured water was injected from the bore hole, confirming that the crack along J2 is the main water passageway. Moreover, a suction opening was found by an underwater diving search at the upstream face near J2, and a drilling and endoscope survey confirmed that the cracks on the upstream face originated at J2 with the inner part. Based on the above water-passageway survey at J2 and its adjacent blocks, the following three points were confirmed as a main water leakage route (See Fig. 10)

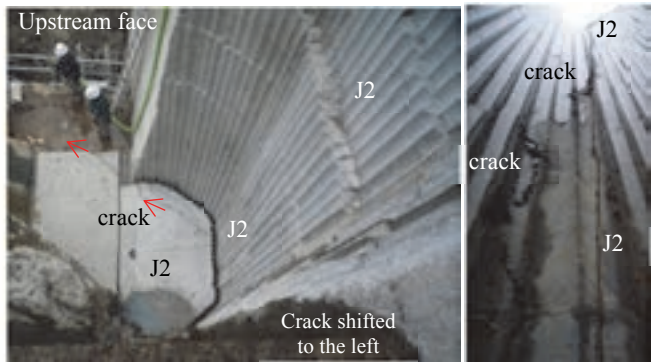
Figure 12. Cutting face and cracks at EL195.0m, 2015.2.26

These works were started in November, 2014 after lowering the reservoir water level, and ended in June, 2015. The cutting situation and extended cracks along J2 are shown in Fig. 12.

The crack was transmitted from the shear key in the water-stop copperplate, and has reached J2.

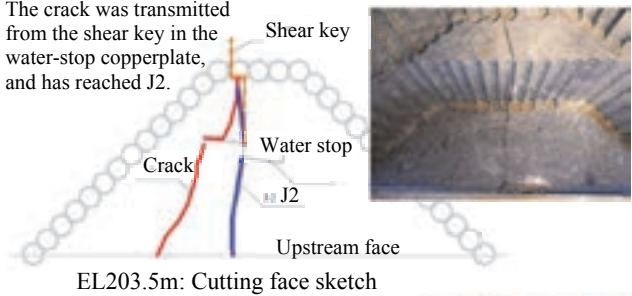
The crack of the downstream disappeared from the water stop.

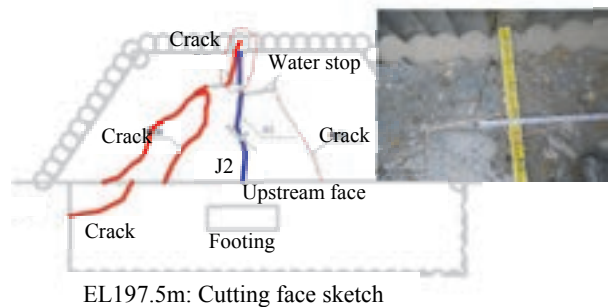
The crack is extended from the water stop to the downstream, and the crack was barely distributed inside the cutting width.

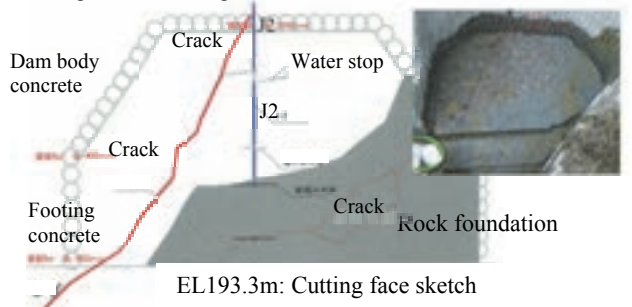
Figure 13. Cutting face observation along the J2

The main crack passed through the left end of the copper water stop from inside J2, and it extended toward the upstream face. It is presumed that the water passageway occurred along the main crack. In the dam bottom, the main crack pierced through the concrete footing adjacent to the upstream side. It was shown that the crack progressed to the upstream side.

The above main cracks continued downward along the left side of the half pipe shielding. The crack tended to incline towards the left (valley side) on the topographic slope. Further, the cracks were extended at the lower elevation, and reached the surface of the bedrock below the dam bottom. In addition, in the vertical cutting face, the crack shifted to the left side at the lower elevation.

It can be said that the main crack progressed upstream from downstream. It is assumed that the shearing that occurred in J2 initiated the crack, and extended it to the upstream face through the left end of the copper water stop. At the dam bottom, the main crack pierced the footing upstream, and below, it also extended to the surface of the bedrock.

The concrete crack is going through the water-stop edge to J2. The crack is mostly contained in the exposed rock foundation, and the right side of cutting face is reached at the rock foundation.

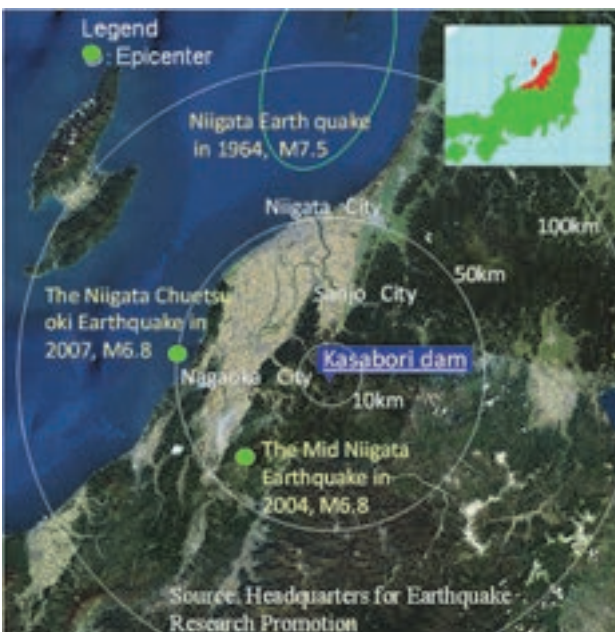
Figure 16. Kasabori dam and the past major earthquakes

The largest external force that induced the above crack was presumably the Niigata Earthquake in 1964 (June 16, 1964, see Fig. 16), which generated quite strong shaking with seismic intensity of 5 on the JMA (Japan Metrological Agency) scale in this vicinity. Although placing concrete at the Kasabori dam ended in October, 1964, the earthquake struck in the middle of high elevation concrete placing in June, 1964. Since the dam concrete, which had not reached sufficient strength suffered from the very strong ground motion, it is easy to imagine that many invisible cracks and other damages might have occurred inside the dam body near J2 and other transverse joints at that time.

On October 23, 2004, the Mid Niigata Earthquake struck the Kasabori dam, causing extremely strong shaking, which recorded 622 cm/s^2 at the dam crest. Then, while the leakage from the inspection gallery decreased sharply, the leakage from the J2 downstream face increased remarkably. It seems, therefore, that the cracks to the downstream face were enlarged and the water-passageway was changed, by this earthquake.
