# Abrasion and Corrective Measures of a Sediment Bypass System at Asahi Dam

**T. Nishikawa & Y. Yamane**

This paper describes the abrasion of the tunnel invert of the sediment bypass system at the Asahi Dam that has been in operation for approximately 15 years, and evaluates possible tunnel maintenance methods using the life-cycle cost based on monitored data of abrasion.

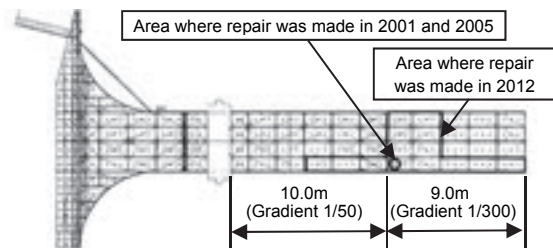
Figure 7. Areas repaired with steel plates at the intake

The intake of the bypass tunnel was lined with steel plates because the severest abrasion was expected. Damage was made predominantly on the right bank side in the steel-plate-applied area where the slope is changed from sharp to moderate (Fig. 7) and sediment likely flowed on the right bank side. Repair has been made three times in this area since the commencement of operation. After the flood of 2011, repair was made again in a wider area mainly on the right bank side too. Frequency of repair has, however, been much less than in the tunnel section.

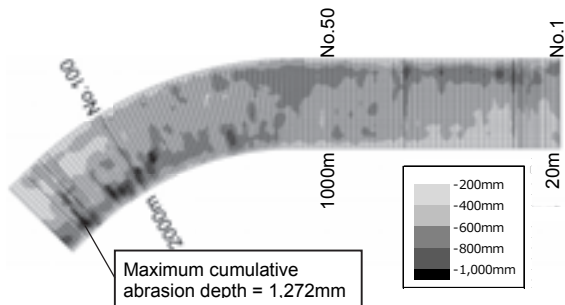
**Figure 8.** Cumulative abrasion in the tunnel invert (sum of abrasion between the commencement of bypass operation and November 2011)

Abrasion on concrete section was observed nearly throughout the invert in the tunnel section. Repair was made periodically using higher-strength concrete (design strength: 70 N/mm<sup>2</sup>) instead of concrete of 36N/mm<sup>2</sup>. From a viewpoint of tunnel structure, fracture of reinforcement in the invert was allowed, however, the invert was repaired before the rock was exposed to prevent adverse effects on the sidewalls and arch section. In actual, repair was made on a priority basis before the fracture of reinforcement over a length of approximately 100 m from the intake which was an important part to tunnel structure. Sidewalls were worn slightly in areas at low elevations. In the arch, long-term cracking and exposure of reinforcement were observed in some areas. Because it

was unlikely that sediment of the grain size contributing to abrasion reached the arch, these phenomena were attributed to the effects of ordinary deterioration. As abrasion in the invert was predominant, the past records of distribution and volume of abrasion in the invert were focused and summarized. The cumulative abrasion since the commencement of bypass operation is shown using contours to verify the tendency of planar distribution of abrasion (Fig. 8). The cumulative abrasion is calculated by annual measurement results. The depth of abrasion is locally larger near the tunnel outlet than near the tunnel intake. In the transverse direction, abrasion was predominant on the right bank side at the intake and on the left bank side at the outlet. The maximum cumulative abrasion depth on the left bank side at the outlet was largest at 1,272 mm. The tendency shows that the sediment does not flow uniformly in the cross section but flows in a certain pattern due to the tunnel alignment that bends leftward from the midpoint. In other words, bed load concentrate on the right bank side at the intake and then on the left bank side downstream of the bend owing to the secondary flow created by bending, resulting in increase in abrasion volume. Abrasion depth was larger at the outlet than at the intake also because secondary flow was more likely to develop in the bend than at the intake and consequently the points of passing sediment flow were concentrated more.

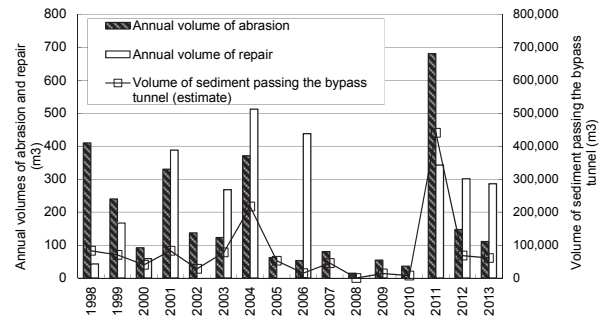
**Figure 9.** Annual volumes of abrasion and repair

The results of measurement of the volume of sediment that passed the bypass tunnel, volume of abrasion in the tunnel invert and the volume of materials used for repair are shown in Fig. 9 in order to quantitatively evaluate abrasion. The changes in abrasion volume affected by the volume of sediment passing the bypass tunnel were indicated by the relation between annual volume of abrasion and sediment load in the bypass tunnel (annual abrasion volume (m<sup>3</sup>/year)/sediment load in the bypass tunnel (m<sup>3</sup>/year) (Fig. 10). The volume of abrasion tends to increase nearly in proportion to the volume of sediment that passed the bypass tunnel. The volume of abrasion that was highest in 2011 when the maximum flow was recorded. The percentage of high-strength concrete increased on the invert surface of the bypass tunnel owing to periodical repair (Fig. 11). Fig. 10 shows that the volume of abrasion relative to the volume of sediment decreased from 2003 when the percentage of high-strength concrete exceeded

70% and in subsequent years. In addition, the planar distribution of abrasion was not affected by the volume of passing sediment, and abrasion was predominant in the convex bend.

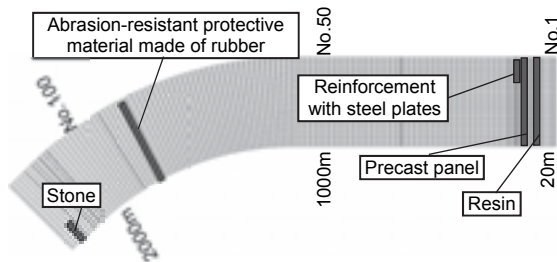
Figure 12. Locations of materials applied in trial construction

Other materials than concrete have also been applied in the invert on a trial basis in order to confirm effectiveness of the original design since 1999. Fig. 12 shows how they were placed. As reinforcing materials, higher-strength precast panels, steel plates and stones which had a good record as materials highly resistant to abrasion, and resins with a low modulus of elasticity were selected. The abrasion resistance of respective materials was tested and monitored through actual bypassing. Nearly all of the materials were greatly worn or delaminated in a few years after its construction. It was found that abrasion was likely to progress from the joint of the material, and created a weak point and that the reinforcing material was

delaminated rapidly at once owing to the impact of gravel or for other reasons. In 2013, an abrasion-resistant protective material made of rubber, which has been applied in many sabo dams, was placed as one of trial materials additionally.

The condition was verified ten months after its installation. As a result, it was found that the volume of abrasion was greater in the bypass tunnel than in sabo dams as the mean abrasion volume was 0.7 to 1.1 mm/year in the bypass tunnel while actual mean abrasion volume in sabo dams was 0.1 to 0.3 mm/year.

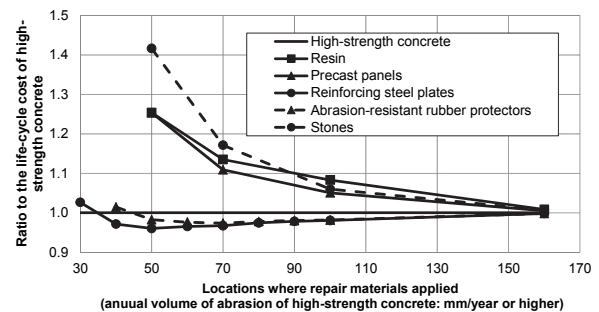
Figure 13. Relationship between the location of repair and life-cycle cost

Fig. 13 shows that the life-cycle cost in cases where resin, precast panels and stones were used were higher than in the case where higher-strength concrete was applied throughout the invert. The life-cycle cost of the case which reinforcing steel plates and abrasion-resistant rubber protectors were used were at a minimum level in case that the material were applied at the location with annual volume of abrasion of high-strength concrete were 50~70mm/year. Applying the materials at a location with smaller annual volume of abrasion led to the increase of

the area where the material should be applied, and increased the life-cycle cost. When the materials were applied in locations with large annual volume of abrasion, life-cycle cost also increased because the area of high-strength concrete that requires frequent repair increased although the area where the material was applied decreased. Life-cycle cost was the lowest in the case where reinforcing steel plates were applied in locations with an annual volume of abrasion of 50 mm or higher. Life-cycle cost was reduced compared to the case where high-strength concrete was applied throughout the invert by approximately 4% in 50 years. Thus, the effect of cost reduction was very small. In the case where abrasion-resistant rubber protectors were adopted, the life-cycle cost was estimated approximately 3% below the high-strength concrete case.

In view of the above discussions, the repair method using high-strength concrete as currently practiced is considered efficient and valid because it requires no large-scale equipment, unlike the method employing reinforcing steel plates, and because it is applicable to the points of repair of varying shapes that are scattered in the invert.

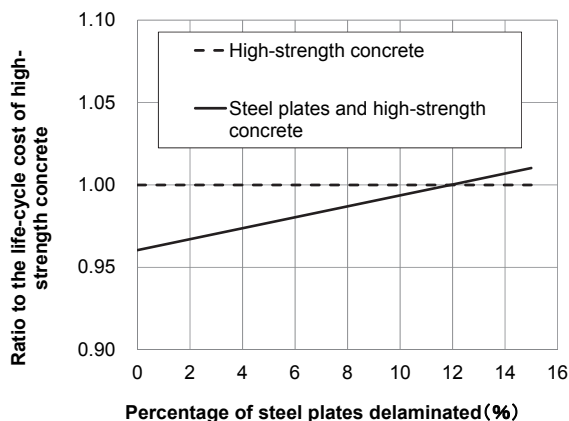
**Figure 14.** Relationship between the percentage of steel plates delaminated and life-cycle cost

Reinforcing steel plates were selected as the most economical repair material based on the results of comparison in life-cycle cost. Reinforcing steel plates, however, have several drawbacks. Uplifting or delamination occurred for unknown reasons in trial construction. There is a possibility of abrasion advancing from the point of uplifting. Such defects, once they occur, involve large-scale repair work. The life-cycle cost shown in Fig. 13 takes no effects of steel plate delamination into consideration. If the effects are considered, life-cycle cost is likely to exceed the cost in the case where high-strength concrete is applied throughout the invert. It was assumed that a certain percentage of reinforcing steel plates are delaminated every five years according to the results of the trial construction, and life-cycle cost including the cost of repair of delaminated steel plates were compared (Fig. 14). It was found that life-cycle cost of reinforcing steel plates exceeded the cost in the case where high-strength concrete was applied throughout the invert when the percentage of delaminated plates exceeded 12%. As the area where reinforcing steel plates were applied in this study (Fig. 15) involve uncertainty, making repairs in a large area bundling scattered locations where reinforcing steel plates should be applied is practical, and then applying reinforcing steel plates is no longer advantageous in terms of cost because high unit cost is required.

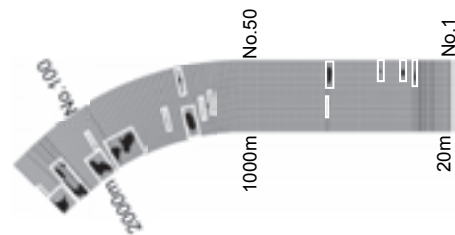
**Figure 15.** Locations where reinforcing steel plates were applied

Shown in black: Locations with an annual volume of abrasion of 50 mm/year or higher  
 Shown in white: Locations where reinforcing steel plates were applied
