VINGT TROISIÈME CONGRÈS
DES GRANDS BARRAGES
Brasilia, Mai 2009

**REHABILITATION OF THE TAISHAKUGAWA DAM WITH THE AIM OF
IMPROVING FLOOD DISCHARGE CAPACITY AND SEISMIC STABILITY ***

The Chugoku Electric Power Co., Inc., one of the major electric utilities in Japan, executed the rehabilitation of an old concrete gravity dam with the aim of improving flood discharge capacity and seismic stability.

The rehabilitation work of the Taishakugawa dam commenced in June 2003 and was completed in June 2006.

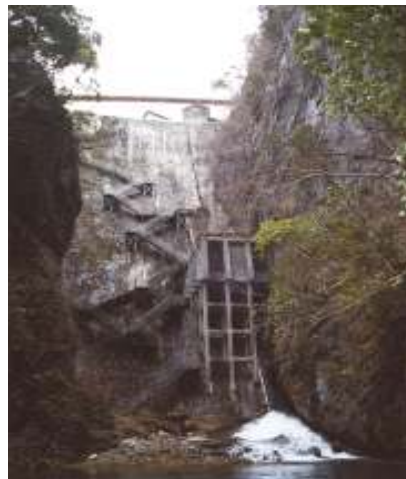
Fig. 2
The Taishakugawa dam
(Before rehabilitation)
*Le barrage de Taishakugawa
(avant la réhabilitation)*

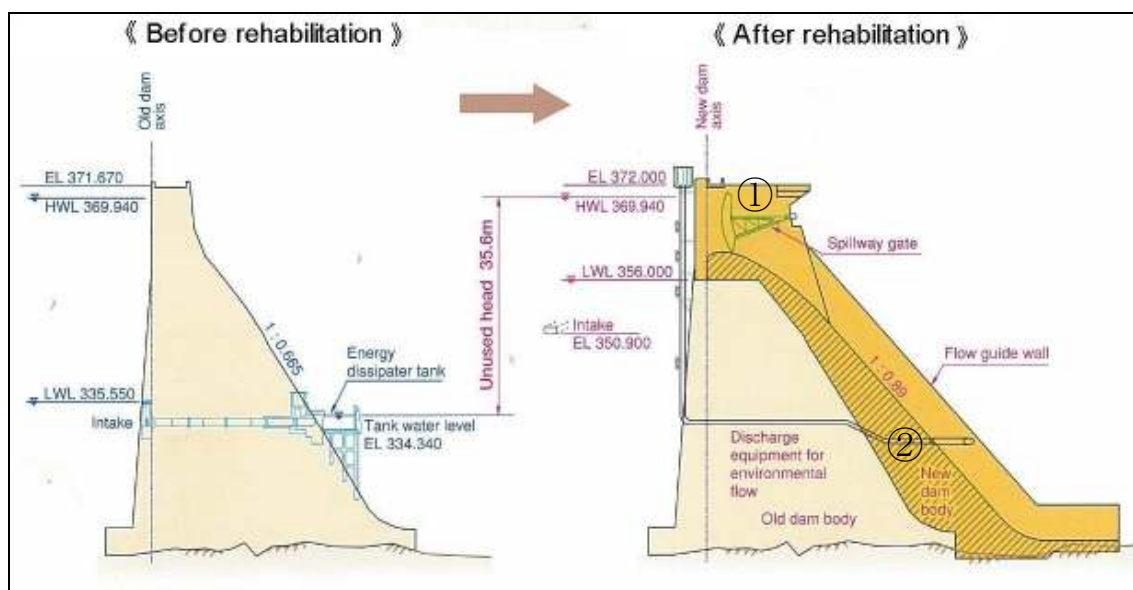
Fig. 3
Cross section of the rehabilitation work
Coupe du chantier de réhabilitation

The rehabilitation work of the Taishakugawa dam is outlined in Fig. 3. The upper part of the existing dam body was cut off so that the overflow type spillway

1 Installation of additional spillway
2 Placing of new concrete

was installed on the top of the dam for the improvement of flood discharge capability and new concrete was added on the downstream face of existing dam body for the improvement of seismic stability. Table 1 shows the dimensions of the Taishakugawa dam before and after rehabilitation.

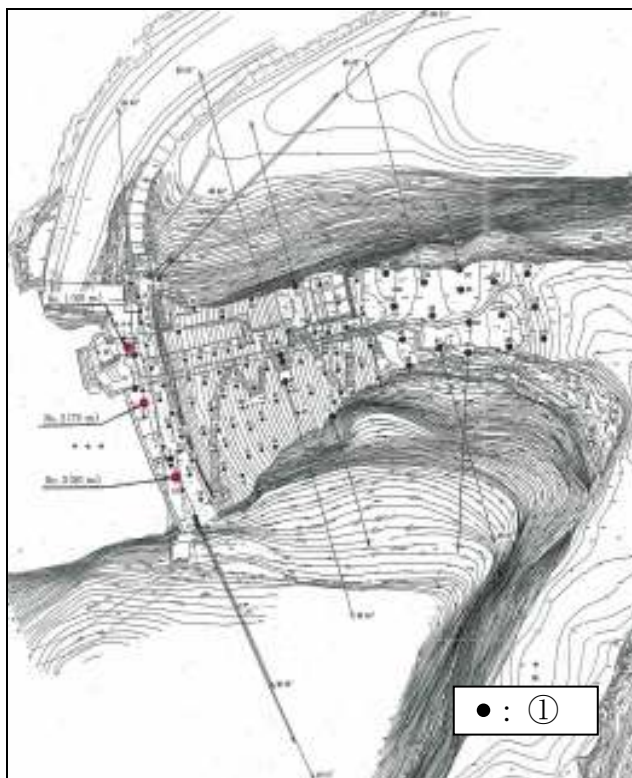
Fig. 5

Exhaustive examinations on the records of past countermeasure works of the dam body were carried out and the effect of countermeasure works was grasped by the results of over 100 borings shown in Fig. 5.

Test results of boring core showed that compressive strength and unit weight were approximately 20 N/mm and 2.34 g/ cm³ on an average respectively, and it was assured that carbonation was not seen by the effect of the masonry facing on the surface of the dam body.

Judging from the results above mentioned, the concrete of existing dam body had enough properties such as watertightness, strength and unit weight required for dam concrete. Consequently, it was proved that the existing dam concrete could be used continuously as a part of new dam.

Borings for the evaluation of the soundness of existing dam body
Forages pour l'évaluation de la tenue du corps de barrage existant

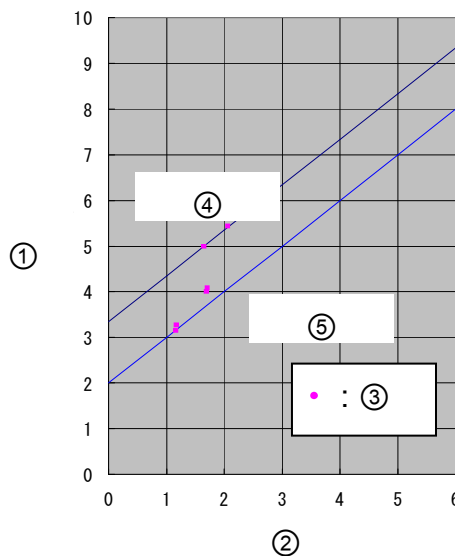
Fig. 6 shows the result of in-situ shear tests. The shear strength of the boundary of existing and new concrete was estimated at least 2.0N/mm² from this figure, and the maximum stress calculated was 0.5N/mm². Therefore, unification of existing and new dam bodies was confirmed.

The Result of the in-situ shear tests
Résultat des essais de cisaillement in-situ

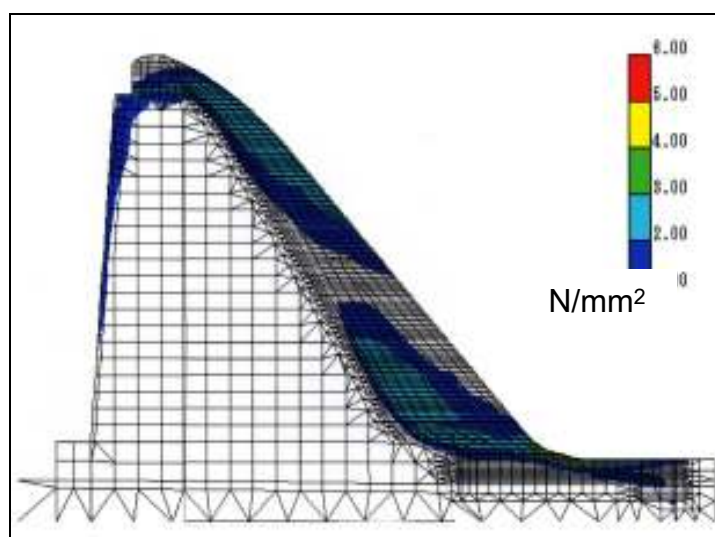
Fig. 7

As a result, it was confirmed that shrinkage by the cooled heat of new concrete generated peculiar tensile stress to the vicinity of the boundary between existing and new dam bodies and the upstream of existing dam body, as shown in Fig. 7.

Example of the results of thermal stress analysis
(Maximum tensile stress)

If concrete cracks at these places, it would have a big influence on the watertightness of the dam. So, on the boundary between existing and new dam bodies in the uppermost part of existing dam body, reinforcement works with the reinforcing bars and waterstops in the direction of the dam axis were executed, as shown in Fig. 8.

As for the tensile stress in the upstream of existing dam body, generated stress was less than the tensile strength of existing dam body. But, considering the importance of watertightness of the dam, grouting in the upstream of existing dam body was executed to make doubly sure.

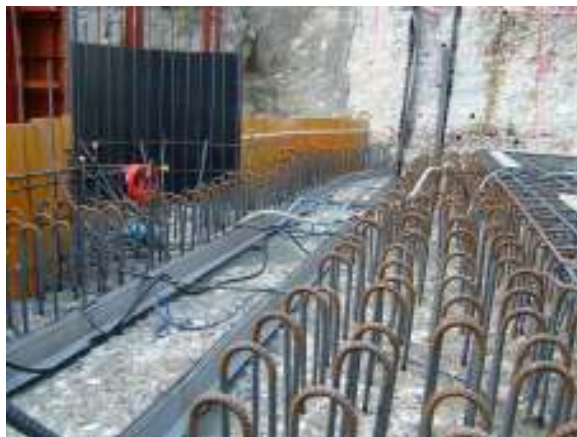
Fig. 8

Reinforcement works on the boundary of existing and new dam bodies
Travaux de renforcement sur les limites du corps existant et du nouveau corps

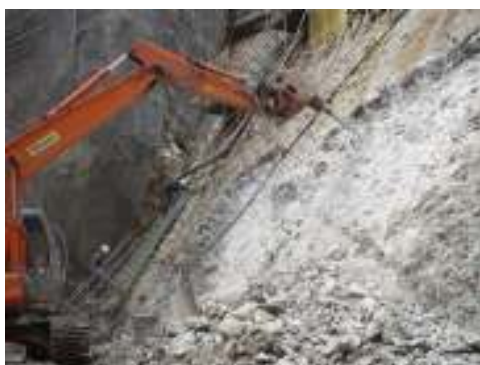
Fig. 11

Removal work of masonry facing and chipping
Démolition du masque en maçonnerie frontale et burinage

From the viewpoint that ensured the unification of existing and new dam bodies, removal of masonry facing and the chipping on the surface of existing dam body were carried out with a concrete breaker in parallel with new concrete placing, as shown in Fig.11.

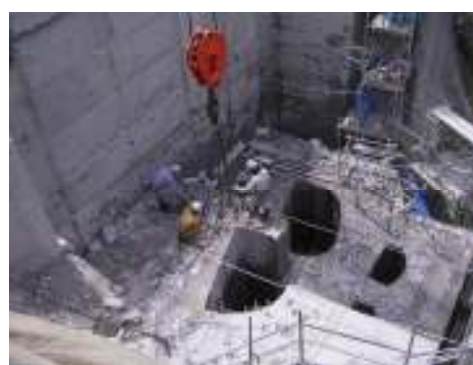
Fig. 12

Removal work of existing dam body by wire sewing saw
Retrait du corps existant du barrage avec la méthode de la piqûre au fil métallique

To install the spillway gates newly on the top of the dam, the upper part of existing dam body of about 16m (concrete amount about 5,000m³) was removed. This removal work was carried out by the wire sewing method (See Fig.12) , which is one of the concrete cutting methods by turning the diamond-encrusted wire continuously, together by a concrete breaker using the nonexplosive demolition agent.

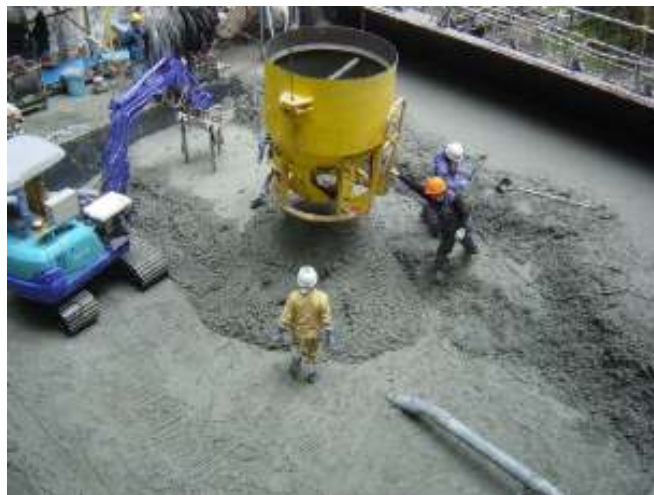
Fig.13
Concrete placing
Déposition du béton

Because the aggregate is stirred easily by the vibrator for the dam of $\phi 150$ mm accompanied by the adoption of the maximum aggregate size of 40 mm and the construction area was extremely narrow compared with usual dam construction sites, the small-scale vibrator vehicle of the special specification of which the vibrator was $\phi 60$ mm was developed aiming at the rationalization of construction, as shown in Fig. 13.

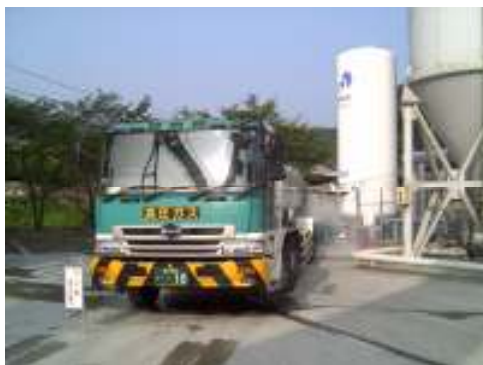
Fig.14

LN₂ plant installed at the ready-mixed concrete plant

Reflecting the result of the thermal stress analysis, concrete pre-cooling by liquid nitrogen (LN_2) was carried out considering the influence of thermal stress by placing concrete in summer. LN_2 plant was installed at the ready-mixed concrete plant and LN_2 was put into concrete during the mixing. The concrete temperature when it was placed in the site was aiming at $20^\circ C$. Moreover, to prevent the concrete temperature rising by heat as much as possible, the heat insulator cover was installed in the agitating truck. Because of the circumstances around the ready-mixed concrete plant, concrete placing in the night-time in summer was abandoned.

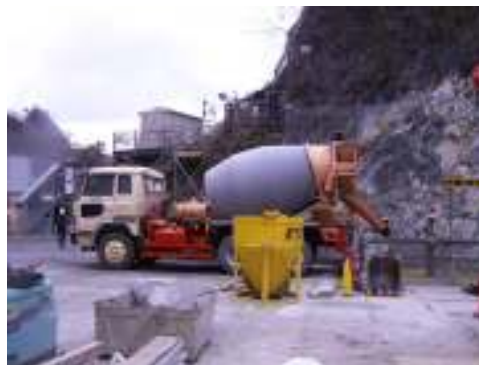
Fig.15

Heat insulator cover installed in the agitating truck

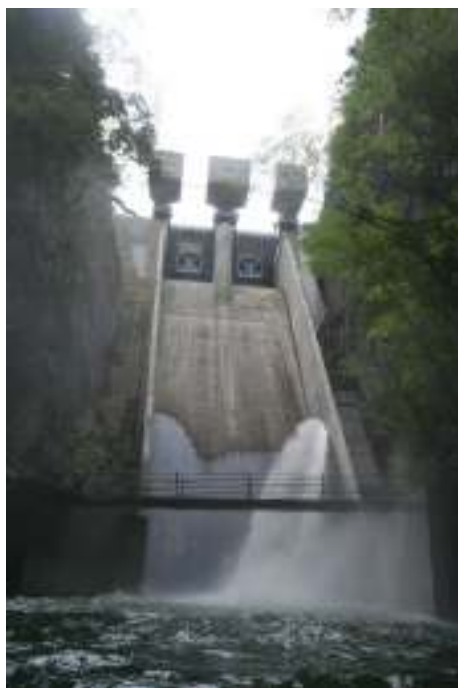
Fig. 16

The Taishakugawa dam after rehabilitation
Le barrage de Taishakugawa après la réhabilitation
