VINGT TROISIÈME CONGRÈS
DES GRANDS BARRAGES
Brasilia, Mai 2009

**BEHAVIOR OF A LARGE-SCALE ROCKFILL DAM CONSTRUCTED ON SAND
AND GRAVEL FOUNDATION DURING FIRST FILLING OF RESERVOIR ***

Chubetsu Dam is a multi-purpose dam 86m in height and with a total storage capacity of 93,000,000 m³. It is constructed across the Chubetsu River that runs in the central part of Hokkaido, Japan. It is a combined type of a concrete

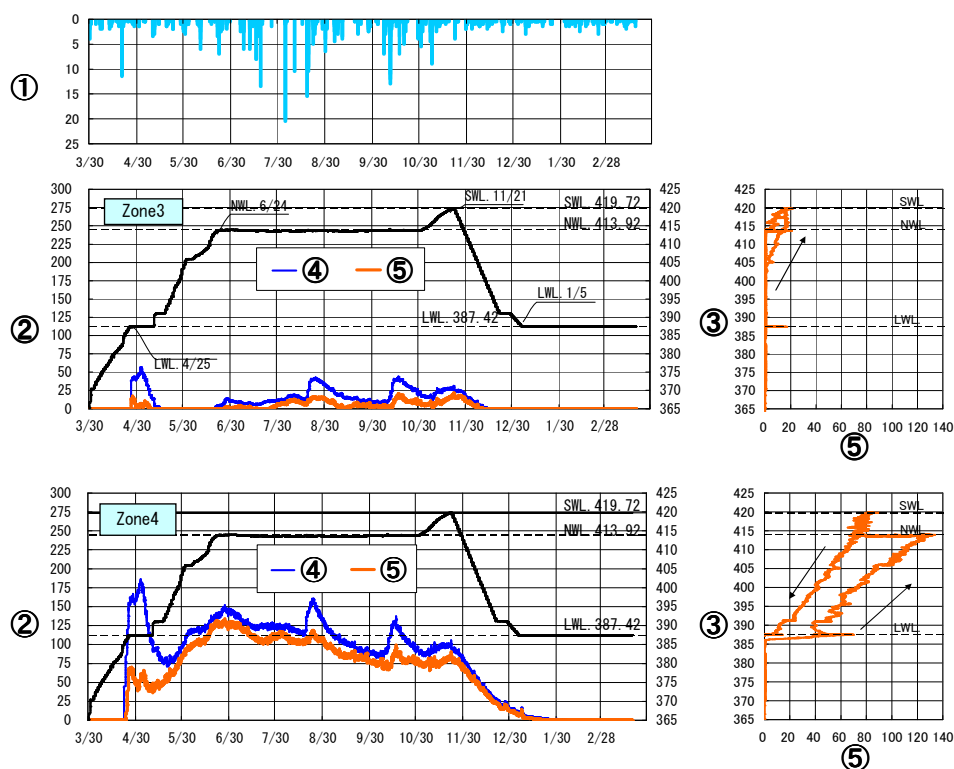
Fig. 4

In Zones 1 and 2 on the left-bank side, the volume of seepage flows from the foundation was too small for measurement. In Zones 3, 4, 5 and 6, substantial volumes of seepage flows were observed when the snow thawed or when it rained, even before first filling of reservoir. To ensure that seepage flows were accurately measured; those from the reservoir were used for the measurement so that these will not be affected by a thaw or rainfall. Therefore, seepage flows due to rainfall was estimated when there was no thaw and when it did not snow, using a highly-reproducible tank model, while seepage flows due to a thaw was estimated using a temperature-rainfall correlation equation. [2].

Fig.4 shows seepage flows based on the above estimation that is not affected by a thaw or rainfall. In each Zone, there is a difference in seepage flows between, until and when the water reaches its normal water level, however, they are generally in linear correlation with the reservoir water levels. In Zone 3, particularly, which has a diaphragm wall for water interception, the volume of seepage flows is less than in other Zones. Moreover, there was no muddiness in the observed seepage.

Based on the correlation between the above estimated seepage flows and reservoir water levels, it was found that the seepage flows directly coming from the reservoir are relatively less and highly correlated with the reservoir water levels. This behavior was considered safe.

Change in seepage flows in the rockfill dam

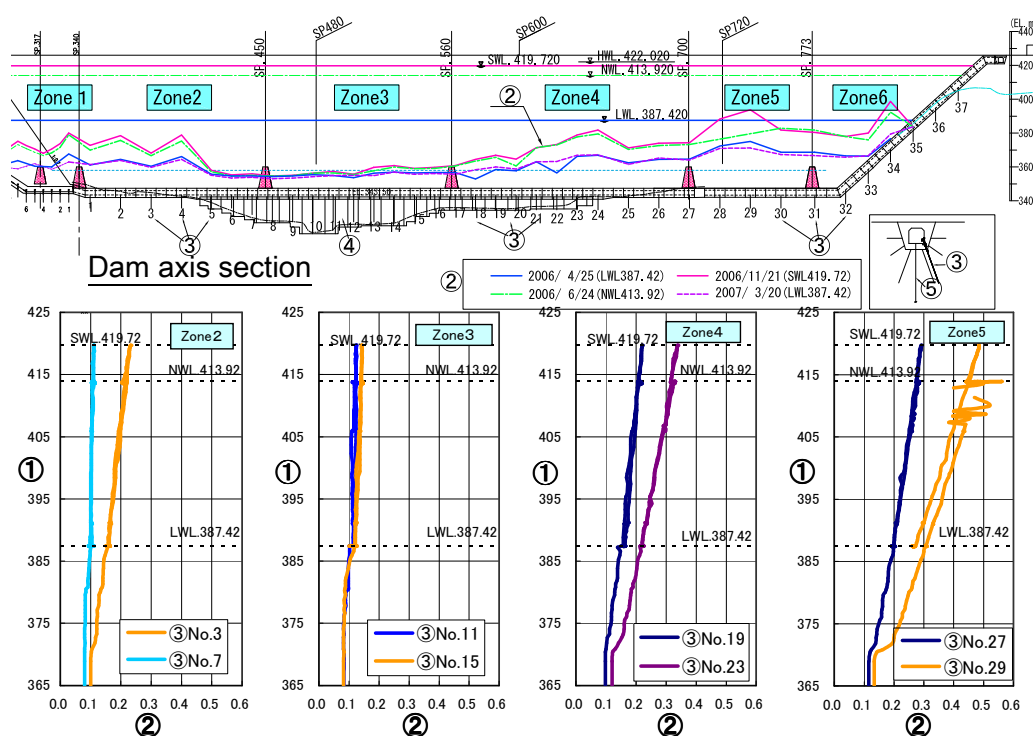
Fig.5

As the longitudinal cross-section of the rockfill dam with the distribution of seepage pressure (Fig. 5) shows, seepage pressure in the rock foundation was higher than that in the sand-gravel foundation. Especially, seepage pressure in Zone 3 in the central part of the sand-gravel foundation was almost constant while the reservoir water level changed, whereas seepage pressure in Zones other than Zone 3 increased when reservoir water levels were higher (Fig.5).

Seepage flows in the rock foundation have correlation with reservoir water levels, while those in the sand-gravel foundation were considered to be intercepted by the diaphragm wall. The behavior was considered to be ascribable to the dam foundation condition and the foundation treatment.

Seepage pressure in the foundation for the rockfill dam
 Pression des percolations dans la fondation du barrage en enrochement

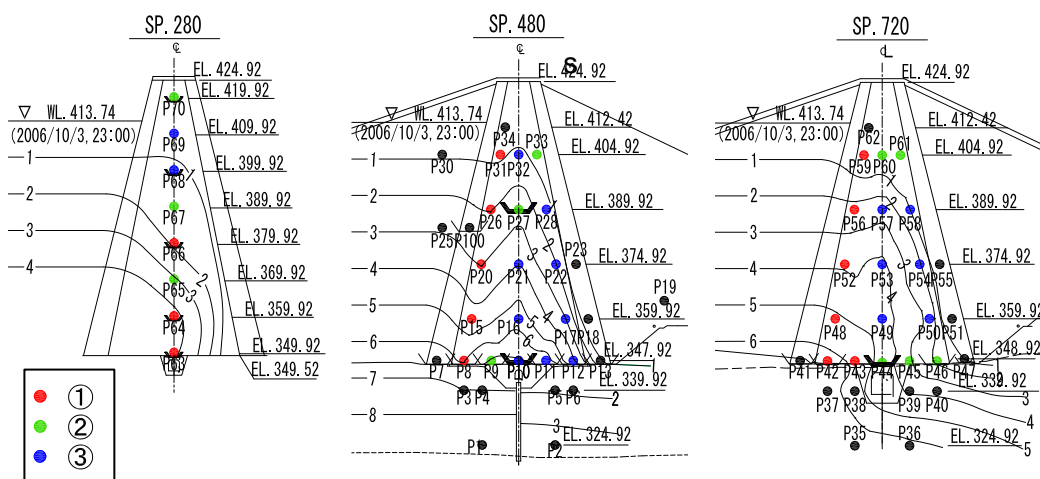
Fig.6

Distribution of ratio of pore water pressure to reservoir water pressure (as of October 3, 2006)

SP280 (dam contact): Pore water pressure was almost constant while reservoir water level changed, although P63 and P64 at lower elevations quite slightly increased at EL. 405 m and above.

SP480 and SP720: Pore water pressure on the upstream side and in the central part increased almost in proportion to the increase in reservoir water level, but there was no rapid increase. On the other hand, pore water pressure (SP480: P8, SP720: P46) on the downstream side was almost constant. In the distribution of pore water pressure, there was difference between SP480 and SP720 especially around the core base and the pressure that remained in SP480.

To understand the overall behavior of the dam with regards to the pore water pressure, the ratio of pore water pressure to reservoir water pressure, as shown in Fig. 6 (above), was calculated respectively in SP280, SP480 and SP720. The results show that there is no abnormality in the distribution of pore water pressure.

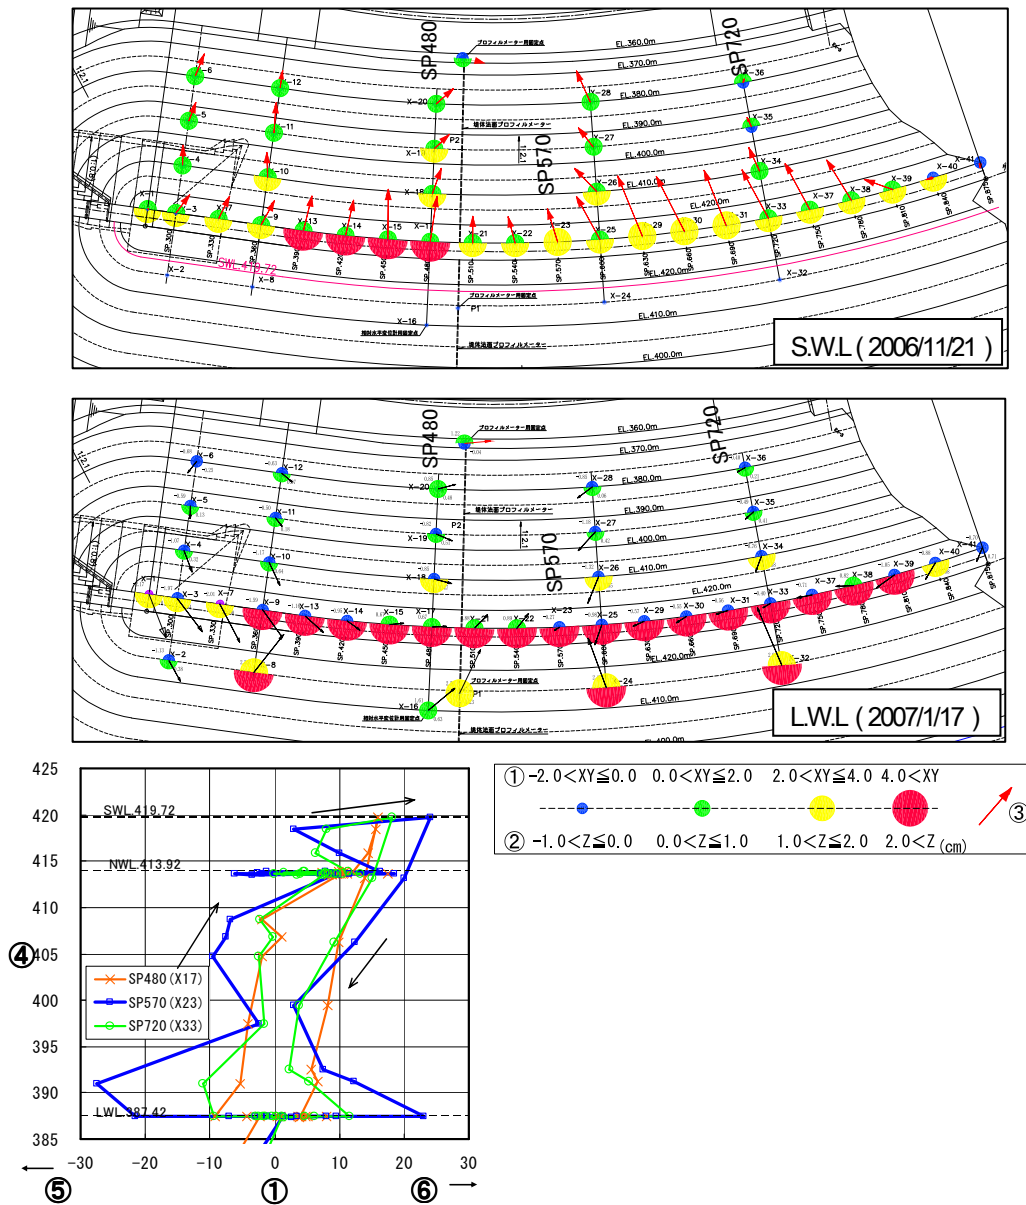
Fig. 7

Although there were different degrees of deformation, the following points were observed (Fig. 7):

- As the reservoir water level rose, horizontal displacement was observed on the downstream side. It was approximately 2.4 cm at its maximum on top of the dam (SP570 in the central part of the rockfill dam) when the water reached its surcharge water level.
- As the reservoir water level dropped, a slight displacement was observed on the upstream side and its behavior was almost elastic.
- Vertical displacement (settlement) increased with time. Especially, when reservoir water level dropped from the surcharge water level, settlement increased and was approximately 2.5 cm at its maximum on top of the dam and approximately 4 cm in the downstream side.

The exterior deformation was typically ascribable to an increase in the reservoir water level, although there was no rapid change in deformation. Although, the central part of the dam body has sand-gravel foundation, it was concluded that said foundation does not contribute to any significant deformation or settlement.

Dam surface displacement distribution

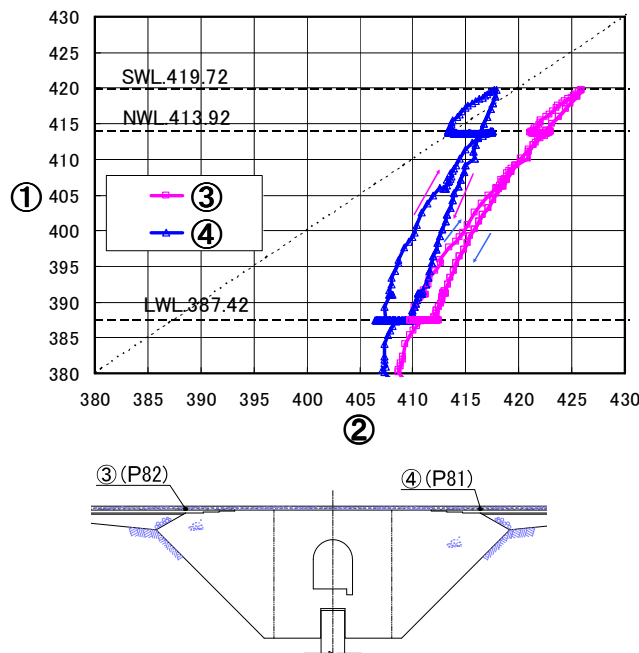
Fig. 8

Pore water pressure in the core base protections changed more slowly than the reservoir water level (Fig.8). As the reservoir water level rose, the difference in water level between the upstream and downstream sides became greater, which showed that seepage in the core base protections was well controlled.

Pore water pressure was generally high because it was difficult to disperse due to the extremely low-permeable compacted fine-grain material of the core and impervious core base protections.

In summary, no rapid change in pore water pressure was observed and consequently the core base protections were found to be impervious.

Correlation between pore water pressure in core base protections
and reservoir water level (SP486)
*Rapport entre la pression interstitielle dans la protection du noyau
et la cote du plan d'eau (SP486)*

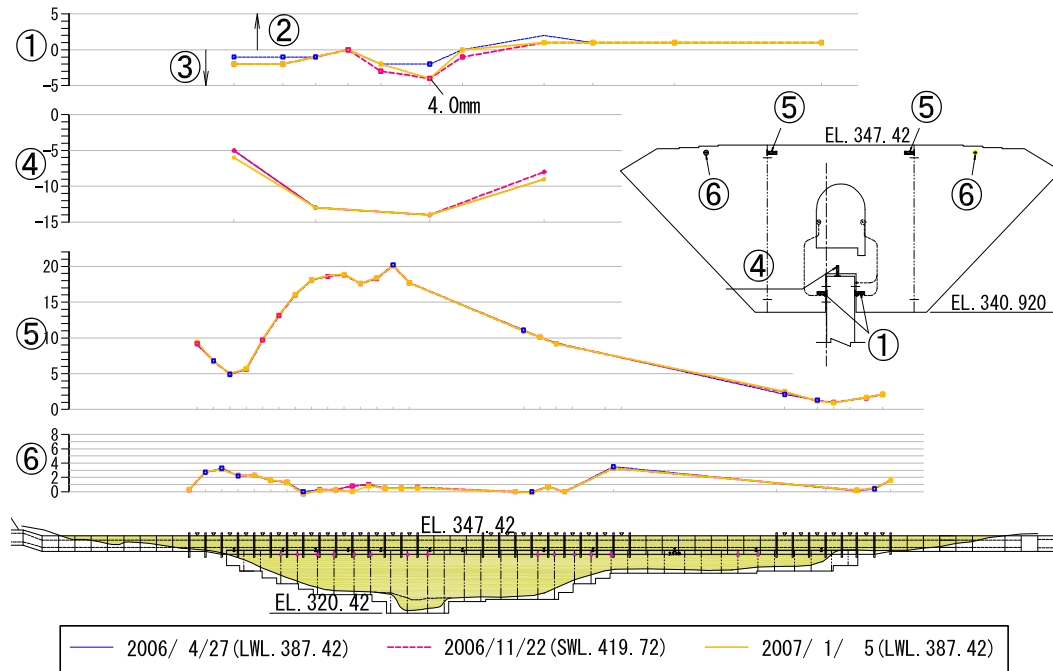
Fig.9

In both longitudinal and stress joints, there was no displacement during first filling of reservoir (Fig.9). Joint displacement was mostly observed in the embankment and converged before first filling of reservoir.

Longitudinal joints were displaced where the depth of the sand-gravel layer changed and the displacement was 4 to 6 mm at its maximum.

The displacement of stress joints was in proportion to the depth of the sand-gravel layer with a maximum of approximately 20 mm in the central part of the thickest sand-gravel layer. On both sides where the layer is thinner, displacement was also smaller. On the right of the central part, a difference in the displacement was observed between the upper and downstream sides: approximately 15 to 20 mm displacement in the joint in the upper reach and approximately 10 mm in the downstream side, for a maximum difference of approximately 10 mm.

Seepage pressure in the joint between the inspection gallery and the diaphragm wall & longitudinal cross-section of displacement measurement

Vertical displacement of the gallery-wall joint was found to be proportional to the depth of the sand-gravel layer, with the maximum of approximately 14 mm compression. Displacement during reservoir impounding was insignificant (Fig.9).

Horizontal displacement was not observed on the upstream side but on the downstream side; it was approximately 2 mm at its maximum (compression) where the depth of the sand-gravel layer is the greatest. The compression increased by approximately 2 mm during first filling of reservoir. This means that there was a decrease of approximately 4 mm at its maximum in the width of the gap.

Joint grouting was conducted for the longitudinal joints with over 10 mm displacement in the central part before first filling of reservoir.

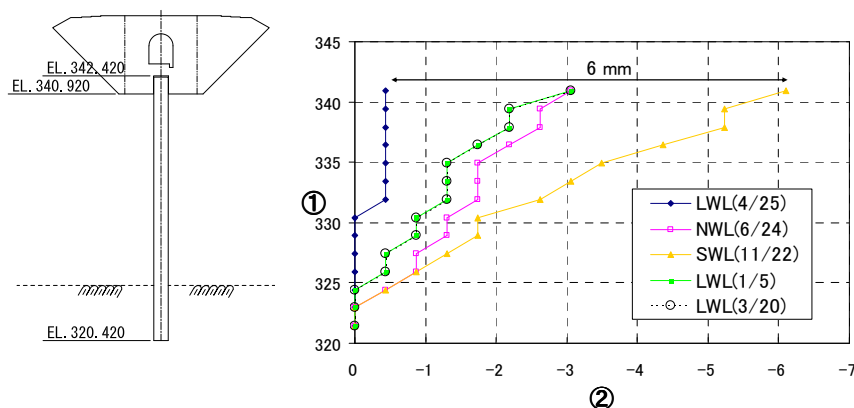
Fig. 10 shows horizontal displacement measured using the tiltmeter during first filling of reservoir. It was more significant in the upper parts. There was no displacement in the lower parts, because the diaphragm wall is embedded in the rock. As the reservoir water level rose, there was horizontal displacement toward the downstream side at around the joint with the inspection gallery in the upper parts. The displacement was approximately 6 mm when the water reached its surcharge water level. As the water level dropped, the horizontal displacement is reduced.

Horizontal displacement in the diaphragm wall (tiltmeter)
Déplacements horizontaux de la paroi étanche (Inclinomètre)

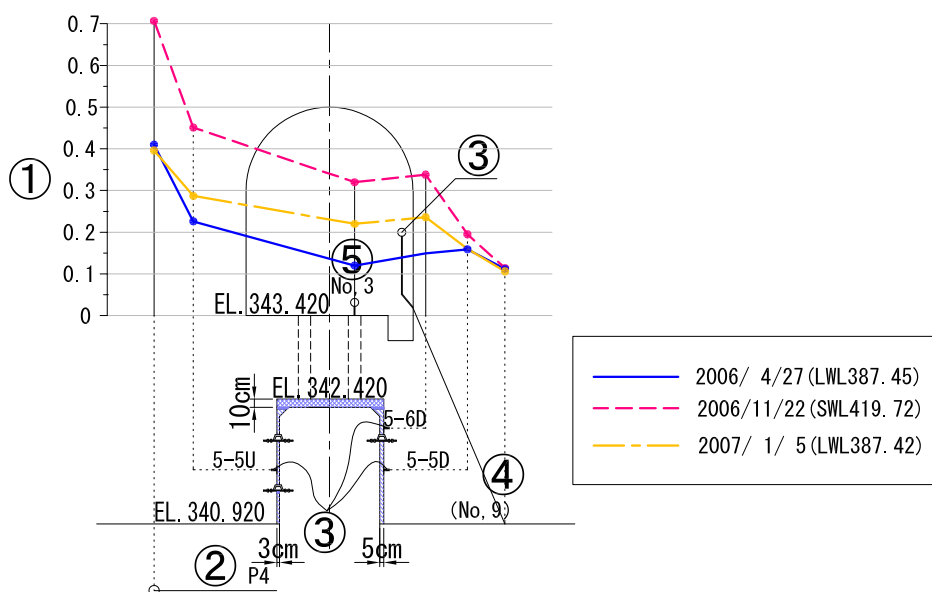
Fig.11

Seepage pressure on the upstream side of the gallery-wall joint was correlated with the reservoir water levels, while that in the lower part of the water stop on the downstream side was not and was almost constant (Fig.11). Therefore, the impermeability of the gallery-wall joint was considered to be ensured by the water stop on the downstream side.

Seepage pressure in the joint between the inspection gallery and the diaphragm wall & cross-section distribution (BL23)
