VINGT SIXIÈME CONGRÈS
DES GRANDS BARRAGES
Vienne, Juillet 2018

**SLAKING COUNTERMEASURES RELATED TO ROCK CONTACT
EXECUTION AT THE SOFT ROCKS FOUNDATION***

Satoshi YOSHIMURA, Singo TAKASUGI
Apporo Dam Construction Office, HOKKAIDO PREFECTURAL GOVERNMENT

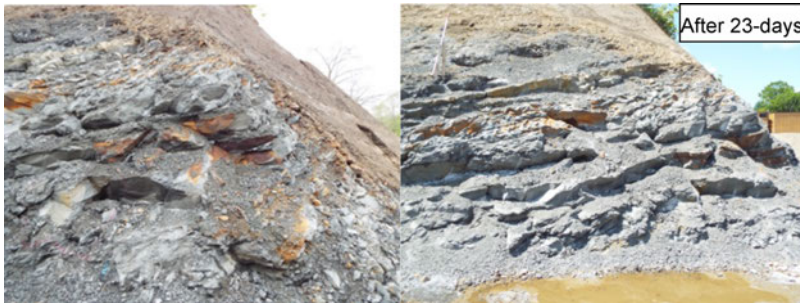
Fig. 4

However, where the surface of bedrock is exposed, hexagonal cracks caused by slaking occur and leads to fine fragments of bedrock (see Fig. 4). So, since the start of the survey, it was understood that this would be a problem to be solved for dam construction. As a result of a past survey, it was known that if bedrock surface was exposed, hexagonal cracks occurred in about 2 days, but they did not become mud, and that when the surfaces were protected by submersion or mortar, hexagonal cracks did not occur.

Slaking of shale strata exposed at long period
Relâchement de la couche de schiste exposée à longue période

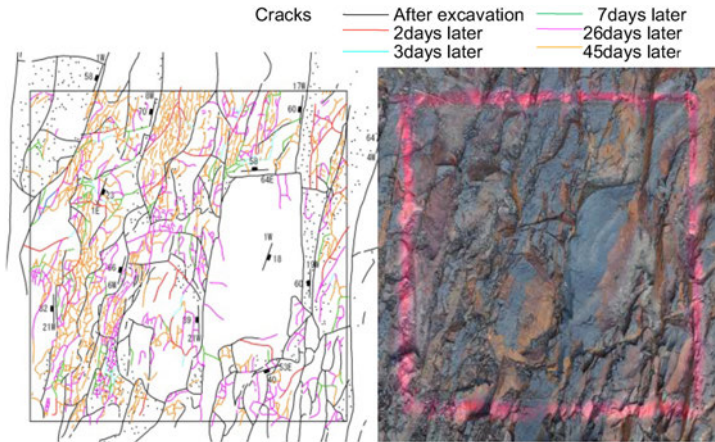
Fig. 6

In-situ test, non-protection surface (45 days after exposure)
Test in situ, surface non-protectrice (45 jours après l'exposition)

The in-situ test of the unprotected surface indicated almost no change immediately after, 3 hours after, and 6 hours after the excavation. However, it was found that cracks appeared 2 days after the start of the test and that the cracks advanced with the passage of time. Seven days later, hexagonal cracks partially increased and partial exfoliation occurred. But the depth of cracks was a few centimeters from the surface. The results up to 45 days after the excavation did not show any transformation into mud. However, until 1 day after the start of test, the test surface was maintained wet condition by rainfall. Cores sampled from the unprotected surface after one year confirmed that the cracks caused by slaking reached to a depth of only 8 cm.

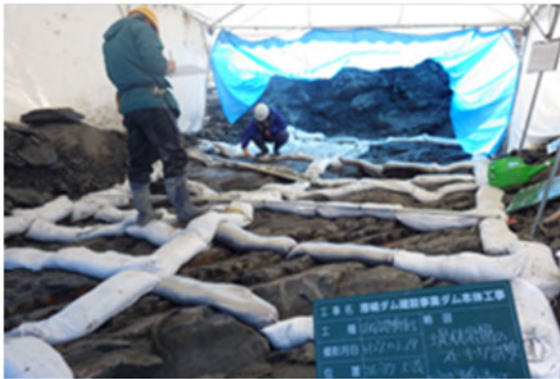
Fig. 12

Slaking confirmation test in field
Test de validation de relâchement sur le terrain

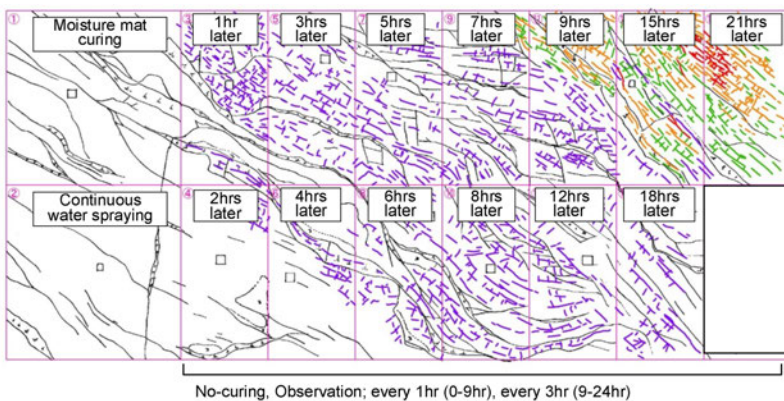
- On *Shal strata* with BIIIb; when the exposed surface was left uncured, slaking caused hexagonal cracks 2.5 hours later, and drying was accompanied by advance of cracks (see Figs. 13 and 14 (1)).
- On *Shal strata* with BIIIc; when the exposed surface was left uncured, slaking caused hexagonal cracks 1 hour and 40 minutes later, and drying was accompanied by advance of cracks (see Fig. 14 (2)).
- On *Sh strata* with BIIIc; when the exposed surface was left uncured, slaking caused hexagonal cracking 1 hour after the start of drying, but this depended on the weather.

Fig. 13
Test results at Yard 1 (alternation strata of shale and sand stone, BIIIb grade)
Résultats du test au chantier 1 (alternance couche de schiste et sable, classe BIIIb)

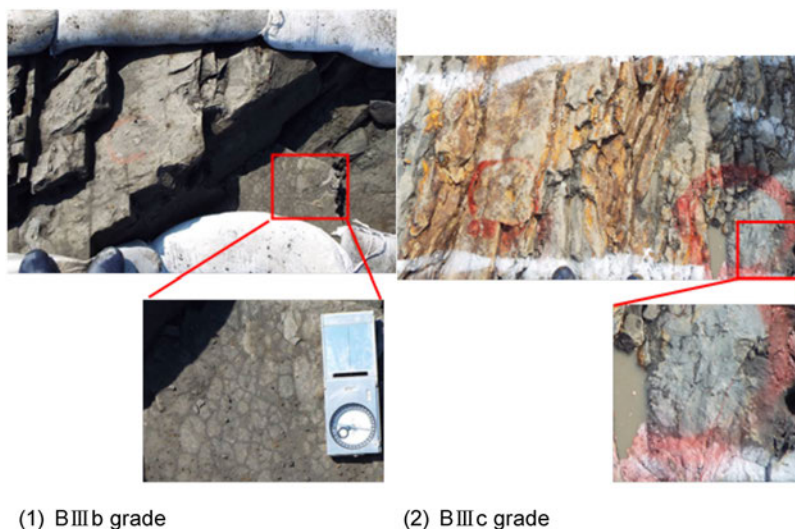
Fig 14

Crack occurrence at alternation strata of shale and sand stone
Apparition de fissure sur l'alternance couche de schiste et de sable

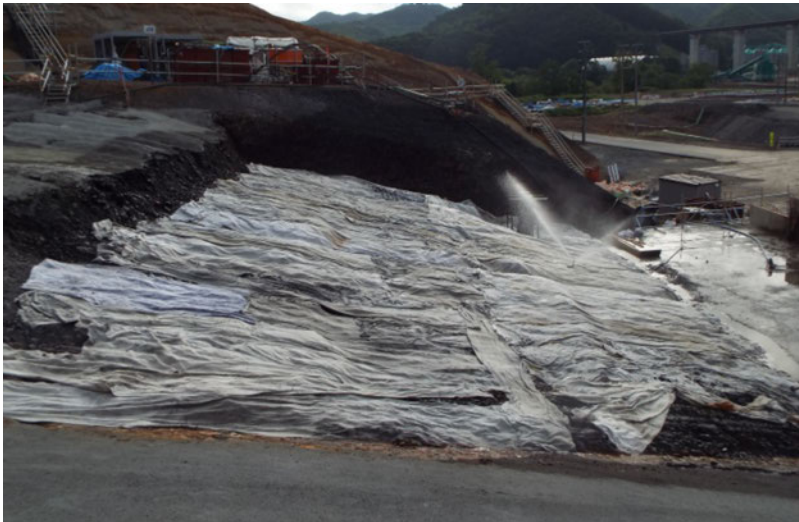
Fig. 15
Moisture mat curing of dam foundation
Maturation par l'humidité de la fondation du barrage

For this reason, secondary (finishing) excavation exposes the bedrock with classification BIIIb. Then after excavation, moisture mat curing starts within 1 hour, and the mortar is laid and placing starts within 6 days (see Fig. 15).
