VINGT SIXIÈME CONGRÈS
DES GRANDS BARRAGES
Vienne, Juillet 2018

**DISCUSSION ON THE MECHANISM OF THE DESTRUCTION OF A
SMALL-SCALE DAM BY THE 2011 OFF THE PACIFIC COAST OF TOHOKU
EARTHQUAKE AND RECONSTRUCTION AND REINFORCEMENT***

SUMMARY

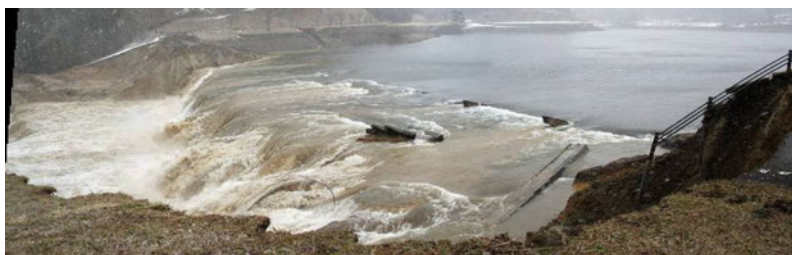
The earthquake caused the failure of the Fujinuma Dam and the failure caused serious damage including the loss of human lives in the area downstream of the dam. The Fujinuma Dam is an irrigation dam in Sukagawa City, Fukushima Prefecture. Its reservoir had a water storage capacity of 1.5 million m³. At the time of the earthquake, a large quantity of water was stored in the reservoir for the coming farming season and the water level was close to the high water level. The earthquake caused the failure of the 18.5m-high 133.2m-long embankment of the dam. A large quantity of water stored in the reservoir flooded the area downstream of the dam and the flood water caused the loss of eight precious human lives. The failure of a small-scale dam or an irrigation dam caused by an earthquake has very rarely incurred casualties in Japan. Fig 1 shows the failing embankment of the Fujinuma Dam.

Fig. 1
Failing main embankment of the Fujinuma Dam
(ataround 15:11, 11th March 2011)
Digue principale défailante du Barrage de Fujinuma
(vers 15 h 11, le 11 mars 2011)

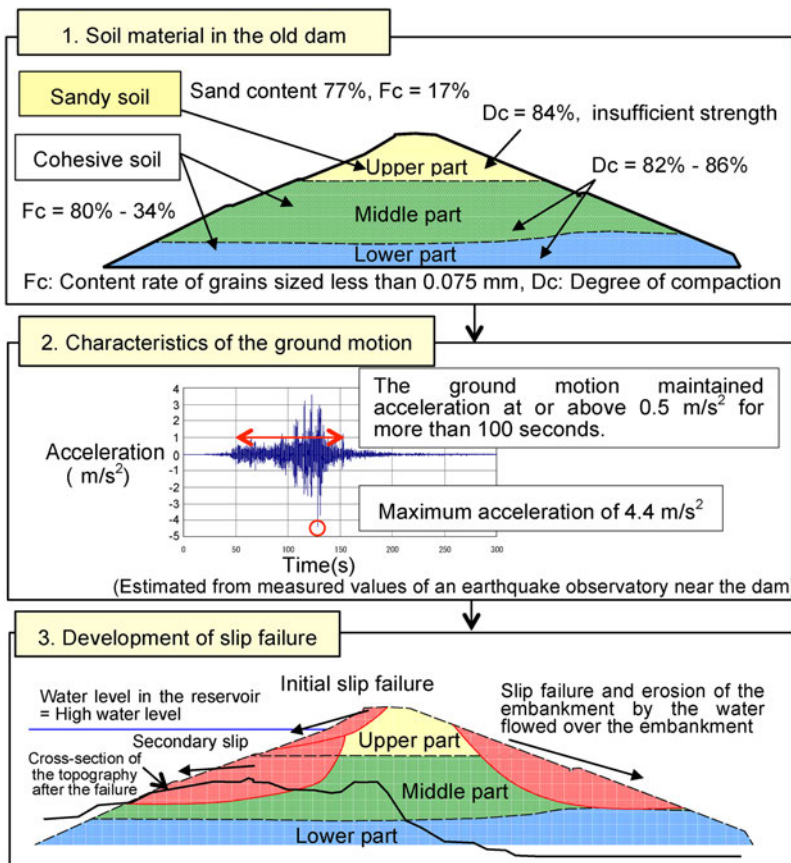
After the failure of the Fujinuma Dam, Fukushima Prefecture established the “Committee for the Verification of Seismic Resistance of Irrigation Dam/Reservoirs in Fukushima Prefecture,” which consists of three experts. The committee investigated the causes of the failure and conducted a risk analysis. In the conclusion to their investigation, the committee assumed that the poor quality and loose compaction of the soil embankment materials used in the dam had been the direct cause of the failure and that the characteristics of the ground motion and the specific form of the development of slip failure triggered the failure [1], [2] (Fig. 2).

Fig. 2
Causes of the failure
Causes de la défaillance

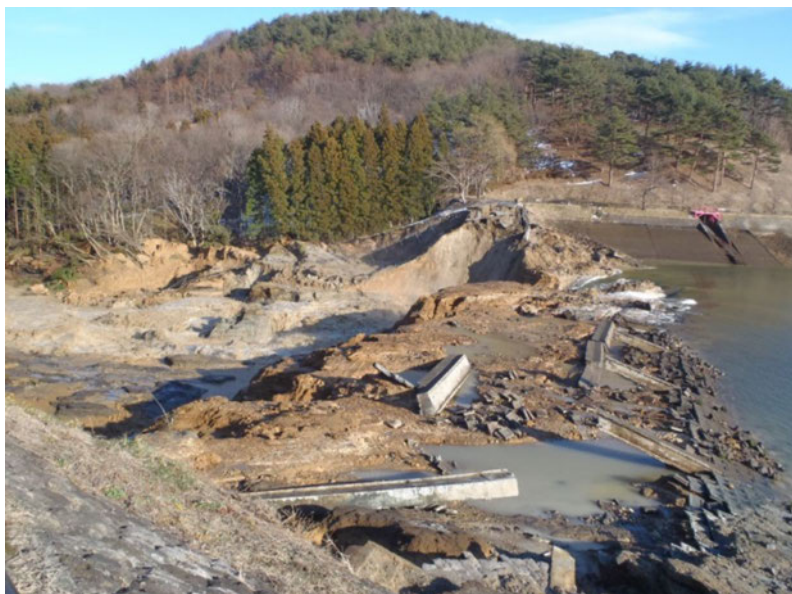
Fig. 3

Scene of the main embankment failure 60 minutes after the earthquake
Scène de défaillance de la digue principale 60 minutes après le séisme

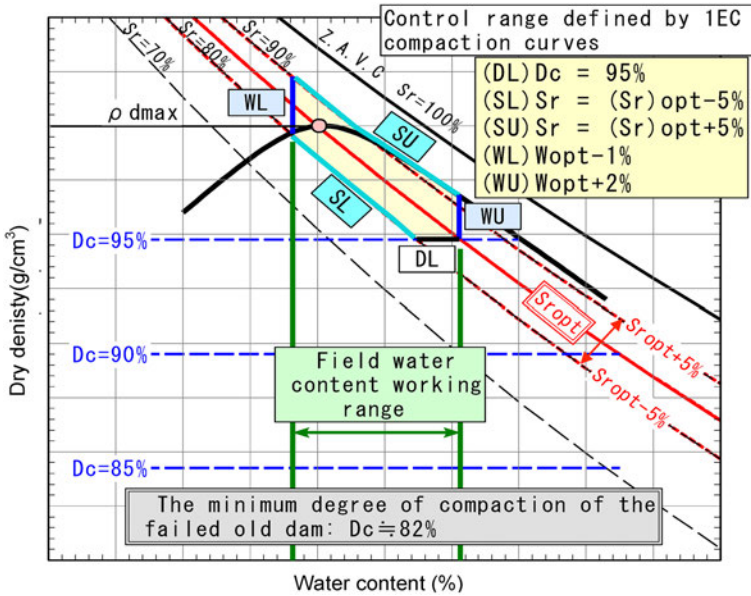
When we established the standards for the density and field water content working range of embankments, we used not only the control of the compaction degree, a conventional control method, but also the control focused on the degree of saturation of the embankment. This control of the saturation degree is a method to control soil compaction proposed by Professor Fumio Tatsuoka, professor emeritus of the University of Tokyo/part-time professor of Tokyo University of Science. It sets a control range of the degree of saturation for a required quality using the 'optimum degree of saturation' as the standard [3] (Fig. 5). It is the degree of saturation when soil has the maximum dry density, which is characteristically within a limited range if the changes in the energy of compaction and soil characteristics are within certain ranges. This control of the degree of saturation has enabled better management of the execution of the embankment work as such control can prevent soil strength reduction due to over-compaction and strength reduction and collapse subsidence due to the seepage of water into relatively dried soil, which have been difficult to prevent with conventional methods.

Fig. 5
Control conditions of the core zone
Conditions de contrôle de la zone centrale

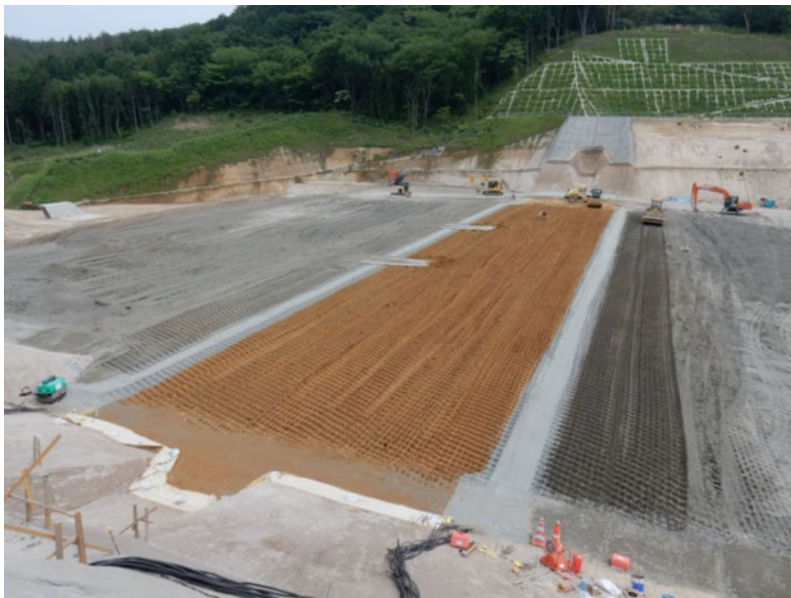
Fig. 6
Embankment work
Travaux d'endiguement

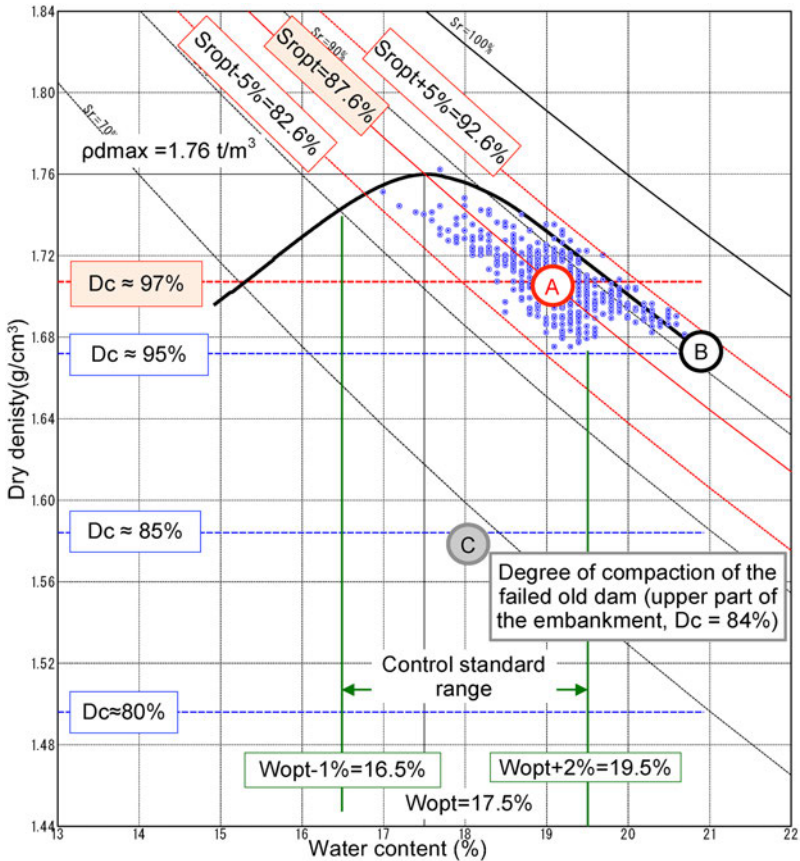
Fig. 7 shows the results of the field density test of the core zone. In this figure, the field density test values measured at each point of measurement in the core zone are plotted with the average compaction curve derived from multiple compaction curves obtained in the control test of the core zone.

Fig. 7 shows that Point A, which represents the mean degrees of compaction and saturation of the core zone ($D_c = 97.0\%$ and $S_r = 87.3\%$, respectively), is near the center of the control zone and that a dam that has a degree of compaction much larger than that of the failed old dam ($D_c = 84\%$ in the upper part of the embankment shown as Point C) has been constructed. Although we observed oversaturation at some measuring points in the test, we concluded that this oversaturation will not cause any problems because the embankment was designed on the condition at Point B to be on the safe side, the number of points with oversaturation was not large and the minimum control standard of the degree of compaction, $D_c = 95\%$, was achieved in all the observation points.

Results of the field density test of the core zone (presented against the mean compaction curve)

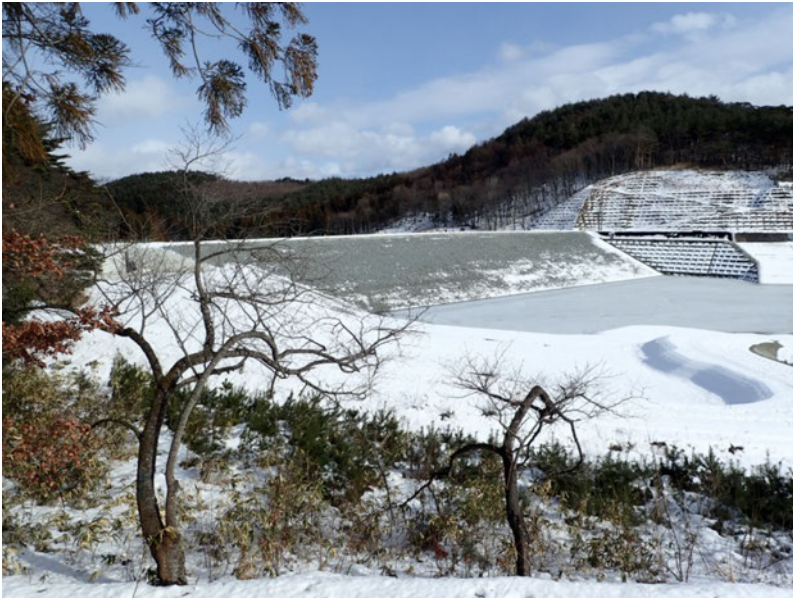
Fig. 8

Embankment at the commencement of test impounding
Digue principale au commencement de la mise en eau d'essai
