## INVESTIGATION OF DAM PERFORMANCE DURING THE NOTO HANTO EARTHQUAKE IN 2007, JAPAN

Tomoya IWASHITA<sup>1</sup>, Nario YASUDA<sup>2</sup>,  
Kazuhito SHIMAMOTO<sup>3</sup> and Tomoki OTANI<sup>4</sup>

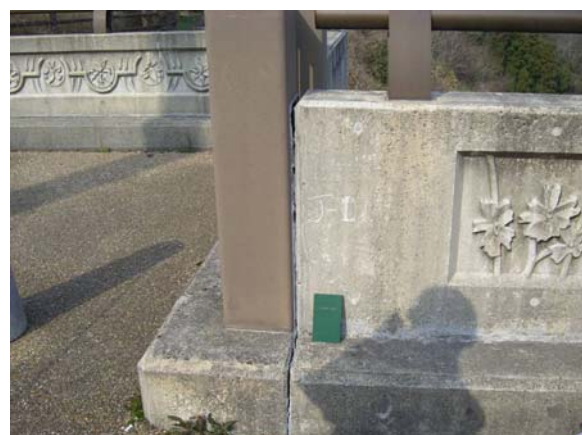
Our survey found a slight opening of the crest parapet joints corresponding to a contraction joint (J-1) as shown in Photo. 2 and chipping of the concrete between the parapet joints corresponding to contraction joints (J-3 and 8) as shown in Photo. 3. Repair mortar surface between the gallery joints corresponding to contraction joints (J-3, 4, 6, 7 and 8) had flaked inside the inspection gallery, and cracks occurred on the slab concrete of the steps in the gallery along contraction joints (J-6 and 8) as shown in Photo. 4.

Photo. 2 Opening of crest parapet joints on contraction joint J-1

As explained above, the external survey of Hakkagawa Dam revealed slight chipping of the concrete at the crest parapet joints and cracking of the slab concrete in the inspection gallery corresponding to the contraction joints. These are assumed to be traces of the scrapings between the contraction joint faces caused by the different behavior of each block of the dam body during the main shock. The displacement response of the dam was larger for the lower-order mode and relative vibration displacement between blocks of the dam body caused a fairly substantial energy loss. Therefore, the spectral amplification factors may be smaller around the lower natural frequency mode, as shown in Fig. 7. As a result of these phenomena, high damping caused by three-dimensional structural form may need to be considered in the case of conducting two-dimensional response analyses of concrete gravity dams with input of strong earthquake motions.

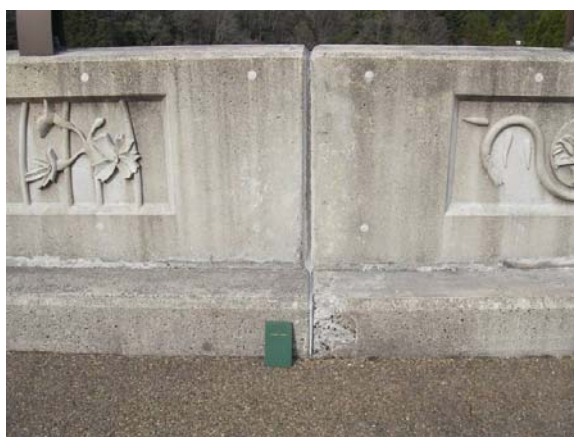
Photo. 3 Concrete chips between crest parapet joints on contraction joint J-8

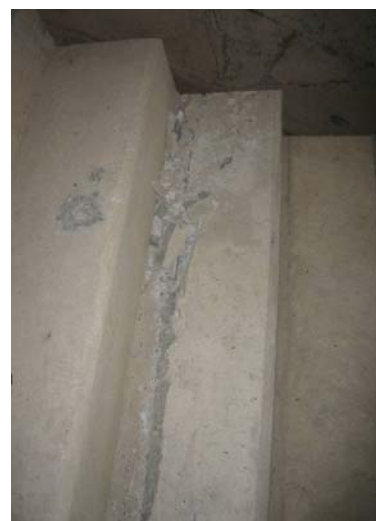
Photo. 4 Cracks in concrete steps along contraction joint J-8 in the gallery

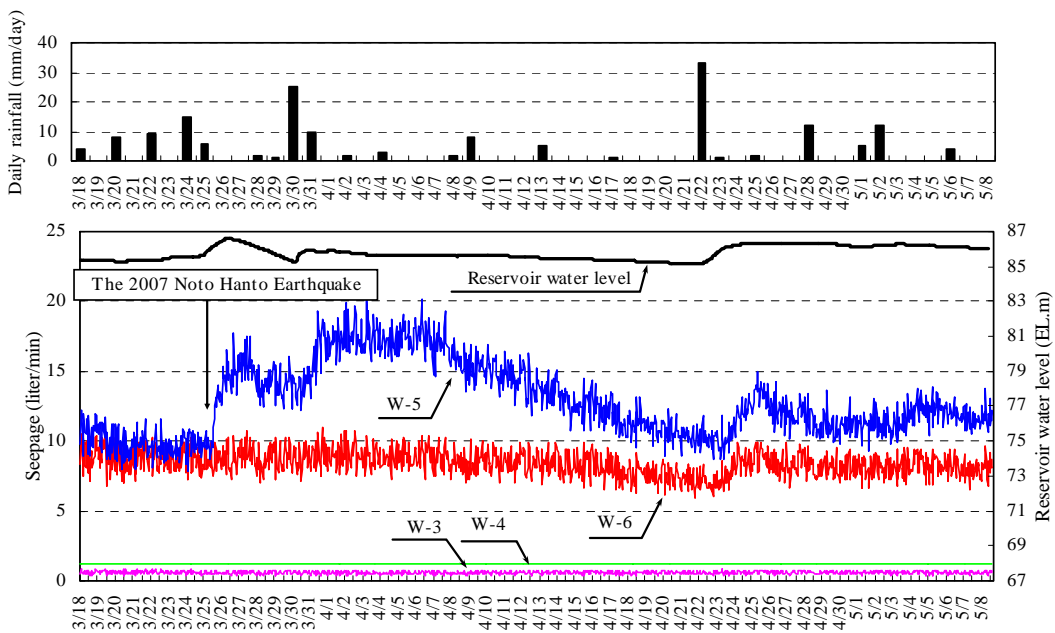
Figure 11 shows the change in seepage for Oya Dam before and after the 2007 earthquake. After the earthquake, the seepage amount rose to 5 liter/min at Zone W-5, and at the other

Fig. 11 Change in seepage amount through the earth core before and after the 2007 Noto Hanto Earthquake

zones there was almost no change. Figure 12 shows the relationship between the seepage amount at Zone W-5 and the reservoir water level before the earthquake (March 18–24, 2007) and after the earthquake (March 25 to April 30, 2007). This figure indicates that the seepage amount during the period of about twenty days after the earthquake (diamond symbols) is larger than the seepage measured before the earthquake. Rainfall of 15 mm occurred on the day before the earthquake. On the other hand, the seepage amount measured about twenty days after the earthquake (square symbols) agrees well with that measured before the earthquake. The slight increase in seepage at Zone W-5 may not have been caused directly by the excitation of the earthquake, but may instead have been caused by the rainfall and change in reservoir level rise before/after the earthquake.

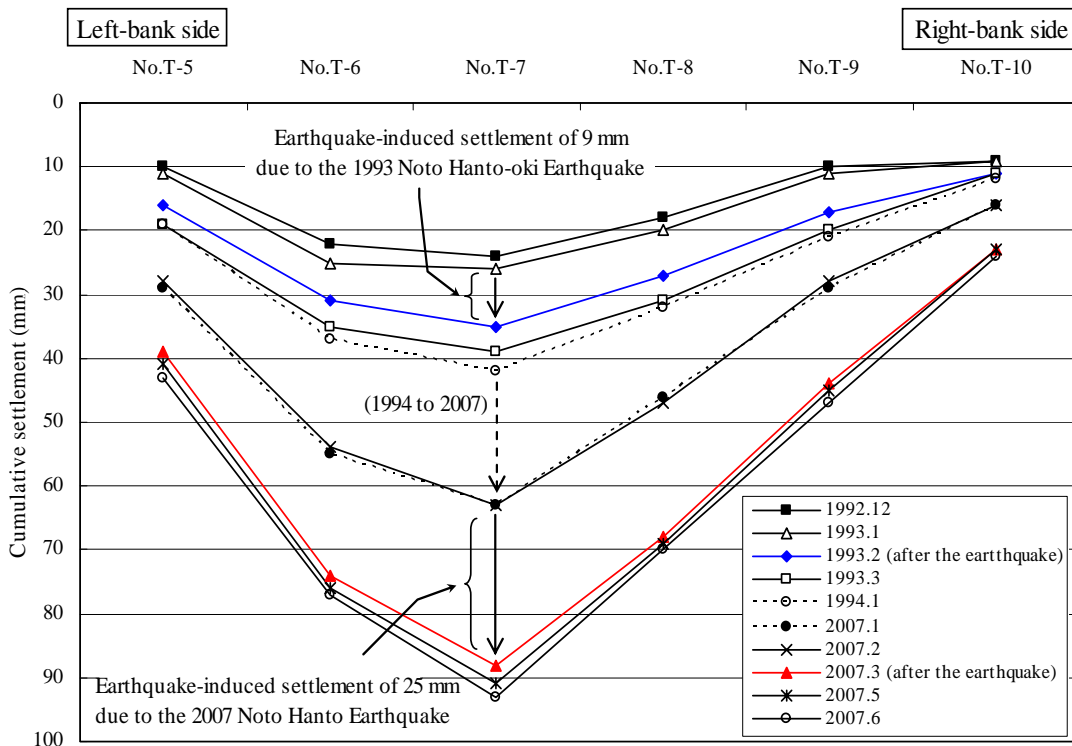
Earthquake-induced settlement in the maximum cross section due to the 2007 earthquake was 25 mm on the dam crest, 19 mm on the upstream slope, and 11 mm on the downstream slope, obtained by comparing the measurements on March 26 with those on March 10 before the earthquake.

Figure 13 shows the change in cumulative settlement measured at the crest measurement line since the completion of dam banking in 1992.

Fig. 13 Cumulative settlement at the crest of Oya Dam

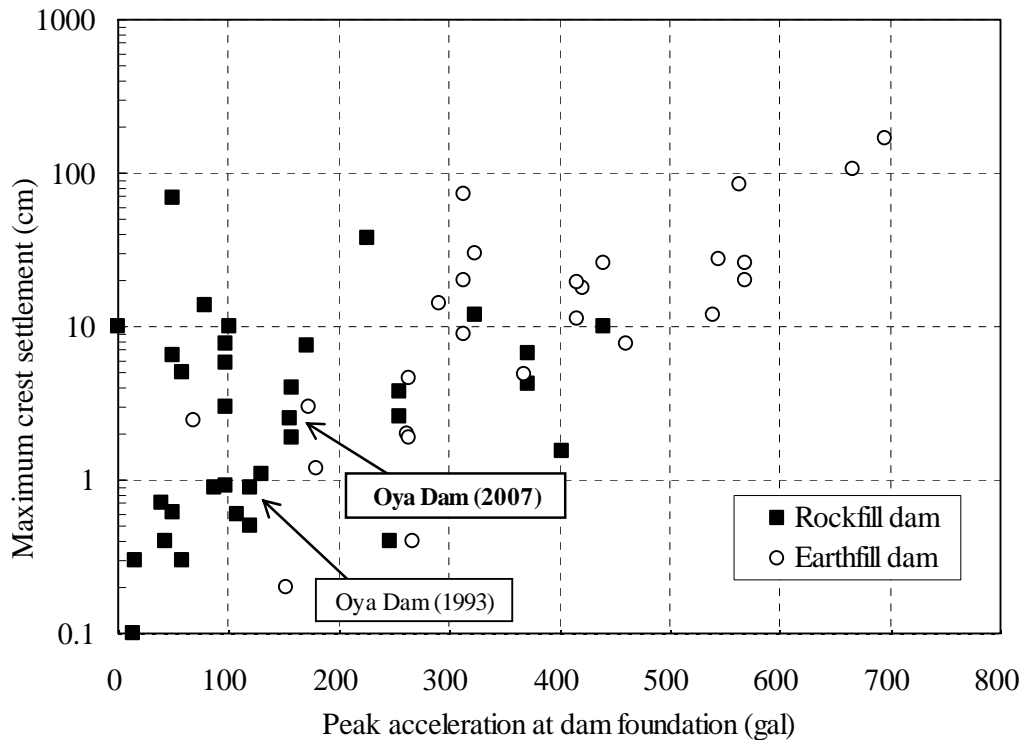
Fig. 14 Relationship between maximum crest settlement and peak acceleration at dam foundation for embankment dams in Japan and six other countries and one region (recent earthquake data added to the figure as per Iwashita (1999))

Figure 14 shows the relationship between maximum settlement at a dam crest and peak acceleration at the foundation of an embankment (including estimates based on the distance attenuation relationship) due to earthquakes that have occurred since the 1920s (After Iwashita, 1999). This figure consists of observation data from embankment dams in Japan and other countries and regions, including the U.S., Mexico, Chile, Peru, the Philippines, New Zealand and Taiwan. Embankment dams with a foundation layer of alluvial deposits are included in this figure. Cases of deformation induced by liquefaction of foundation and dam materials are omitted from this figure. The maximum settlement of 25 mm at the crest of Oya Dam induced by the 2007 earthquake and that of 9 mm by the 1993 earthquake are also dotted in Fig. 14. The dots of Oya Dam are located in a relatively lower portion of the distribution in this figure. The reason for this may be that Oya Dam is a rockfill dam constructed on foundation rock and well compacted using large mechanized works. The earth core of the dam was compacted using 21-ton tamping rollers under compaction control by a  $D$ -value of 95% or higher. The rock zone of the dam was compacted using 18-ton vibrating rollers.

Earthquake-induced settlement at Oya Dam (rockfill) was evaluated through a comparison with cases of other embankment dams in Japan and other countries. The settlement at Oya Dam due to the earthquakes in 1993 and 2007 is located in a relatively lower portion of the distribution in the relationship between crest settlement and peak horizontal acceleration at the dam foundation.
