LA 78^{EME} CONGRES
DES GRANDS BARRAGES
Hanoi-Vietnam, may 2010

**EXTERIOR DEFORMATION MEASUREMENT
FOR CFRD AFTER A LARGE-SCALE EARTHQUAKE USING GPS**

This paper reports on the results of the installation of an external displacement measurement system using GPS at the Ishibuchi Dam which was damaged by the Iwate-Miyagi Nairiku Earthquake of June 14, 2008 immediately after the earthquake, and the subsequent use of the system to perform safety management based on real-time displacement measurement.

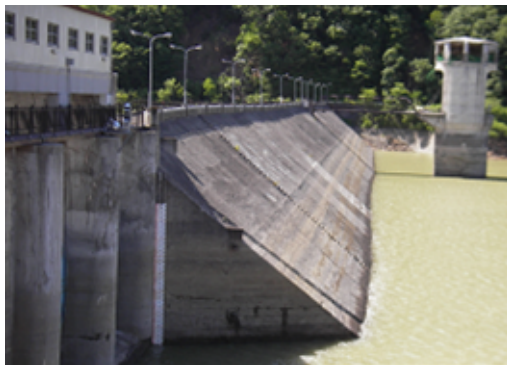
Ishibuchi Dam is a concrete faced rockfill dam (CFRD) with a dam height of 53m completed in 1953, and managed by Tohoku Regional Bureau, MLIT. Fig. 1 is the cross section and longitudinal section of the dam. The upstream concrete face maintains the water tightness of dam body of this type of dam. No severe damage was found in the concrete face and its joints shown in Fig. 2.

Fig. 2
Concrete faced upstream slope on which no damage was found at the Ishibuchi Dam June 15, 2008. [3]

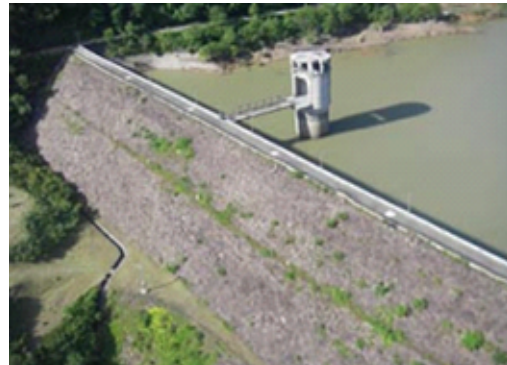
Fig. 3
Overview of the crest and downstream slope of the Ishibuchi Dam on June 15, 2008. [3]

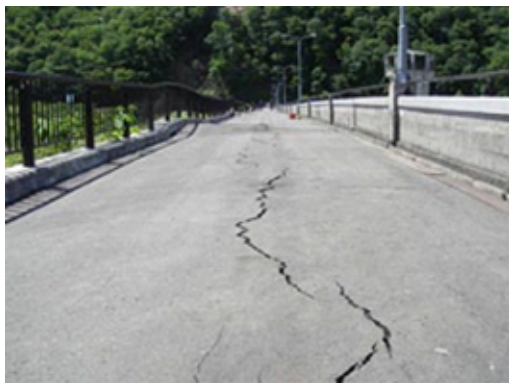
Fig. 4

At the crest of the dam, the pavement was waved and cracked, as shown in Figs. 3 and 4. And gaps appeared on the boundary between the railing and pavement on the shoulder of the slope at the crest. On the downstream slope surface of the dam, projections were observed on the rock materials at the protruding parts of the wave on the crest pavement shown in Figs. 5 and 6, but damage of this kind was limited to the higher elevations. This dam was constructed by the dumped rock construction method as shown in Fig. 7. The piers for the railroad from where trucks dropped rock materials were left buried in the dam body. It is hypothesized that the whole dam body settled due to the earthquake, while the areas near the buried piers only settled a little. The maximum differential settlement is supposed to be about 50cm.

Cracks and waving of the crest pavement of the Ishibuchi Dam on June 15, 2008. [3]

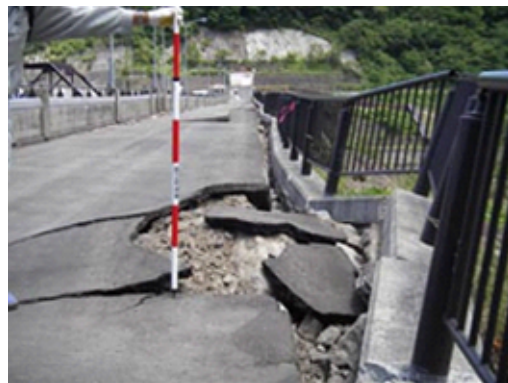
Fig. 5

Gaps between the railing and pavement on the crest of the Ishibuchi Dam on June 15, 2008. [3]

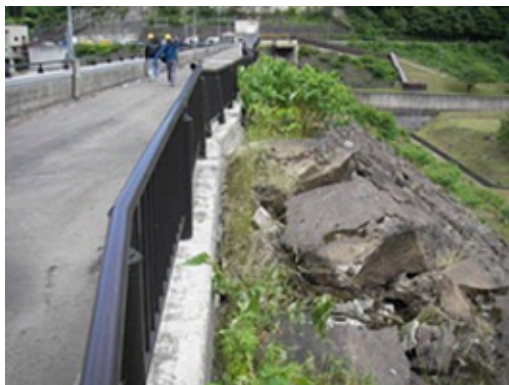
Fig. 6

Projection of the riprap rocks around the top of the downstream slope of the Ishibuchi Dam on June 15, 2008. [3]

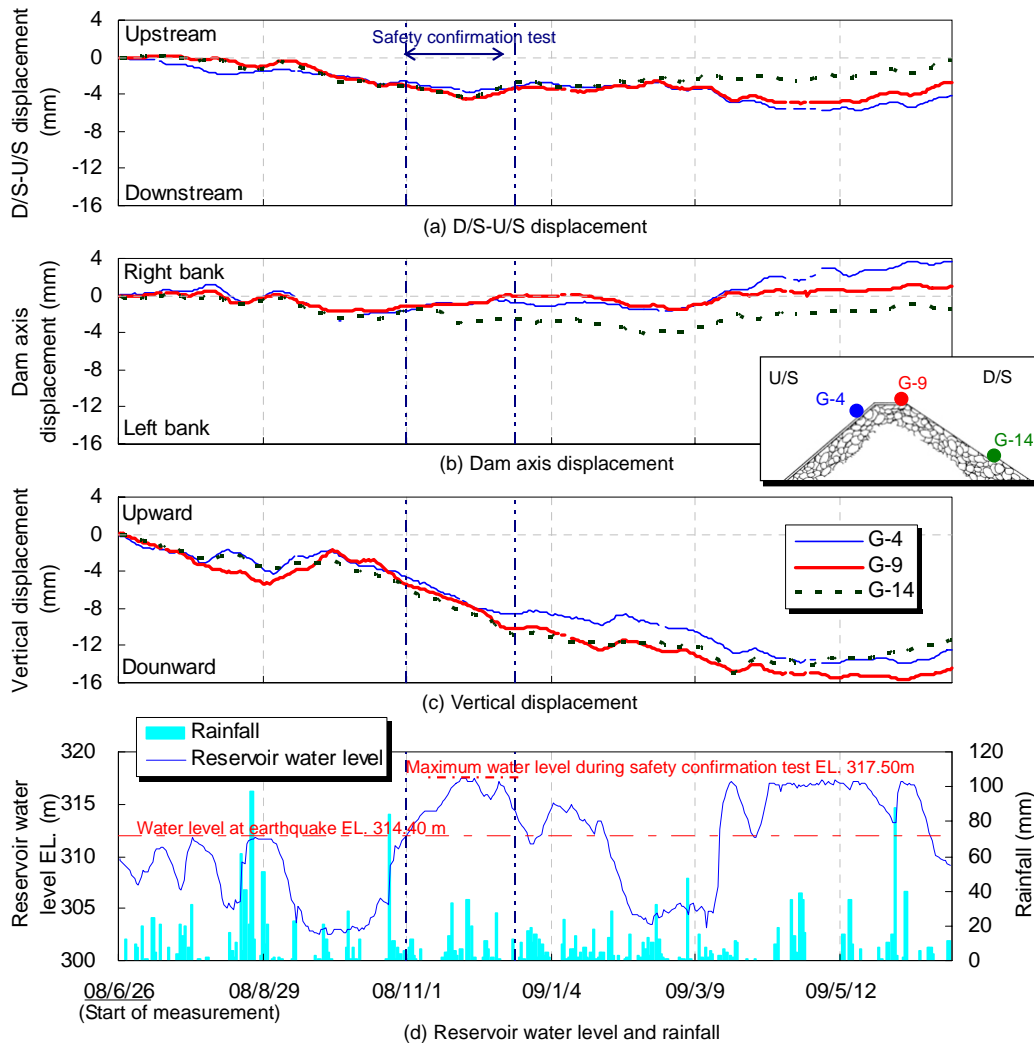
Fig. 13

Results of GPS measurement of dam deformation on No. 20 Line

Behavior from the start of observations includes a similar slight displacement forward the upstream side trend over time at every measurement point, and displacement up to a maximum of 4mm to the downstream side during the safety confirmation test. When the reservoir water level was again increased from EL. 305m to EL. 317m beginning on March 17, 2009, at G-4 on the upstream concrete face and G-9 near the dam crest, similar behavior was seen, with the rising reservoir water level accompanied by displacement downstream, and a tendency to return to the upstream side as the reservoir water level fell. But

beginning March 17, 2009, at G-14 on the rock block on the downstream side of the dam, almost no downstream displacement occurred as the reservoir water level rose and while it was constant, but when the reservoir water level was lowered, displacement to the upstream side occurred.

Fluctuation of the reservoir water level was initially accompanied by similar behavior at every measurement point, but their behaviors differed from those before the safety confirmation test. The maximum displacement was 4mm towards the right bank at G-4. Normal behavior of rockfill dams during impounding appears as upstream-downstream displacement and compressive vertical displacement, primarily under the strong impact of fluctuation of the reservoir water level. Dam axis displacement revealed by the measurements are not large values as absolute quantities, so strict analysis and consideration is difficult, but it is possible that it is the result of three-dimensional deformation behavior under the impact of water pressure acting on the upstream side concrete face.

Behavior from the start of observations showed a similar trend at every measurement point, and during the safety confirmation test, displacement at a maximum of 8mm occurred. Later, the settlement continued, and on June 10, 2009, displacement of -15.7mm (settlement) was measured at G-9 near the dam crest. Until March 5, 2009, even when the reservoir water level was maintained at a constant level (Sept. 17, 2008 until Oct. 14, 2008 and from Feb. 11, 2009 until March 5, 2009), the settlement tended to progress. Later, from March 17, 2009 until June 14, 2009, the reservoir water level was kept at the high level of EL.317m, but continued settlement was not measured during that period. So it is assumed that the settlement behavior has stabilized.

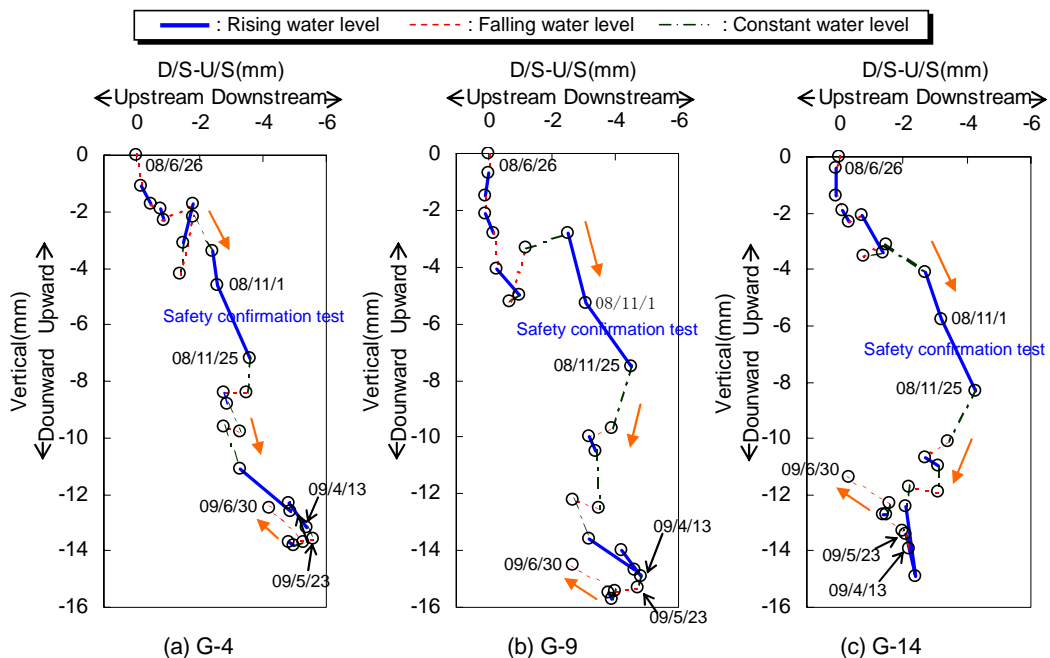
Fig. 15

Displacement vectors in the dam upstream-downstream and vertical directions

The overall trend can be divided at the maximum reservoir water level during safety confirmation testing (EL. 317.50m). Before the maximum water level during the safety confirmation test, when the reservoir water level is rising, downstream displacement and settlement occur, and even when the reservoir water level is falling or constant, downstream displacement occurs. But after the maximum reservoir water level during the safety confirmation test, when the reservoir water level is rising, downstream displacement and settlement occur, but when the reservoir water level is falling or is constant, upstream displacement and settlement occur. And the reservoir water level was operated at a high reservoir water level of approximately EL. 317m from April 13, 2009 until May 23, 2009, but almost no displacement occurred, neither in the upstream-downstream direction nor vertically. Later, as the reservoir water level fell, upstream displacement occurred.

At G-4 on the upstream concrete face, settlement continued over time, but upstream-downstream displacement was downstream displacement even after the maximum reservoir water level during the safety confirmation test, and the maximum downstream displacement was measured while the reservoir water level was constant from April 13, 2009 until May 23, 2009. At G-9 near the dam crest, gradual settlement tended to continue after the safety confirmation test, but upstream-downstream displacement occurred according to reservoir water level fluctuations. At G-14 on the rock block on the downstream slope of the dam, upstream displacement occurred along with settlement after the maximum reservoir water level during the safety confirmation test.

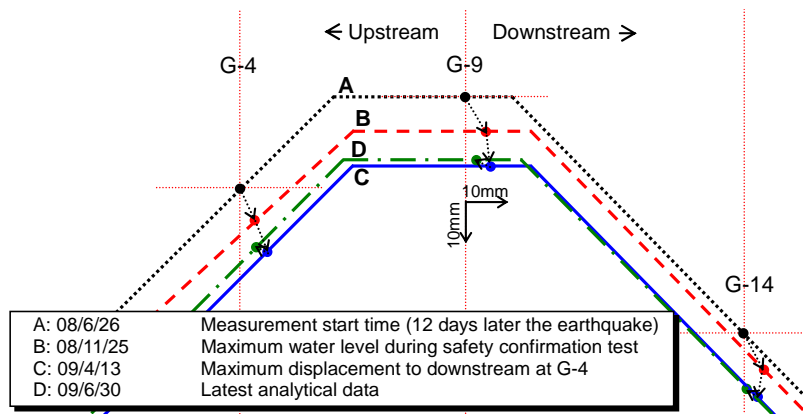
Fig. 16 schematically presents the deformation behavior measured by the GPS method. Until the maximum reservoir water level during the safety confirmation test, regardless of the rise or fall of the reservoir water level, settlement occurred over time, accompanied by gradual downstream displacement (from A to B on the Fig. 16). It is hypothesized that this might be a result of loosening which occurred in the dam body, particularly near the crest and surface on the downstream side as a result of a large-scale earthquake.

Later, as a result of the safety confirmation test, relatively high water pressure acted on the dam, and downstream displacement at the G-9 point near the dam crest where the impact of the water pressure is relatively low, and at G-14 on the rock block on the downstream slope of the dam receded and the displacement was primarily only settlement (B to D in the Fig. 16). At the G-4 point on the upstream concrete face, which was strongly impacted by the water pressure, downstream displacement occurred, but the absolute value of this displacement was small. Beginning on April 13, 2009 (C in the Fig. 16), looseness near the surface presumably caused by a large-scale earthquake is assumed to have generally constrained the displacement.

Fig. 16
Schematic displacement diagram
