COMMISSION INTERNATIONALE DES GRANDS BARRAGES ----- LA 78 ^{EME} CONGRES DES GRANDS BARRAGES <i>Hanoi-Vietnam, may 2010</i>	
--	--

A STUDY FOR THE BEHAVIOR OF GROUNDWATER FLOW ALONG THE OPEN FISSURES WITH HIGH DIP ANGLES

The Yashio dam which is the upper dam of the Shiobara Power Plant has a thin ridge at the right bank of its reservoir.

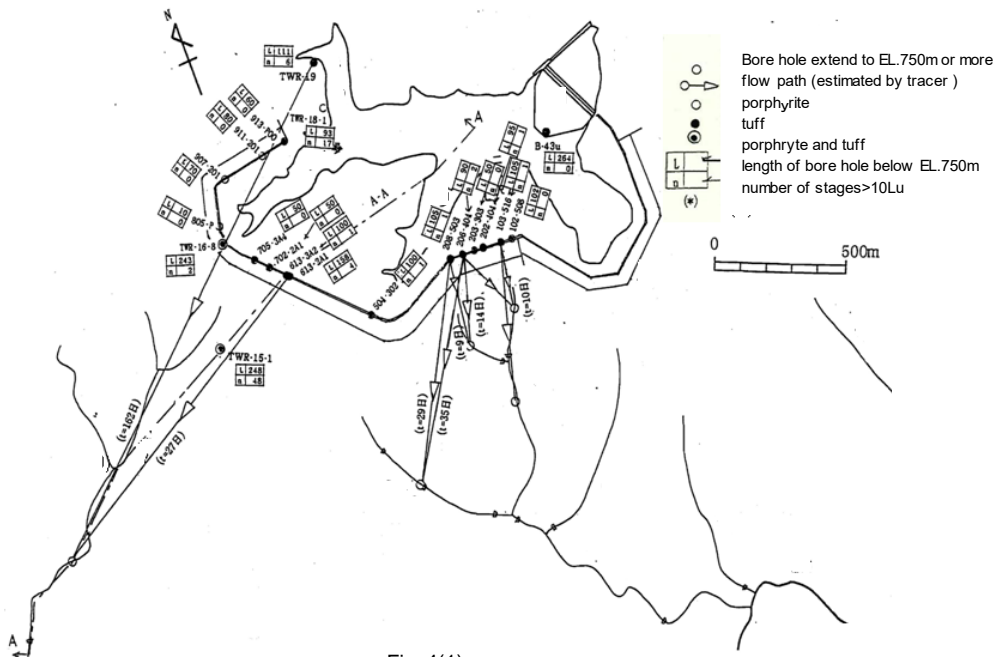
Fig. 4(1)
Results of tracer investigation

Via this investigation, we found that the permeability didn't decrease corresponding to the depth, and that the highly permeable zone (10 to 100 Lu or more) exists at a deeper area (Fig. 4, Fig. 9). In addition, we found that groundwater flowed from the reservoir to the opposite mountain stream which was confirmed by the a activable tracer investigation. On the other hand, we discovered the drainage holes at the bottom of the reservoir. Through this investigation, we found that the drainage holes like craters existed on the layer of the bentonite which we placed on the whole of bottom of the reservoir for this investigation.

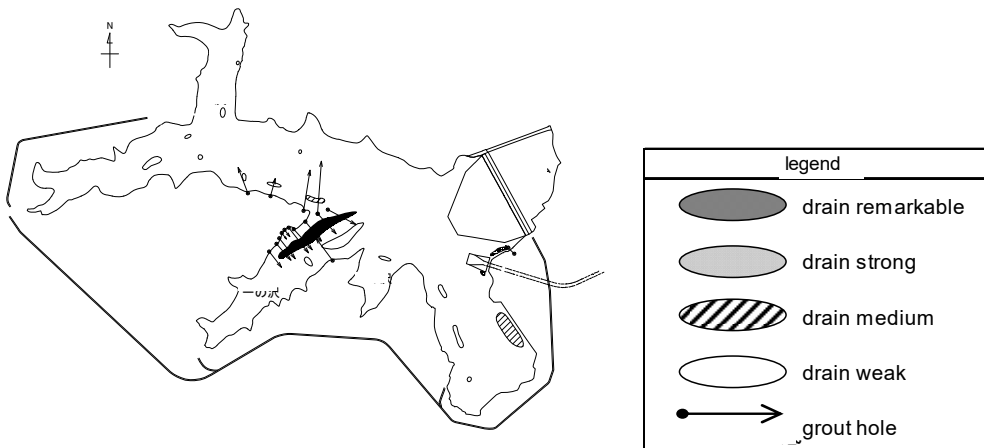
Fig. 5
Result of the investigation at the bottom of reservoir

According to this result, we conducted the grouting at the area (Ichinosawa: one of the streams in the reservoir) where craters were distributed. Though, the grouting was conducted at about 30m intervals, we were able to significantly reduce the leakage (Fig. 5). For further reduction of the leakage we anticipated a clogging up the permeable zone with fine particles in the water of the reservoir.

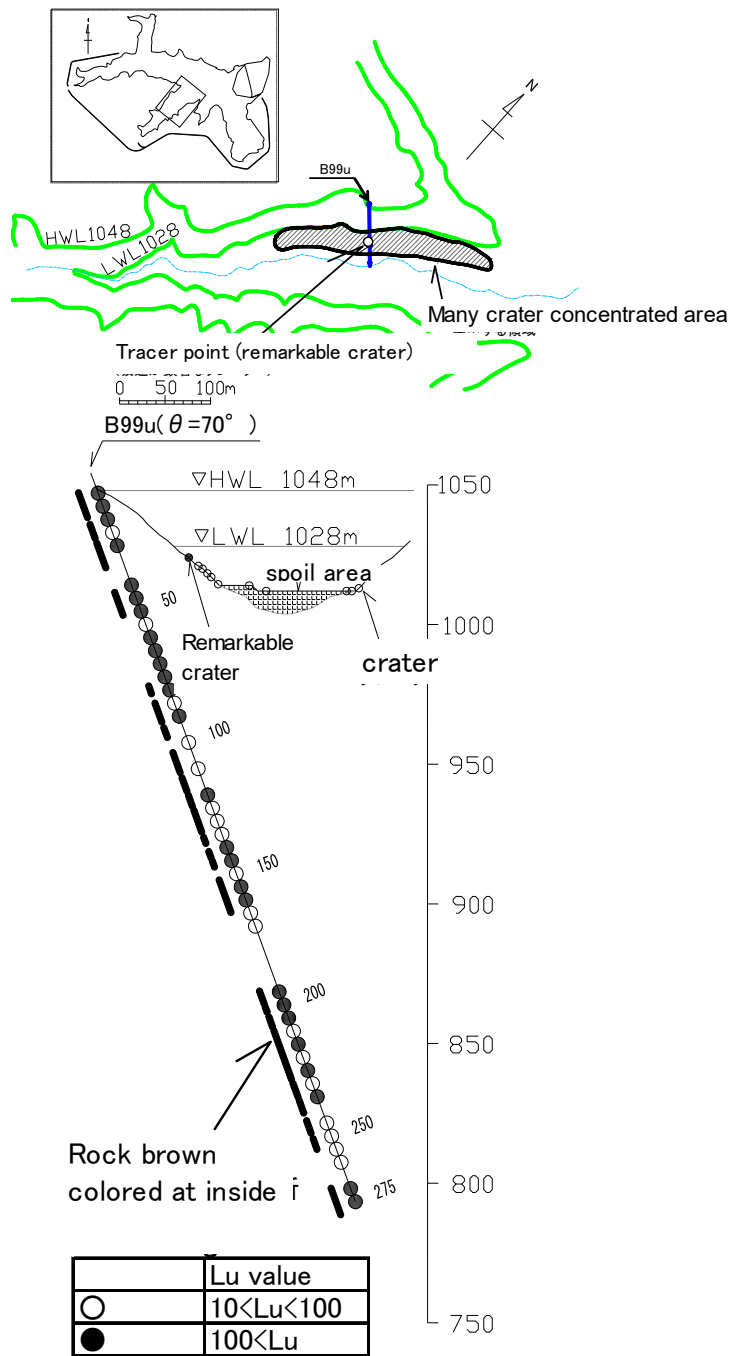
We investigated the geological features and others by boring holes at the bottom of the reservoir in the Ichinosawa area where a large number of craters were distributed. We set the boring holes below the craters where water flow was strong. These craters were the mouths of the path of leakage and led to the Hirisawa which had the largest increase of flow quantity in the opposite mountain streams. We confirmed it by investigation using activable tracers. The activable tracer is the high precise tracer, used in the fields of medical treatment or agriculture. The boring hole was 275m in length. We confirmed that tuff was distributed in the boring core. The site was comprised mainly of tuff. The high permeable (10Lu or more) zone was found continuously in deep areas. And we found that the extreme high permeable zone (more than 100Lu) existed intermittently (Fig. 6).

Fig. 6
Distribution of permeability of boring hole at the Ichinosawa area

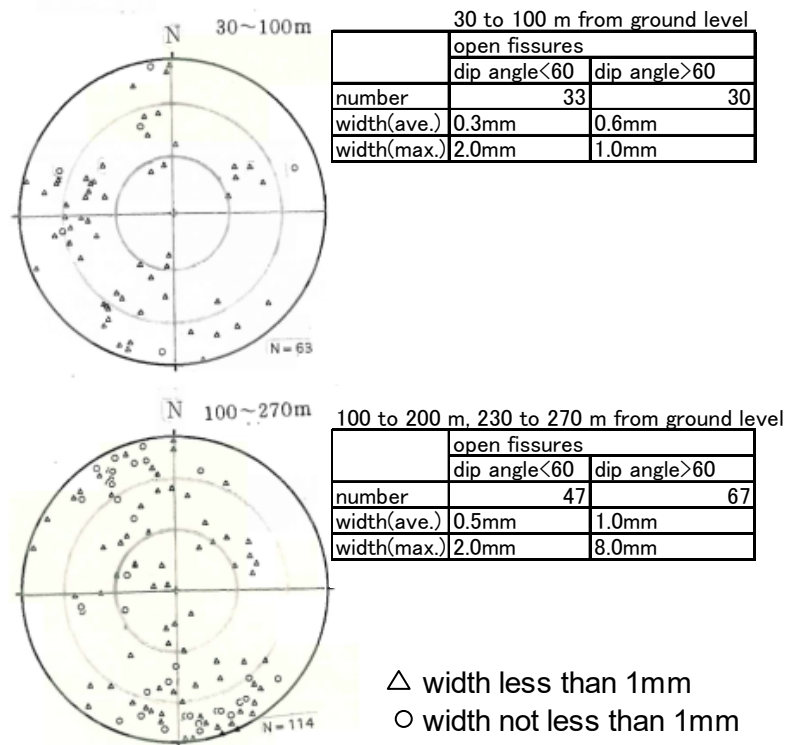
Fig.7

We investigated the features of the open fissures by BHTV (Bore Hole Tele Viewer) in the boring hole. We divided the data of strikes and dips of the open fissures into four groups which were classified by their width (more or less than 1 mm) and their depth from ground level (more or less than 100 m). The maximum width of the open fissures was 8 mm. We found that the open fissures with a width of more than 1mm mainly had an N-S strike and mainly had a dip of more than 60

degrees. This N-S direction was equal to the direction to Hiraaisawa (Fig. 7).

The strikes and dips of the open fissures at the Ichinosawa area
(The projected figure on the southern hemisphere)

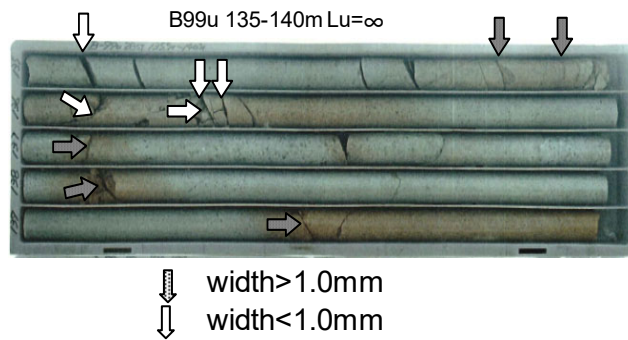
We described the features of rock by observing the boring core below. The rock distributed less than 30 m depth from the ground surface was weathered and brown colored in appearance. The rock which was distributed more than 30m in depth has a brown colored in appearance at the most of the parts where open fissures existed. Especially, at all of the open fissures with more than 1 mm width appeared brown color along the fissures and at the inside of the rock. We concluded that the brown color of rock was caused by hot water with high pressure. We came up with this estimate based on the state of gradation and observation of the foil of the rock utilizing a polarizing microscope. We verified that the brown color lightened gradually, as there was inside of the rock and identified a brown colored area developed along the micro cracks. We also identified that some alterations caused by hot water was existed at the edge of the chlorite and that there was a little bit of calcite existing (Photo. 1).

Photo.1
Boring core at the Ichinosawa area

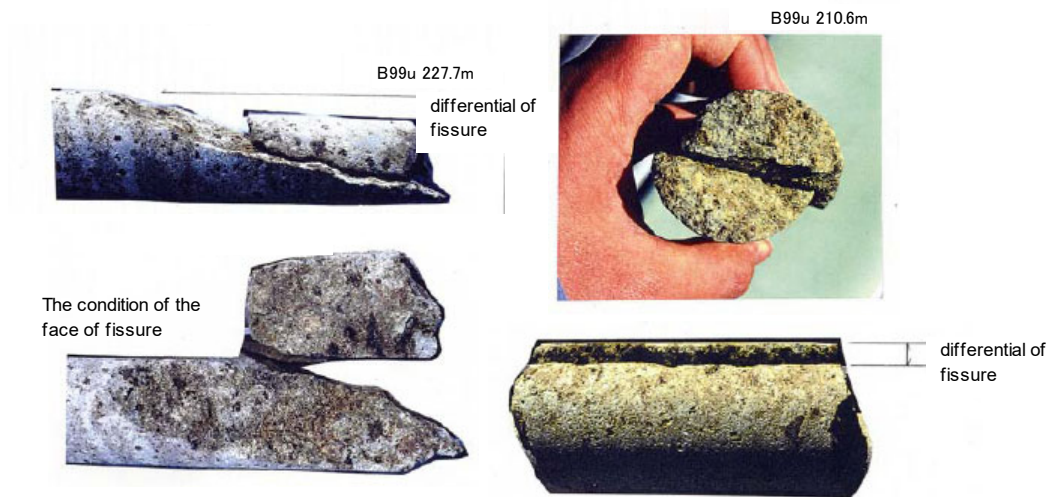
The pieces of boring cores of each side of the open fissure were met well

and we couldn't see the streak, so we concluded that the open fissures were made by tensile stress (Photo. 2).

Photo.2
The pieces of boring cores of each side of the open fissure

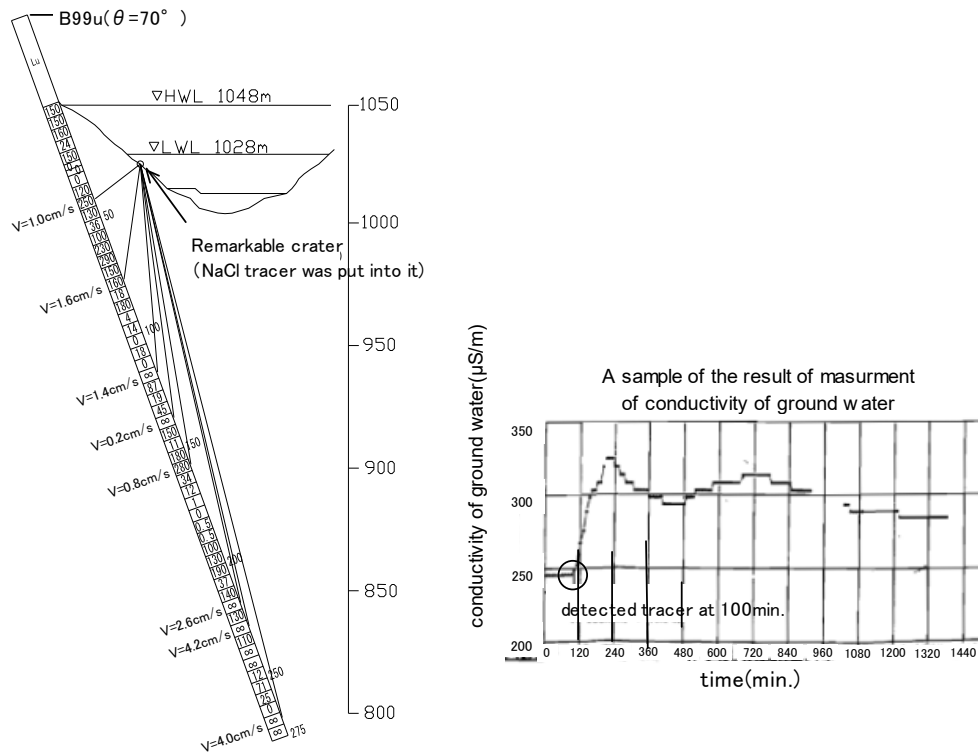
borehole and the time when we identified an increase in conductivity. We identified that the tracer reached all the observing points. The tracer traveled the fastest moving vertically than any other direction with a maximum velocity of about 4 cm/sec. We estimated that the ground water that flowed along the network consisted of fissures, because more than one peak value of conductivity was observed. We estimated that ground water at the Ichinosawa area mainly flowed along the open fissures with high dip angles and that the network consisted of open fissures. And they were found in deeper areas in the bed rock (Fig.8).

Fig.8
Results of the investigation of velocity of ground water flow by NaCl tracer

At present, we are conducting the grouting at the bedrock of the bottom of the reservoir filled with water. We adopted this method, because we considered that it would be impossible to make a grout curtain at more than 500 m in depth, and we expected that the groundwater flow (velocity of fluid was about 4 cm/sec) brought the grout material a long distance and the leakage of grout material to the

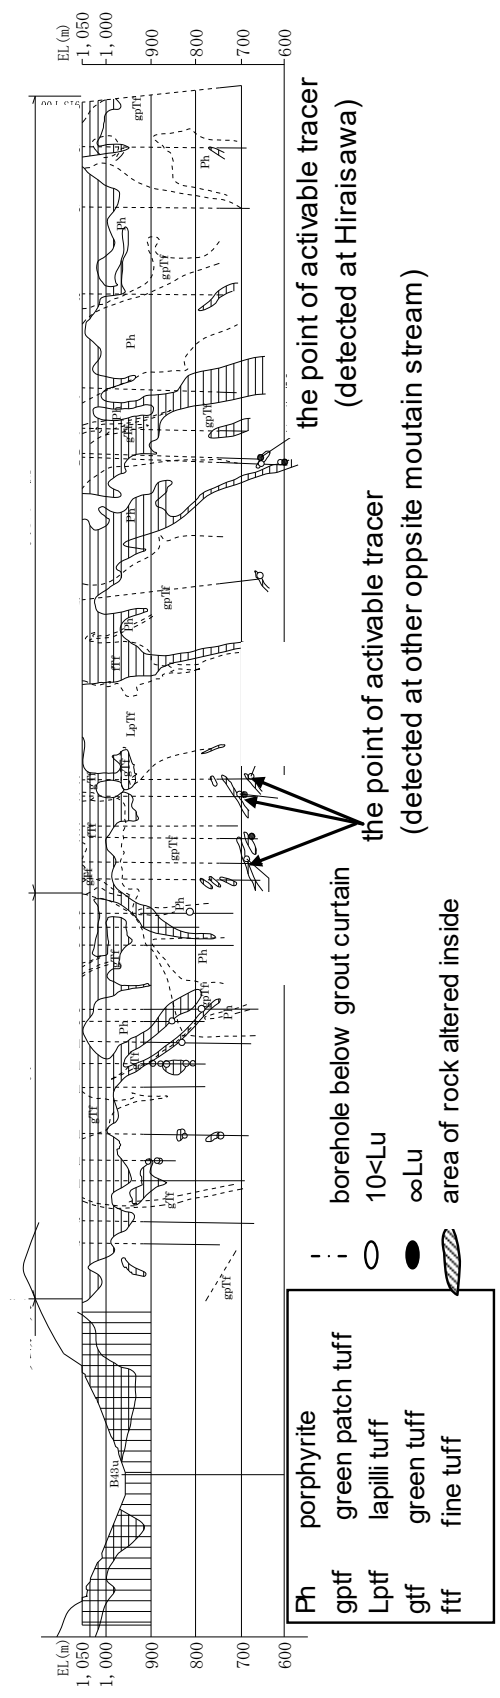
As mentioned above, the boring cores at the part where we put the activable tracer appeared with brownish color and had a high permeability of 10 to 100 Lu (Fig. 9, Photo.3). Incidentally, this activable tracer was detected in the running water at the opposite mountain stream. And we investigated the features of the open fissures by BHTV at the part of the bore holes where we put the activable tracer into. All of the dips of the open fissures in the bore holes whose width were 1 to 4 mm were more than 60 degrees.

Fig.9
Geological features below the grout curtain area

Their features were similar to the ones of the Ichinosawa area. We estimated that the one of causes of the paths of leakage to the deeper areas in the bed rock was alternation by the hot water. We estimated that the network of open fissures with high dip angles was formed by hot water with high pressure and tensile stress caused by unloading due to reason unverifiable at this time.

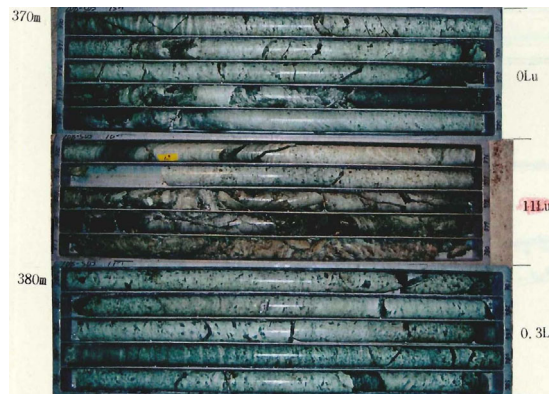
Photo.3

A sample of boring core below the grout curtain
