COMMISSION INTERNATIONALE
DES GRANDS BARRAGES

LA 78^e REUNION ANNUELLE
Hanoi, Vietnam , mai 2010

DEVELOPMENT OF CRACK OBSERVATION METHOD USING VIDEO
CAMERA FOR CONCRETE ARCH DAM (*)

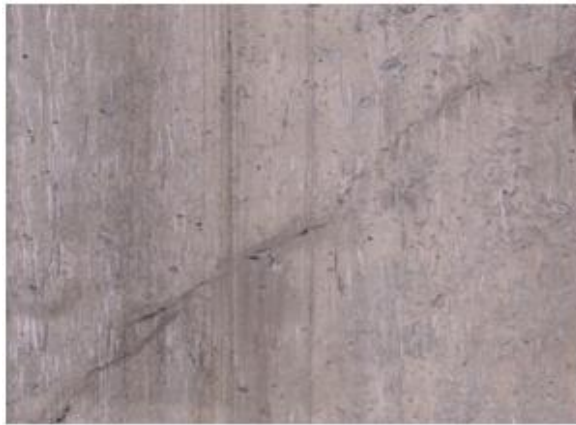
Fig. 9
 Example of a crack shown in recorded image
Exemple d'une fissure trouvée dans l'image enregistrée

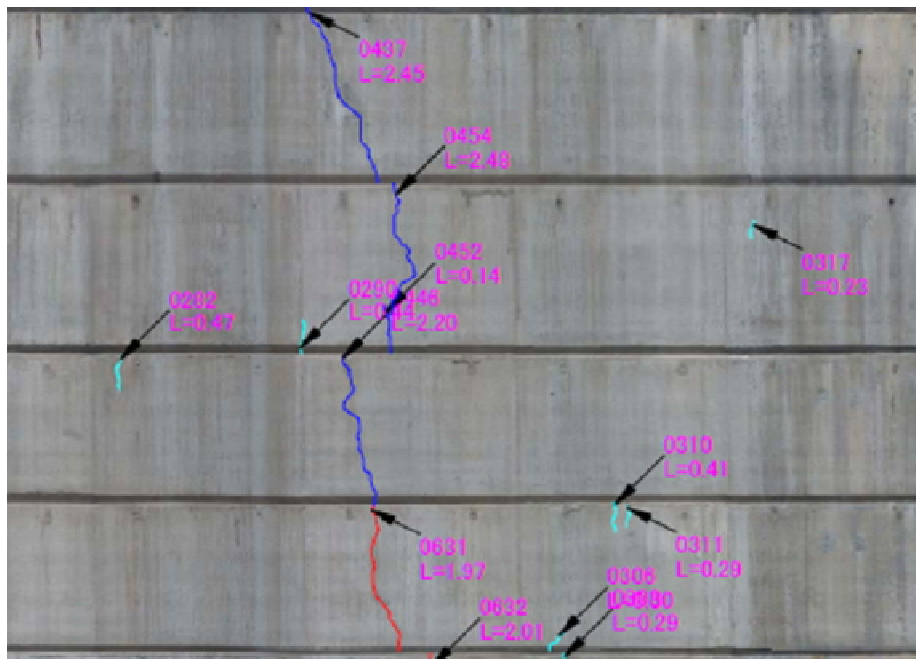
Fig. 10 shows an example of an image showing traced cracks. The numbers shown in the figure are automatically assigned to cracks when they are traced on the display screen. The crack lengths calculated automatically during crack mapping are also shown on the image.

Fig. 10
 Crack map
Carte des fissures

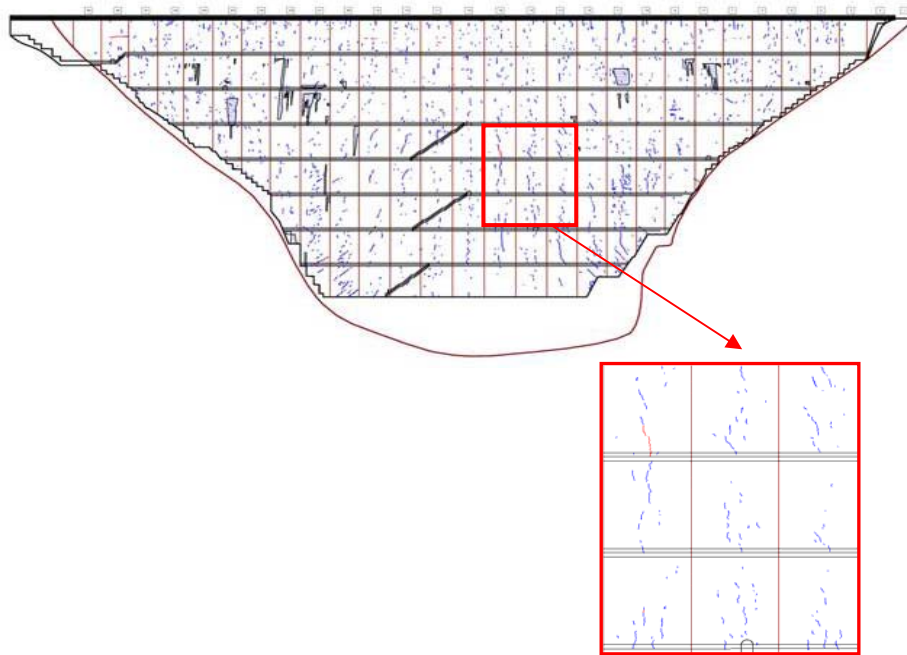
Fig. 11

Crack map of the downstream face of the arch dam
Carte des fissures du parement aval du barrage-voûte

Red line: crack width larger than 0.5 mm

Blue line: crack width in the range from 0.2 mm to 0.5 mm

In Fig. 11, Fig.12, regions wetted by spring water are shown in the upper

part of the dam (the areas encircled by a blue line). The crack map indicates the following:

- There is no highly continuous crack.
- There is no leakage of water outflow from cracks.
- There are localized microcracks at the central part of each block.
- There are localized microcracks perpendicular to the bedrock surface on both sides of the lower part of the dam.

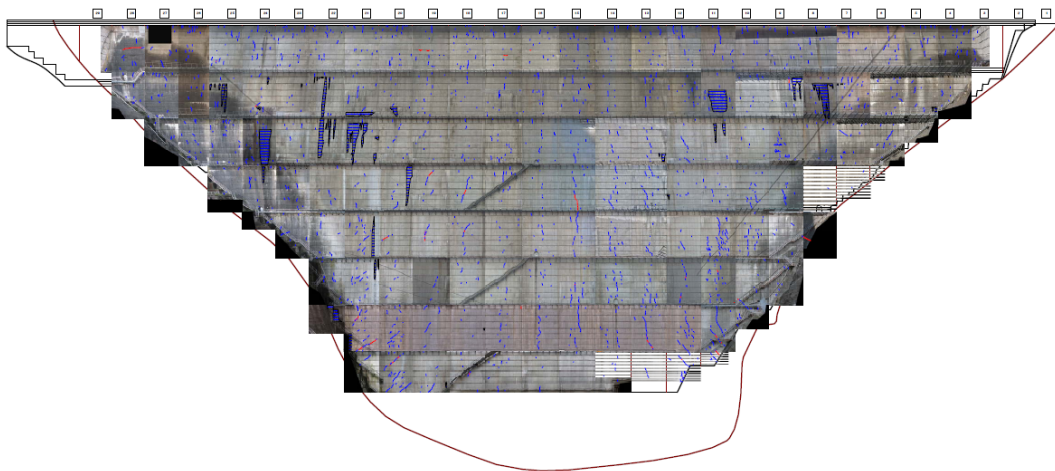
Fig. 12

Superposition of image and crack map
Superposition des images et la carte des fissures

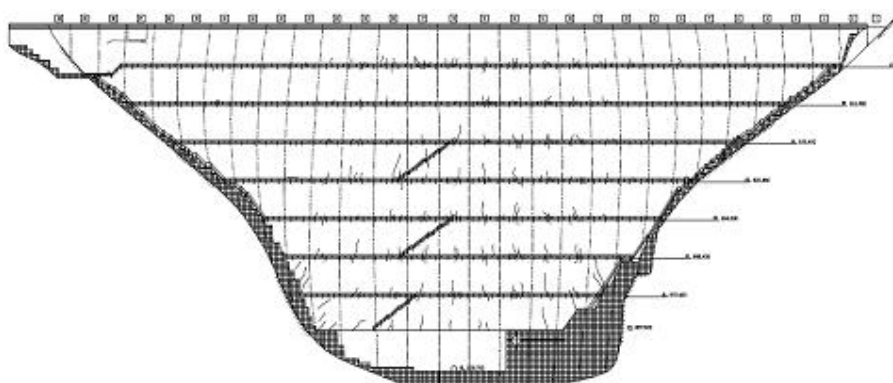
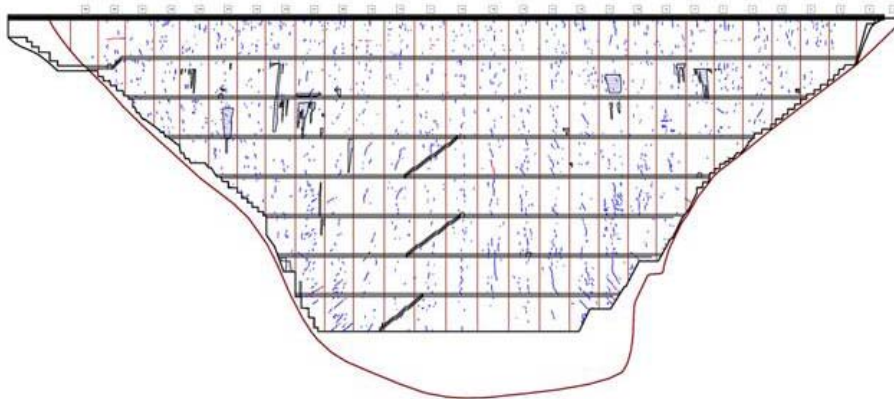
Fig. 13 compares the results of conventional visual observation of cracks in the downstream face of the arch dam and the observation results obtained from the newly developed system. As shown, the cracks excluding those near the catwalks could not be observed by the conventional visual observation method, while the newly developed system made it possible to observe cracks in any part of the dam face.

As shown, there are many cracks in the areas that cannot be observed by the conventional observation method. The comparison has revealed that many of these cracks are very small, and most of the cracks are not highly continuous.

The comparison has also revealed that there is little difference on width of crack between the visual observation results and the video-based observation results, and that 0.2 mm wide cracks can be identified by using the newly developed system.

Comparison with conventional visual observation results

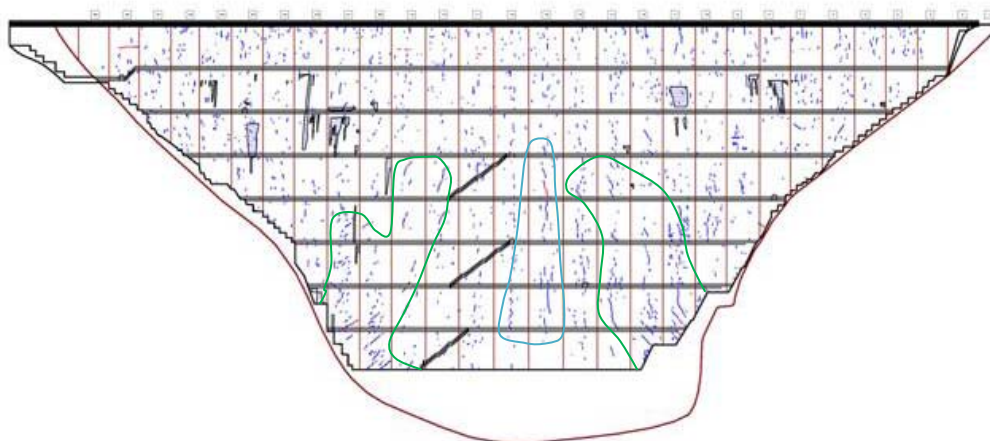
Fig. 14

According to the crack observation results mentioned earlier, there are no highly continuous cracks, and most of the existing cracks are microcracks, which are thought to have been caused by drying shrinkage and thermal stress. These cracks, however, are somewhat continuous and are characteristically oriented in the same direction as follows.

- Inclined cracks

There are inclined cracks oriented toward the bedrock above the boundaries with the right- and left-bank rock surfaces and below a level roughly

corresponding to two-thirds of the dam height. Most of the cracks have widths not greater than 0.5 mm, but there are also a very small number of local cracks having widths greater than 0.5 mm near the bedrock surface. It is thought that at present, these cracks do not pose a serious problem on dam safety because they are discontinuous, but they need to be monitored (the areas encircled by a green line in Fig. 14).

- Vertical cracks

There are more or less continuous vertical cracks in the central region of the dam above the boundary with the bedrock and below a level roughly corresponding to two-thirds of the dam height. Most of the cracks have a width of 0.5 mm or less, but there are also a very small number of cracks having a width greater than 0.5 mm. These cracks need to be monitored (the area encircled by a blue line in Fig. 14).

Distribution of more or less continuous cracks
Distribution de plus ou moins fissures continues

Since, however, there are some more or less continuous inclined cracks in the lower parts of the right- and left-bank regions of the dam and there are also more or less continuous cracks in the lower part of the central region, monitoring needs to be continued on a continual basis. Because crack maps indicate crack coordinates, crack growth detected through two or more observations can be clearly expressed numerically. The newly developed system, therefore, is thought to be useful as an aid in visual observation conducted as part of a periodic inspection or a special inspection of a dam.
