Damage to the Ishibuchi dam by the Iwate-Miyagi Nairiku earthquake in 2008 and seismic assessment

H. Yoshida, A. Nakamura & N. Matsumoto
Japan Dam Engineering Center, Tokyo, Japan

ABSTRACT: The Ishibuchi Dam is a dumped rock CFRD with height of 53 m, completed in 1953. During the Iwate-Miyagi Nairiku Earthquake in 2008, a seismograph installed on the crest of the Ishibuchi Dam, which was located 9.4 km from the epicenter, recorded maximum acceleration of 14.61 m/s² horizontally and 20.70 m/s² vertically. However, the concrete facing was largely unaffected, the water storage function of the dam was completely maintained, and the damage to the dam body and the appurtenant structures remained within a repairable range.

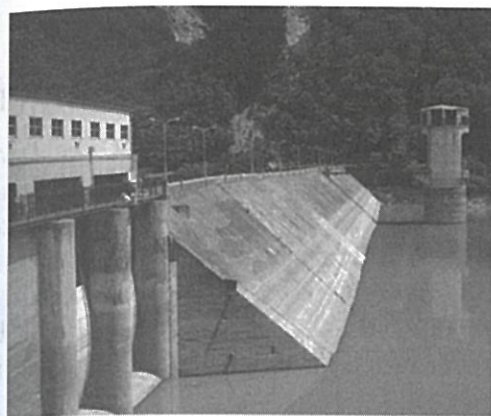
According to the emergency inspection of the concrete facing after the earthquake, as shown in Photo 1, no damage was found at either the reinforced concrete slabs or its joints.

An emergency discharge was performed immediately after the earthquake, lowering the reservoir level by about 3 m. In order to determine whether or not the concrete facing was deformed below the reservoir water level, a diver conducted an underwater inspection to check for suction by injecting a tracer along the surface of the concrete facing. The underwater inspection was accompanied by the performance of a boring inspection of the concrete facing to obtain a core sample and a fiber scope was inserted to make sure that the rock behind the concrete slab adhered to the concrete slab. The results of the above inspections did not detect any abnormality on the concrete slabs or its joints.

Photo 1. Concrete facing after the earthquake.

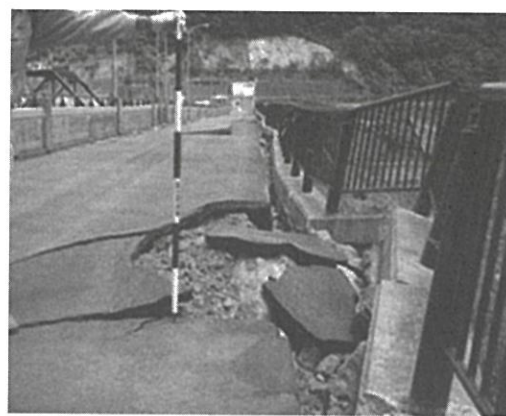
As shown by Photo 2, on the pavement on the dam crest, wavy deformation and cracks were found, there was a gap on the boundary between the handrail and pavement on the downstream side, and a waving level difference of about 50 cm formed on the waves on the crest pavement. Rocks from part of the rubble fell from the edge of the crest on the downstream side.

Piers under the trolley track used to dump the rock during construction of the Ishibuchi Dam were left standing inside the dam body. It was hypothesized that the waving on the downstream edge of the crest formed because the earthquake caused the dam body to settle while the piers did not settle. When locations of the waving were excavated, as expected, piers were discovered.

Photo 2. Deformation at the dam crest.

Restoration work was also executed at locations where cracks had formed: the crest, the sides of the gate columns at both the left and right bank ends, the tops of the gate columns, joints of the operating bridge, and so on.

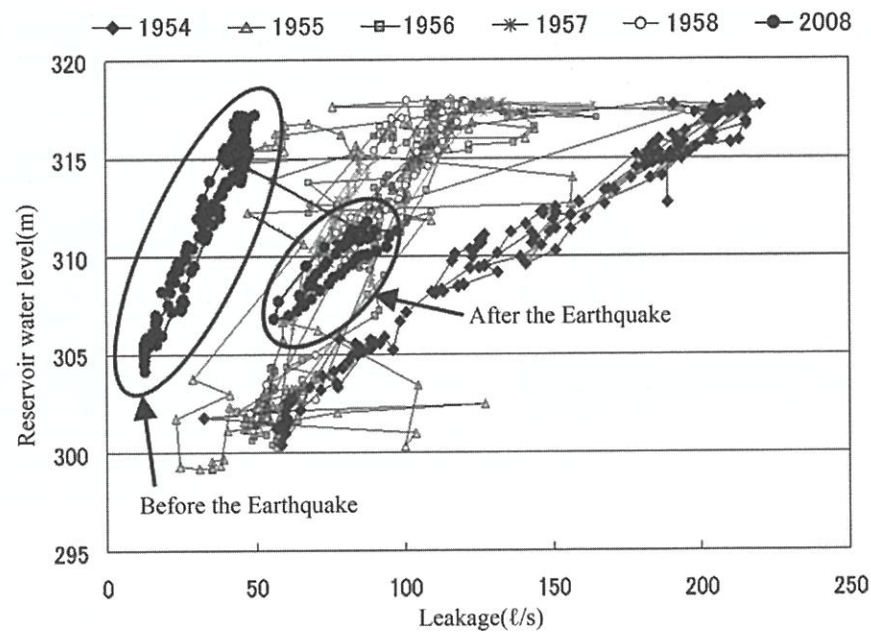
Amount of leakage on the riverbed part nearly doubled, from 42 to 98 liters per second, in the aftermath of the earthquake, but later, it stabilized to follow the reservoir water level. And immediately after the earthquake, turbidity of the leaked water was observed, then a few days later, it disappeared.

As shown by Figure 2, leakage on the riverbed part increased after the earthquake, but it was smaller than the leakage measured in 1954 immediately after completion of the Ishibuchi Dam. The relationship between the leakage that occurred after the earthquake and the reservoir water level stabilized at almost the same state as it was in the late 1950s, a few years after completion of the dam.

Figure 2. Reservoir water level and leakage history.

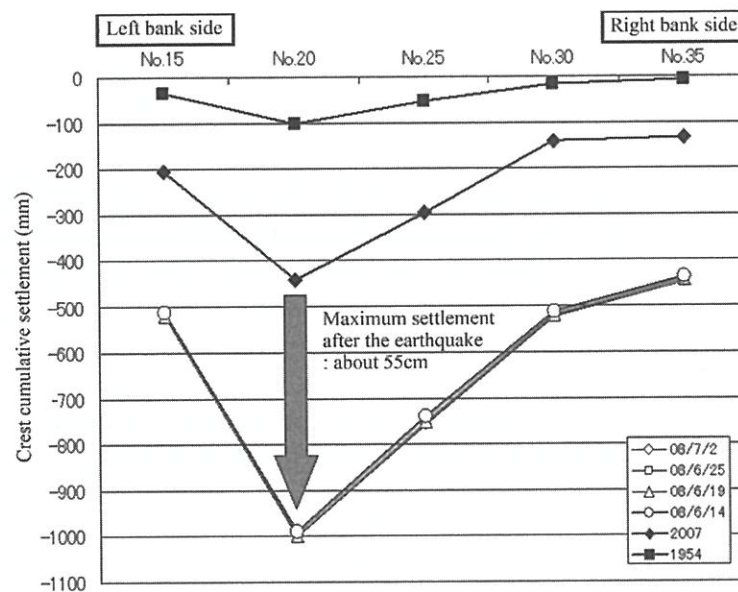
Figure 3 shows the cumulative settlement along the crest occurring between the completion of the dam and the occurrence of the earthquake. The maximum settlement after the earthquake was about 55 cm at the crest of cross-section No. 20, which is the maximum cross-section. An examination of change in the cross-section shape of the maximum cross-section reveals that, generally speaking, the deformation was large near the crest. Moreover, the entire dam body was deformed toward the downstream side, while the crest was displaced by about 53 cm in the downstream direction.

Focusing on the middle elevation reveals settlement of about 60 cm near the berm on the downstream side and displacement of about 72 cm in the downstream direction. However, on the upstream side, settlement was only about 16 cm and downstream direction displacement was only about 13 cm. Only small deformation occurred on the upstream side, presumably because the rock material was constrained by the concrete slab and the water pressure. This is consistent with the observation that while there was almost no deformation of the concrete facing on the upstream side, unevenness appeared on the downstream side rubble.

Figure 3. Changing cumulative settlement at dam crest.

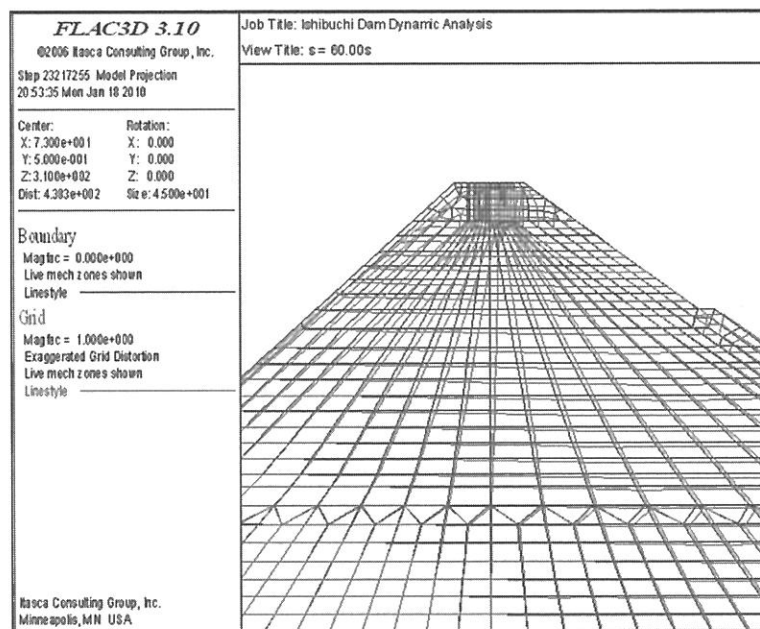
In Case 2, the analytical values of the maximum acceleration at the crest were smaller than the observed values because the input earthquake motion was lowered to 90%, but the analytical values of the crest displacement, and the crest settlement in particular, were almost identical to the measured values. Therefore Case 2 was regarded as the results of calculations to reproduce the dam body behavior during the earthquake.

The dam body deformations observed in both cases after the earthquake at the Ishibuchi Dam are shown in Figure 4 (Case 2) and in Figure 5 (Case 3). A close examination of the

Figure 4. Results of analysis of dam body deformation after the earthquake (Case 2).

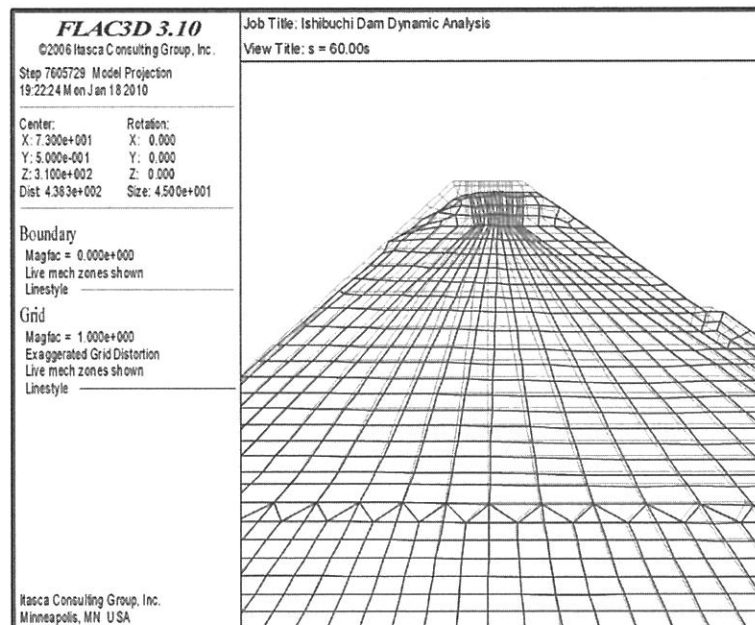
Next, in Case 3, the upstream-downstream displacement of the crest was 0.59 m and settlement was 0.85 m, which was almost 0.3 m larger than the settlement of the crest in Case 2.

dam body deformation after the earthquake shows that in Case 3, deformation was greater than it was in Case 2, with (1) large settlement and deformation near the upstream edge of the crest, and (2) more conspicuous deformation in the downstream direction of the high elevation parts of the downstream side. However, as in Case 2, the dam body deformation after the end of the earthquake was small in parts below the reservoir water level on the upstream side.

Figure 5. Results of analysis of dam body deformation after the earthquake (Case 3).

For the above reasons, it can be said that the rubble work that was installed on the upstream and downstream sides played an important role in sparing the Ishibuchi Dam severe damage despite the large scale of the earthquake motion that struck it.
