Long-term behavior of the Yashio dam, asphalt faced rockfill dam

T. Tsukada & M. Doi
Tokyo Electric Power Company, Tokyo, Japan

ABSTRACT: The 90.5 m high 15 year old Yashio dam, which was completed in 1995, is the upper dam of Tokyo Electric Power Company's Shiobara pumped storage power plant. There has been no leakage through the asphalt facing, and leakage through the foundation and exterior deformation of the dam body has been stable. We have measured the deformation of the asphalt facing utilizing a clinometer mounted on a vehicle towed from the crest of the dam. In addition, we have investigated the aging of the asphalt facing at the exposure test yard which was installed near the dam site on the same elevation level of the dam. We estimate that the asphalt facing was performed adequately after the aging.

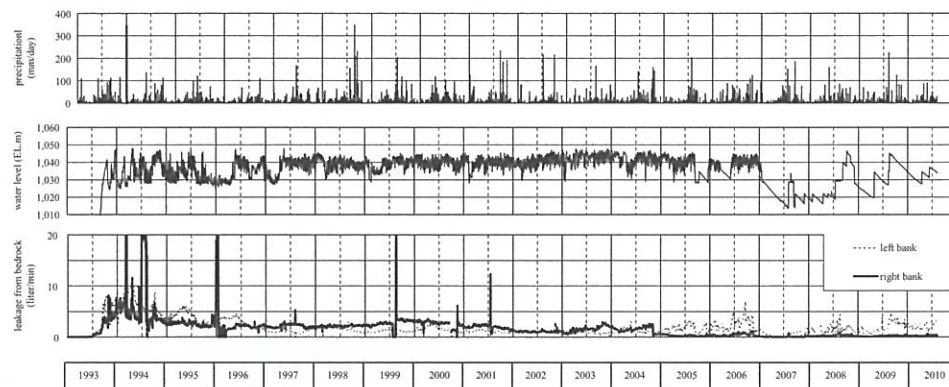
Figure 3.2. Flowing quantity from the dam body side drain.

The leakage seeping through the facing and the bedrock are guided respectively to the inspection gallery. The drainage layer and the rock material of the dam body are connected with the inspection gallery with the drainpipes respectively. They are measured separately by the weir installed at eight points in the gallery. The flowing quantity is measured with the automatic measuring system. The leakage measurement equipment is shown in Figure 3.1. The leakage through the upper impermeable layer has been almost zero. Even though a slight amount of leakage through the seams and hair cracks of the inspection gallery concrete was measured for the period of the initial filling, it was stopped up. We installed drain pipes in the inspection gallery at the side of the dam body so that the backing pressure should not act on the facing. The amount of flowing quantity from these drain pipes was 10 liter/min. for the period of the initial filling, but it decreased and is about 5 liter/min. now. Moreover, it is judged that there is no danger of backing pressure or piping fracture occurring in the dam, because there has been no fine-grained fraction in the water. The flowing quantity from the dam body side drain in the inspection gallery is shown in Figure 3.2.

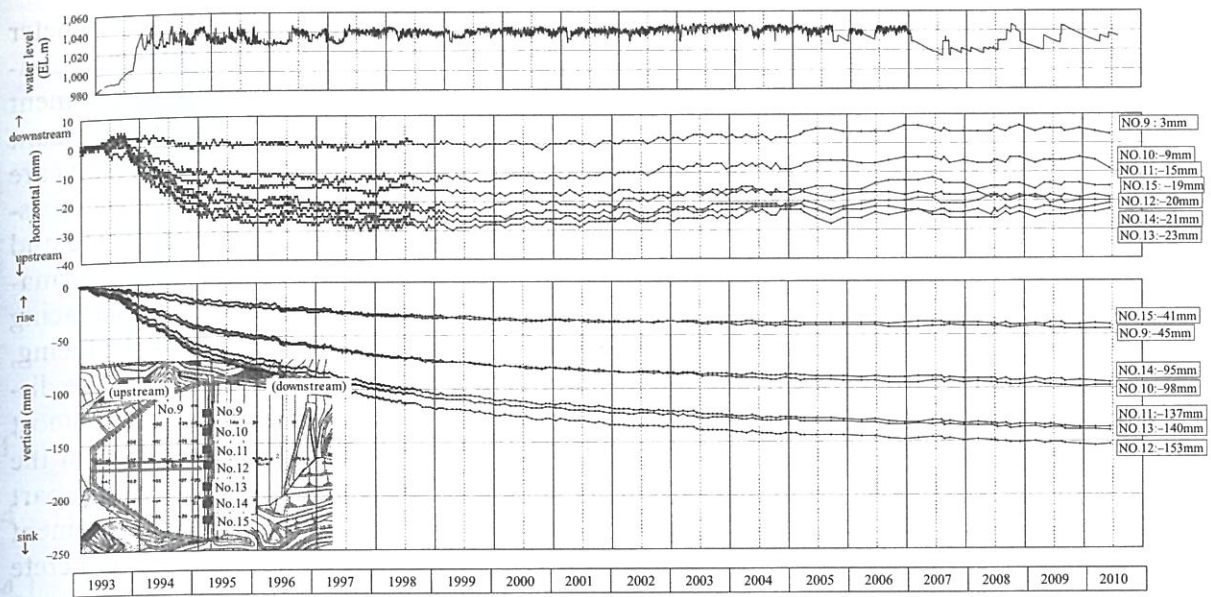
Figure 3.4. The exterior deformation measurement results (dam crest).

The maximum horizontal displacement towards the direction of the upstream was about 30 mm at No. 13 (near the center of the dam crest) and 25 mm at No. 3 (in the middle of the downstream at the left bank) towards the direction of the downstream. The maximum vertical displacement is about 150 mm at No. 12. We estimate that it has been stable because its increase has been 2 mm a year over the past five years. Further, we estimated that the vertical displacement near the center of the dam crest caused the horizontal displacement towards the direction of the upstream. The horizontal displacement towards the direction

of the upstream of No. 13 increased along with the water level rising in the period of the initial filling. Further, it had decreased gradually for 10 years since five or six years after the water level reached the HWL. Now that the horizontal displacement toward the direction of the upstream of No. 13 is 20 mm. Similar behavior has been shown at other points on the dam crest, and it has been evaluated that the displacement towards the direction of the upstream was caused mainly by the influence of the vertical displacement of the upstream side of the dam by hydraulic pressure. The horizontal and vertical displacements are shown in Figures 3.4 and 3.5. Further, the distribution of the horizontal displacement and the vertical displacements in the dam central cross section is shown in Figure 3.6.

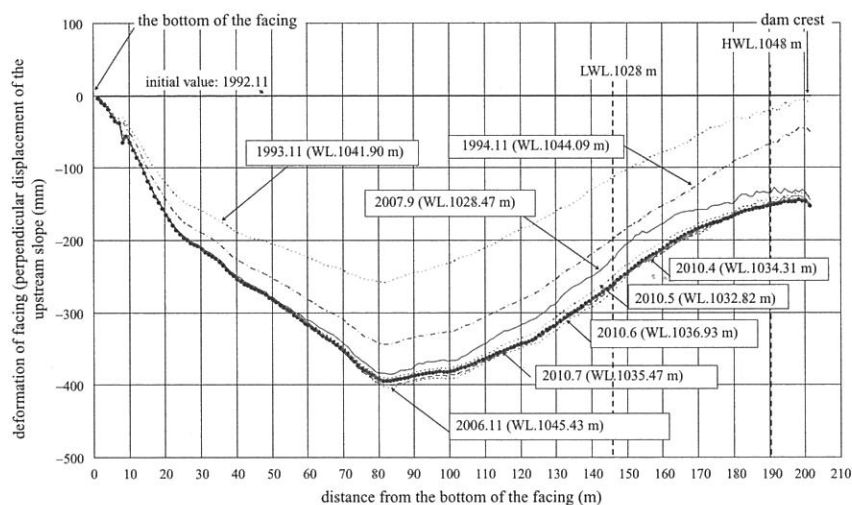
Figure 3.8. The deformation of the facing.

The deformation of the facing is calculated by measuring the tilt angle with a clinometer and the distance between the measurements (1 m). We have observed it by the difference, converted to a perpendicular displacement of the upstream slope, between the each measurement and the initial value that was measured before the initial filling. The maximum displacement is about 400 mm at about 80 m from the bottom of the facing. The measurement results are shown in Figure 3.8. The deformation of the facing had increased according to the water rising in the initial filling, and have showed little elastic behavior according to water rising and the descent and creep deformation since the water level reached HWL. However, the deformation has been stable in recent years. The increase of the maximum displacement of the facing has gradually decreased. We evaluated that there is no problem with the stability of the facing, because the increase ratio of the maximum displacement is small and the increase of the displacement of the joint part of the facing with the inspection gallery concrete has been almost zero in recent years because the maximum tensile strain by hydraulic pressure occurs at the joint part of the facing with the inspection gallery concrete. The tensile strain at the joint part of the facing with the inspection gallery which is calculated by the deformation measurement result is about 0.5% or less, it is small enough for the yield strain of the asphaltic concrete of about 5% at the temperature of 5°C and the strain rate of 5×10^{-5} 1/sec. 5°C is the lowest water temperature of the reservoir, and the strain rate of 5×10^{-5} 1/sec is the lowest strain rate of the test machine(actual strain rate during the initial filling was about 1×10^{-10} 1/sec).

We estimated that the facing is stable because the calculated tensile strain is smaller than the yield strain under the test conditions of a larger strain rate at the same temperature.

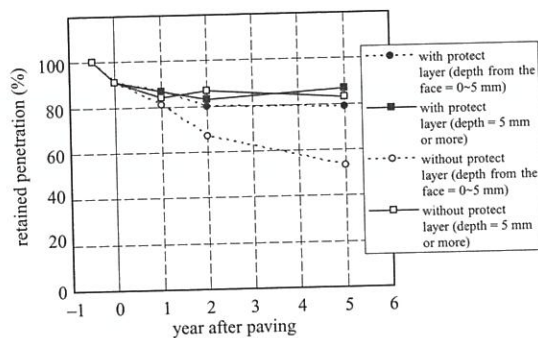
Figure 4.1. The retained penetration after aging.

The property changes of the test pieces with the protective layer were comparatively large for the first few years. The penetration became small and the softening point rose up and the yield bending tensile strain became small, but after that they didn't change that much. In other words, asphaltic concrete hardens after few years, but after that, there are no changes, if it was coated with a protective layer. The bending test condition of -15°C is the lowest temperature of the dam site and the strain rate of 1×10^{-2} 1/sec is the one during the earthquake in Figure 4.3.

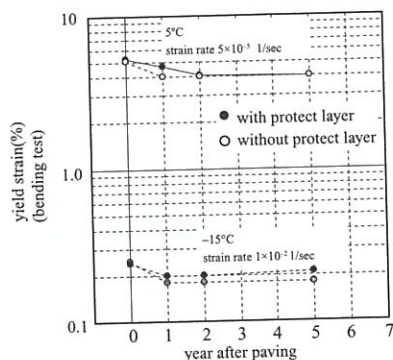
Figure 4.3. The change of yield strain.

The amount of the tensile strain occurring on the facing during earthquakes was calculated using the two-dimensional dynamic response by means of the finite element method was about 0.1%, it is enough smaller than yield tensile strain.

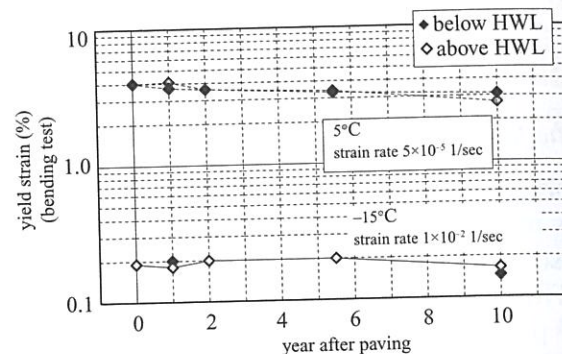
Figure 4.4. The change of yield strain after exposure.

The results of the investigations are almost similar to the aforementioned former exposure tests results. The results of the bending test from this test yard are shown in Figure 4.4 as one

of the examples. We have confirmed that the decrease of the yield bending tensile strain of the asphaltic concrete was small and that it had enough deformation performance about ten years after paving because we estimate that the tensile strain which occur during the earthquake is 0.06%. And we will continue investigating the change of the properties of the facing in the future, because they have tended to be a little hardened by aging.
