Performance of Highly Ductile Modified Asphalt for Use in Impervious Facing Zone

T. Mizuno & M. Shimazaki

Keywords: Modified Asphalt, Impervious Facing Zone, Remedial Work, Follow-up Survey

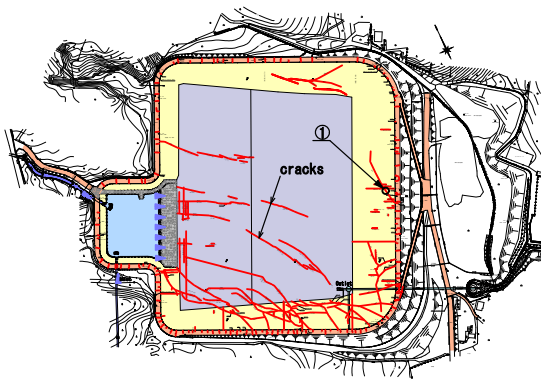
Figure 2. Plan view of reservoir and cracking damages

As taking the reservoir level down after the earthquake, extensive surveys were conducted on the circumference of the reservoir, the embankment body and the reservoir bottom. Although the dam body itself was scarcely damaged, many cracks were detected over the asphalt

facing zone of the embankment slope and the reservoir bottom, as shown in Fig.2. The locations of cracking and the total extension lengths of cracks observed in the site are summarized in Table 1. On the slope surface, most of cracks appeared running across the slope, having the maximum width of 10 to 15mm. Fig.3 shows a few core samples taken from the cracks. The maximum depth of cracks reaches to about 10cm, and most of them penetrated to the extent of the surface impervious layer.

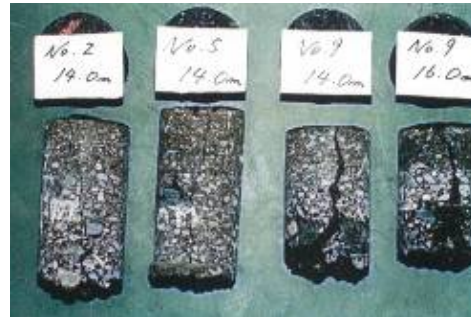
Figure 3. Core samples taken from ① in Fig.2

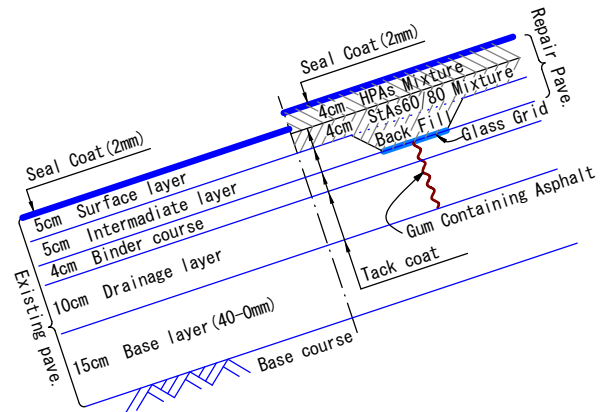
a) Section for south part

The standard section adopted for the southern part is illustrated in Fig. 4a). The repair work is planned to conduct in the following sequence; 1) the surface layer is cut and removed by 1 cm in thickness because asbestos was included at the time of construction of the existing asphalt pavement. 2) The layer is moreover removed by 4 cm, and overlaid with the asphalt mixture of StAs60/80

in 4 cm. 3) the asphalt mixture of HPAs is subsequently overlaid in 4 cm and followed by surface treatment. At the point where cracking reached to the intermediate layer, additional treatments are required in the process as, cutting the pavement along the crack, filling it with gum containing asphalt, and back filling with a material to prevent reflection crack such as glass grid.

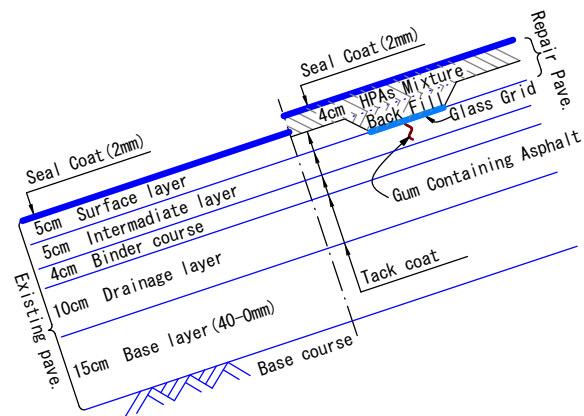
b) Section for north part

In the northern part, on the other hand, the asphalt mixture of HPAs is directly overlaid in 4 cm to cover the surface after the removal process of 1 cm thick, as shown in Fig. 3b); that is, the processes of 4 cm extra cut and the subsequent 4 cm overlay with the asphalt mixture of StAs60/80 are cut down. At the point where cracking reached to the intermediate layer, penetrating into the upper surface of stone sheet, additional treatments are planned by cutting the pavement with a margin of 4 cm along the crack and, after back filling with the StAs60/80 mixture, HPAs mixture is overlaid and followed by the final surface treatment.

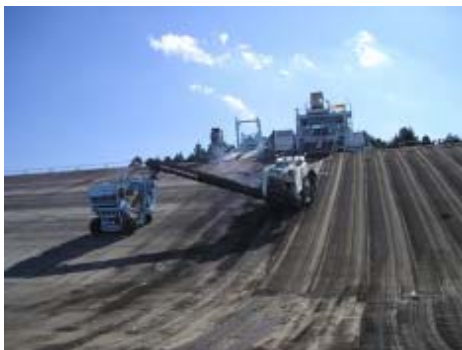
Figure 5. Cutting & removing process

The repair works were conducted first by cutting and removing the old pavement, see Fig. 5, and then by overlaying new asphalt pavement, see Fig. 6. In whole process of works along the embankment slope, a winch machine called by Winch-porter was set on the crest to draw up and down the cutting machine, the asphalt finisher and the vibration roller, which were specially prepared for works on sloping surfaces. In overlay works, the placement of new asphalt mixture composed of high performance HPAs was successfully done without any trouble, similarly as in the case of the usual mixture.

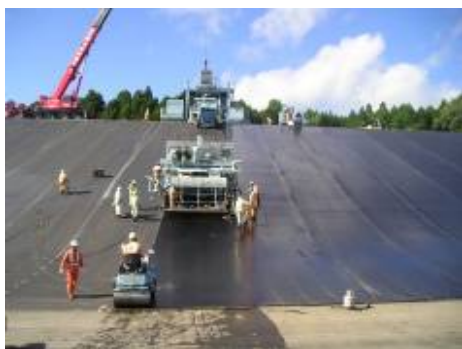
Figure 6. Overlay pavement

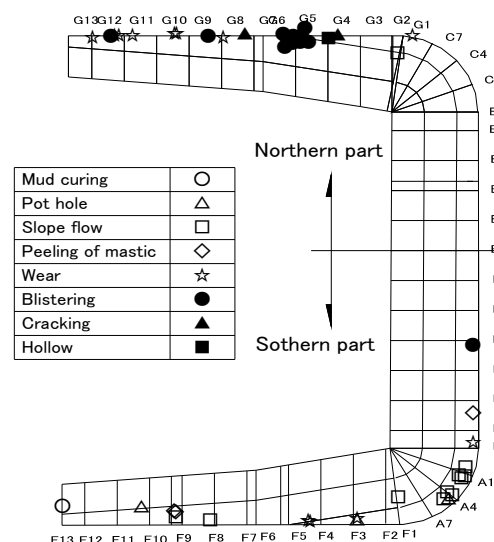
Figure 7. Location of damages

Results of the inspection survey are presented in Fig. 7 and in Table 5, summarizing location of damages and detail item records. Figs. 8 and 9, respectively, show

example damages appeared in the field of slope flow and blistering. Total number of damages detected was 47 points, 30 of them in the protection layer and 17 in the impervious layer. The frequency and level of these damages were recognized rather usual, similarly found in other earth dams, and not so serious to affect on the essential function of the impervious zone. Comparing the southern and northern parts of the reservoir, frequency of damages was almost the same. In the southern part, most of damages occurred in the protection layer, and very few worse conditions such as blistering, which usually appear in the early stage of service, were noticed in the impervious layer. In the northern part, on the contrary, blistering was found at many points in the impervious layer, but the damage situation was considered, judging from experience, not so severe and irregular.

One of the reasons of these differences might be thought largely based on the difference in cross-sections adopted at the repair works, as already noted in Fig. 4. In the southern part of repair, after removing the existed surface layer, the regular asphalt mixture of StAs60/80 was first placed, and then the new asphalt mixture of HPAs was subsequently overlaid. In the northern part, on the other hand, the new mixture was overlaid after removing only the protection layer to cover the existed surface layer. Deterioration by aging of the remaining existed layer is supposed ready to come out to the surface and to be one of influential factors to cause higher level of damages observed in the northern part of the facing zone.

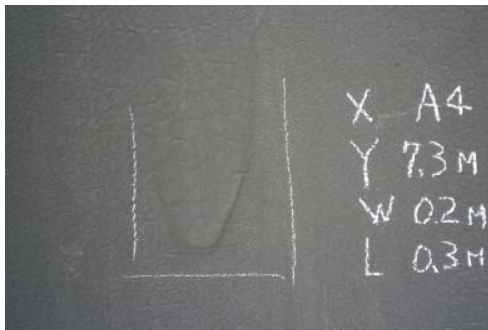
Figure 8. Slope flow in the protection layer

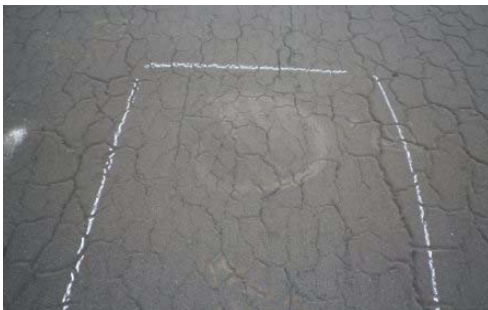
Figure 9. Blistering in the impervious layer

The results of wave radar survey generally revealed satisfactory performance of the facing zone. In the northern part of the facing zone, however, some trapped water was found at a few points, between the overlaid layer and the existed pavement, where blistering had been detected in the inspection survey. This situation is considered natural, because blistering may happen under the condition that water is trapped in some reasons in the pavement as placed or in service and evaporates and expands in volume at high temperature during summer.
