## **Earthquake Induced Failure of Fujinuma Dam**

Fujinuma Dam failed due to The 2011 off the Pacific coast of Tohoku Earthquake and large amount of released water reached the downstream community causing a loss of seven lives and one missing. In order to identify the cause of the failure of Fujinuma Dam the geotechnical properties of embankment were grasped by investigations of the remnant embankment and the construction and repair works were evaluated. The stability of the embankment before the earthquake was also examined. Even though any abnormality had not been detected by regular inspection, the possibility of incurring failure still exists if and when it is exposed to strong and long duration earthquake motion such as that of The 2011 Tohoku Earthquake, depending upon its construction material and degree of compaction.

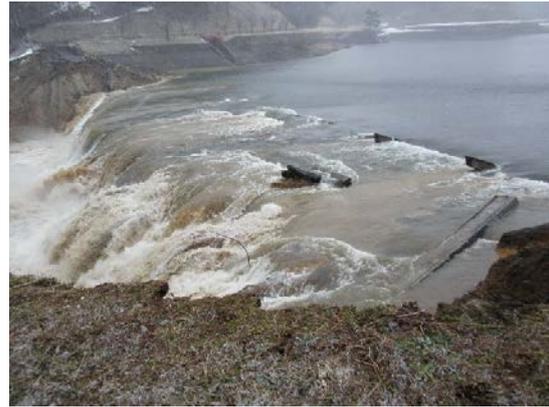
The water stored in the Fujinuma reservoir overflowed and breached the dam body because the reservoir, being

full when the earthquake struck, was severely deformed by the earthquake (Fig.1). As a result of the breaching, the reservoir water severely damaged the community located downstream. At the auxiliary dam, the upstream slope flowed down into the reservoir from the dam crest. The front end of the sliding failure moved to 60m into the reservoir.

On the dam body of right abutment side, the water overflowing from the reservoir eroded the dam down to the foundation ground, while the left bank side body was also eroded by the flowing water, but the dam body remained to its middle height. During upgrading of the dam between 1983 and 1991, six exploration holes were bored, then after the disaster, five more exploration holes were bored. The excavation exploration of the dam body has clarified the following facts.

Figure 1. Breaching state of Fujinuma Dam

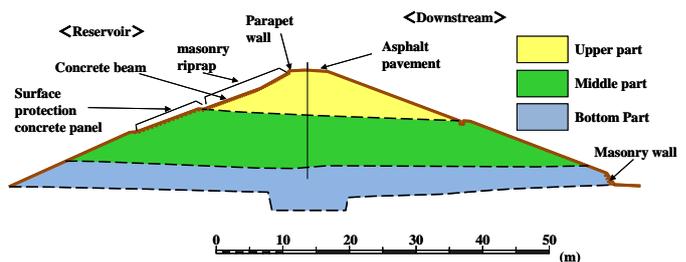
- (1) The fill material can be classified into three embankment layers according to differences between the soil quality (top embanking, middle embanking, and bottom embanking), as shown in Fig.2.

- (2) The top embankment layer is 6 to 8m thick, its material is generally homogeneous, with most consisting of gray coarse sand, and there are few clear traces of compaction layer or spreading.

- (3) The middle embankment layer is between 7 and 9m thick, consists mainly of brownish gray sandy silt with alternating 20 to 30cm layers of sand containing yellowish-gray silt, loam-type clay, and humic silty sand ranging from black to dark gray, and shows clear traces of spreading.

- (4) The bottom embankment layer between 4 and 6m thick, consists mainly of coarse to fine sand containing gravel including a silt fraction, with alternating 20 to 30cm layers of loam type clay and humic silty sand ranging from black to dark gray, and shows clear traces of spreading.

Figure 2. Cross section and classification of embankment layer

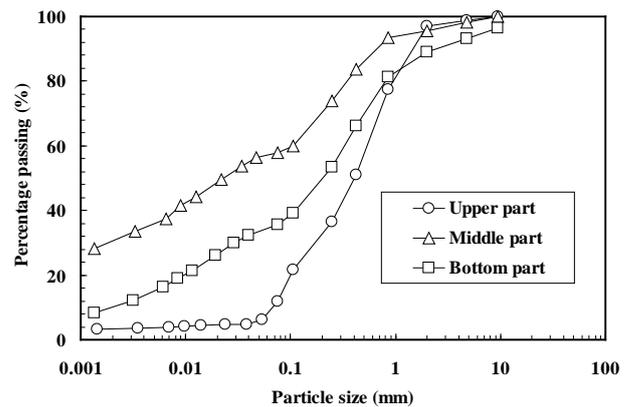
Laboratory soil tests of the fill materials remaining after the disaster were performed. The particle size distribution, as revealed by Fig.3, shows abundant silt to clay in the middle embankment, and abundant sand in the top

Figure 3. Particle size distribution of embankment materials

embankment and bottom embankment. The soil material in the top embankment in particular, was 17.2% fine grain material of 0.075mm and lower. Compared with normal uniform embankment dams constructed in the past, the top embankment consists of semi-impervious materials, and the middle embanking material is similar to impervious materials, while the bottom embanking is grain size material in an intermediate relationship to these materials. The degree of compaction value D of fill materials was, in the remaining part of the top embankment, 87.9% by the Standard Proctor test, but in the middle embankment, it was 81.6% and in the bottom embankment, it was 86.4%. In the middle embankment, a low value of 81.6% was obtained, confirming scattering in the degree of compaction of the fill material just as shown by the boring data. Most of the top embankment was washed

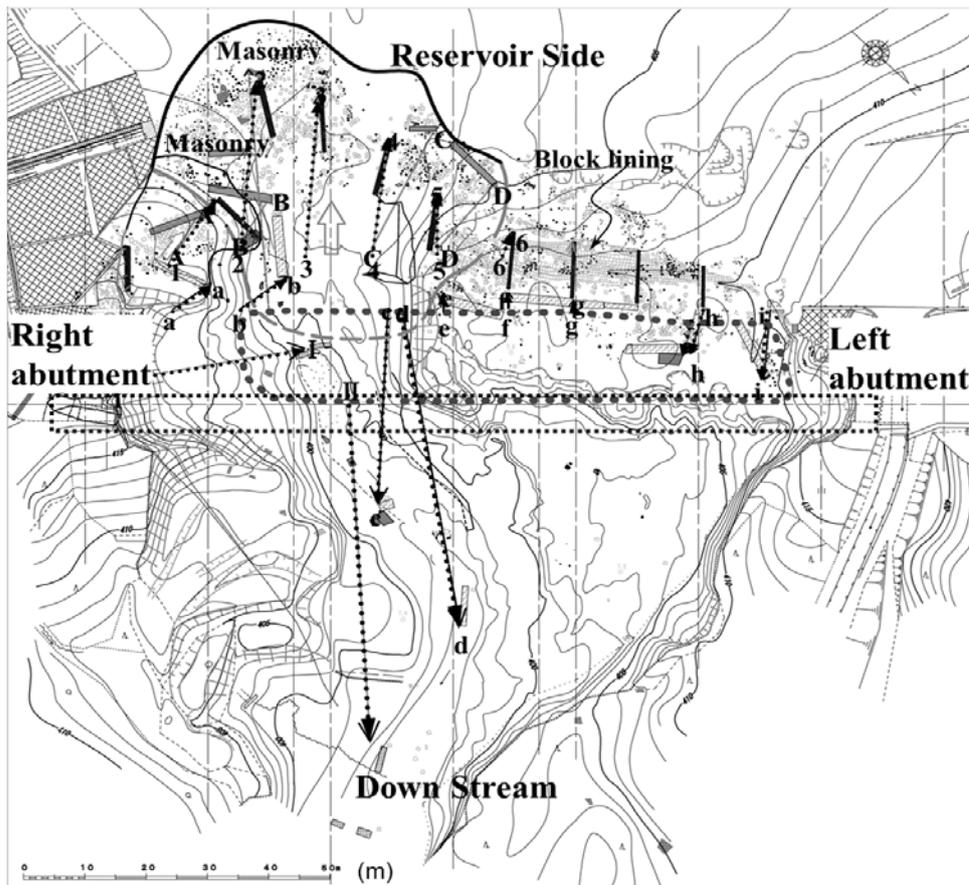
(2) From the movement of the structural elements, first masonry riprap of upper part of embankment fell to the reservoir and subsequently the surface protection work from the middle to the right abutment moved substantially to the reservoir (Fig.4).

Figure 4. Mapping of structural elements after failure

Notes: The dot colored blue is the parapet wall. The dot colored green is masonry riprap. The small square colored purple is the surface protection work. The rectangular colored yellow is concrete beam on the upper upstream slope. Most structural elements moved to upstream.

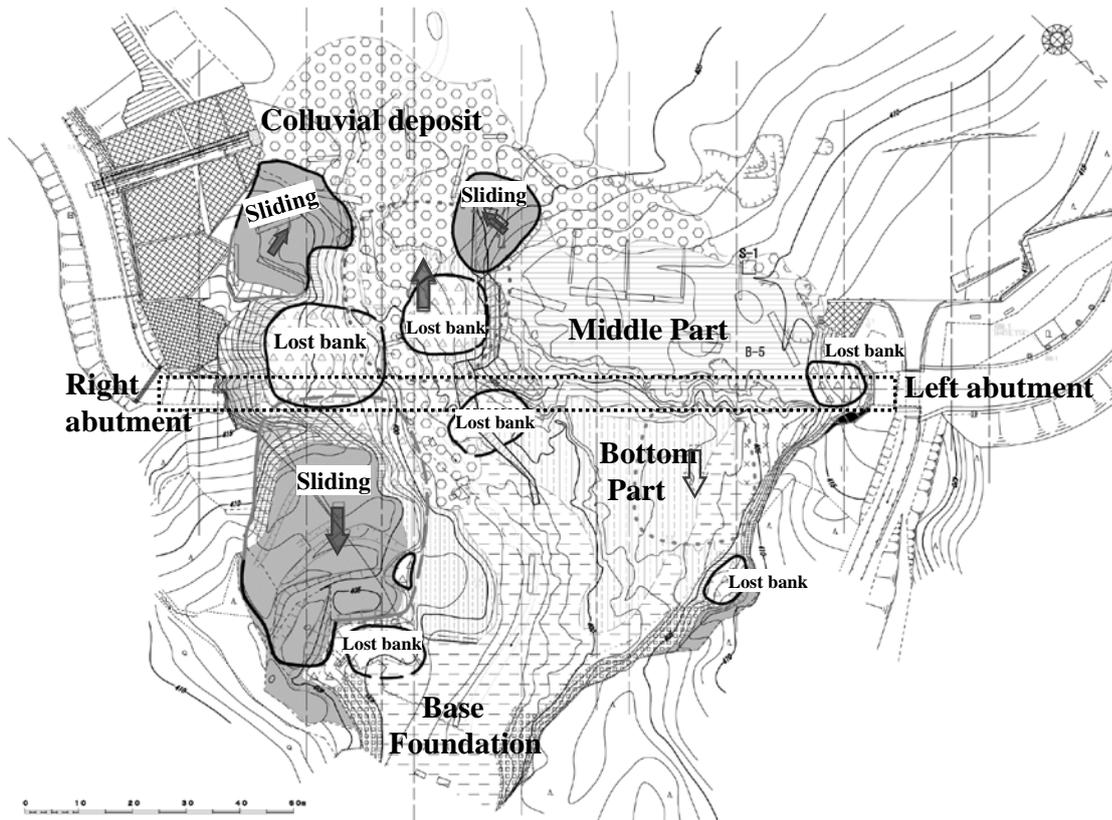
(3) It was confirmed that slides occurred in the direction both of the reservoir and downstream judging from the distribution of main scarps, sliding surfaces and moved layers (Fig.5).

**Figure 5.** Possible slides estimated from geologic and topographic mapping  
 Notes: Circled lines indicate the slide block.

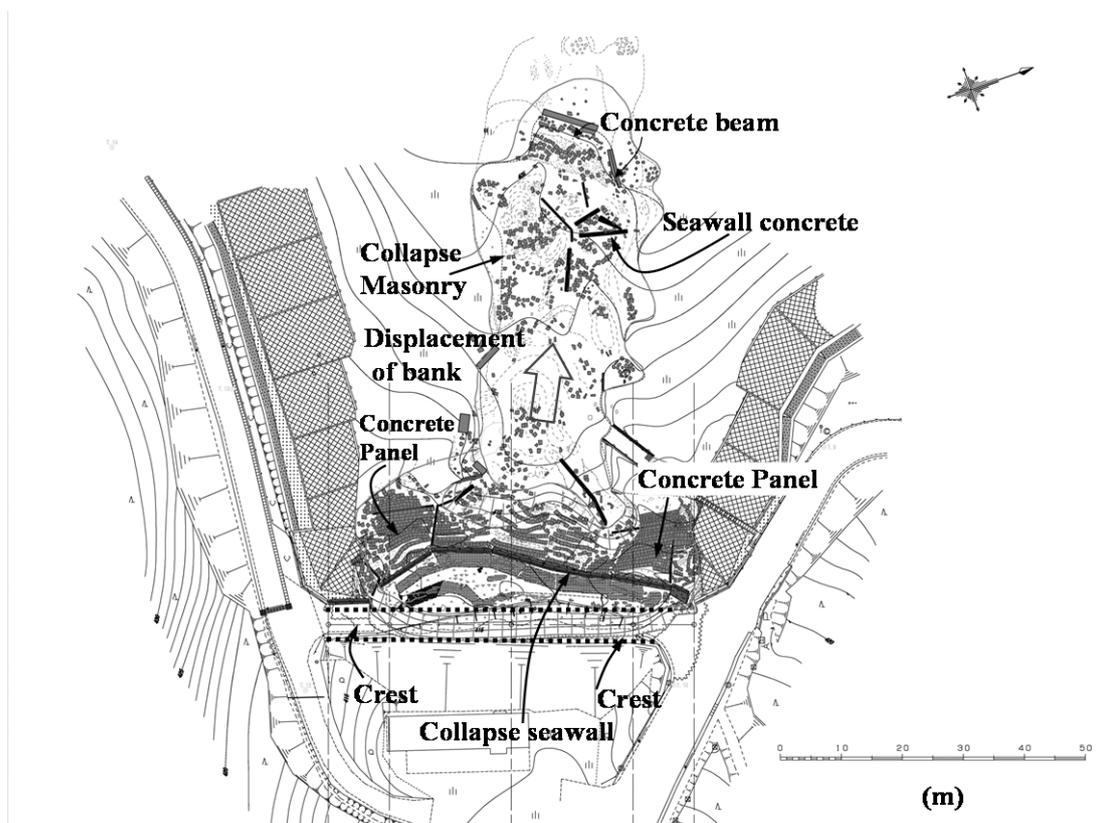
(4) In the auxiliary dam the main slide with the width of 55 meter, length of 25 meter and depth of more than 3 meter occurred and the secondary slide happened at its front (Fig.6).

**Figure 6.** Damage of structure and slides of auxiliary dam  
 Notes: The area colored blue is concrete parapet wall. The small square colored purple is concrete block for surface protection work.

(3) The slide occurred in the auxiliary embankment consisting of similar material to upper embankment of main dam and one of its failure causes is the nature of the soil of embankment, rich with sandy materials.

(4) In the slide occurred in the auxiliary dam, sliding surface was restricted to the embankment boundary of the different construction periods. In the main dam, the difference of the degree of compaction depending on the different construction periods is possibly attributable to the occurrence of the sliding.

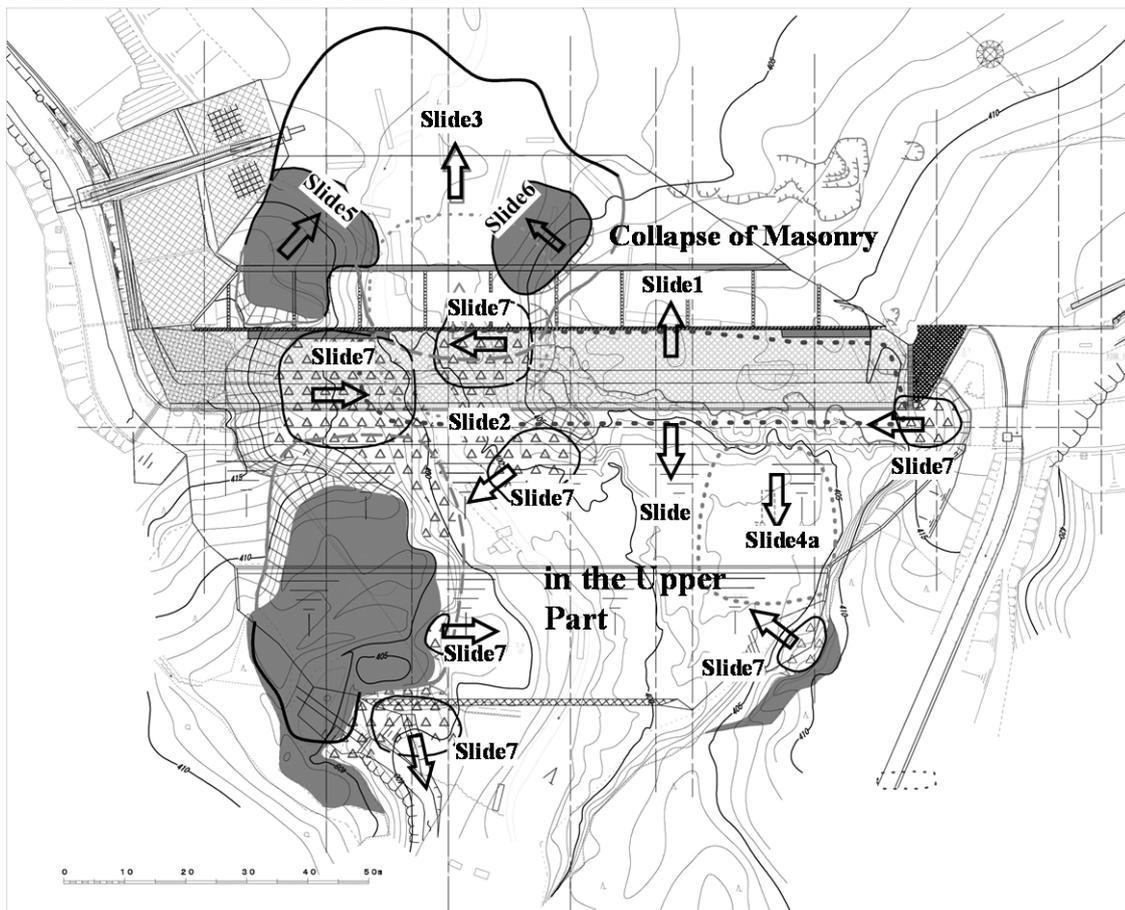
Summing up the investigation results, slides are broadly classified to seven stages (Fig. 7). Among these slides, the upstream slide No.1 and No. 2 triggered the subsequent overflow and erosion and resulted in a failure of the dam. The slide No.1 occurred in the upper embankment and it was recognized from the remnant of the structural elements in the reservoir and sliding surface was lost by wash out. However, the earthquake deformation analysis (by modified Newmark procedure) considering the strength reduction due to cyclic loading indicated the existence of this slide.

Figure 7. Integrated map of slides of Fujinuma main dam

Notes: The solid lines are existing slide bodies. The broken lines are estimated slide bodies which were lost by wash out.

There may be some possible processes of breach (initiation of overflow) such as the case of the slide No.1, No.2 combined with the secondary downstream slide and the case of the downstream slide caused by the reduction of water tightness in the upper embankment and others.

Considering the loss of upper embankment in the large areas in a short period, it was possible that these processes were combined resulting in a cause of overflow hence accelerated the development of erosion of the dam.
