Effects of the 2011 Tohoku Earthquake on Dams

N. Matsumoto & T. Sasaki

Japan Dam Engineering Center, Japan
matsumoto@jdec.or.jp

ABSTRACT:

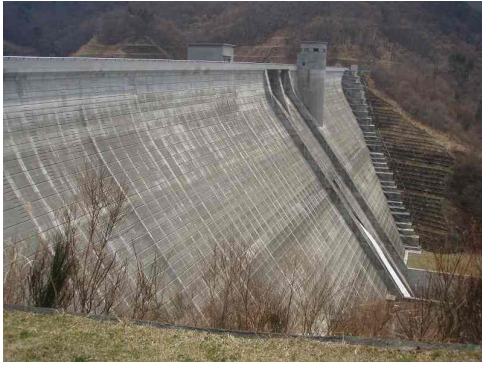
Fig. 10 is Takou Dam (PG, 77 m in height) in Iwate Prefecture. The distance to the epicentre is 155 km, and the shortest distance to the fault is 59 km. Due to blackout, the earthquake records of this dam were not obtained. On April 7, the after-shock of M7.1 was occurred and horizontal PGA of 372 gal at foundation was observed. The duration was about 100 sec. Main damage of the quake in Takou Dam was cracking of the wall of intake tower and elevator tower on the crest (see Fig. 11). The dam body suffered no damage.

Figure 10. Takou Dam after the earthquake

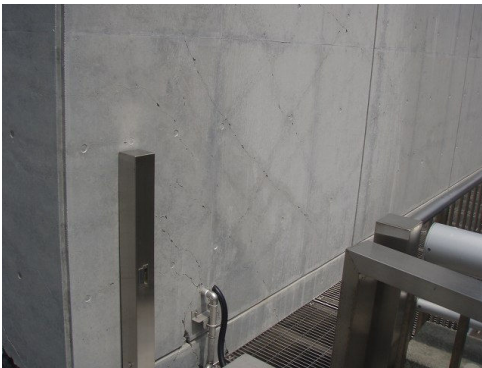
Figure 11. Cracking at gate house of Takou Dam

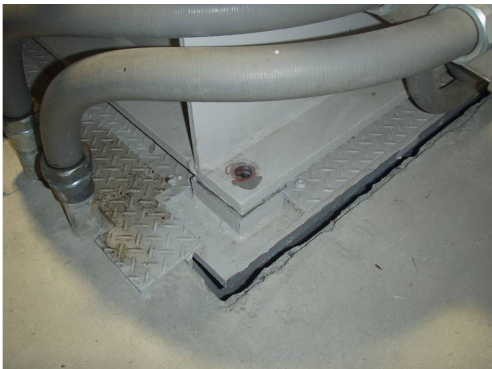
In the intake tower, the hoist equipment was displaced due to breakage of anchored bolts (see Fig. 12).

Figure 12. Shifting of hoist equipment and breaking of anchored bolts

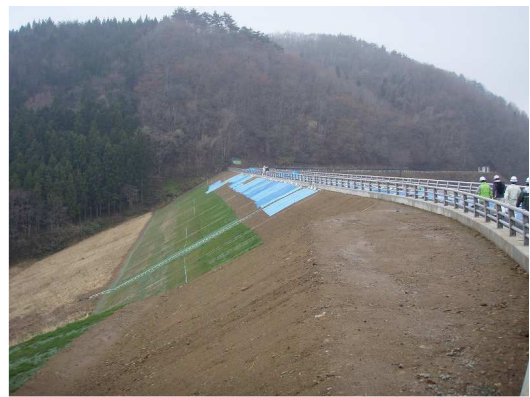
Fig. 13 is Koromokawa No.1 Dam (TE, 35.5 m in height) in Iwate Prefecture. The distance to the epicentre is 200 km, and the shortest distance to the fault is 89 km. The maximum acceleration of 106 gal at foundation of the Koromokawa No.4 Dam located 5 km from No.1 Dam. This Koromokawa No.1 Dam was suffered from cracking damage by the former earthquake, 2008 Iwate Miyagi Inland Earthquake and the restoration countermeasure by re-embankment had been conducted.

Figure 13. Downstream View of Koromokawa No.1 Dam

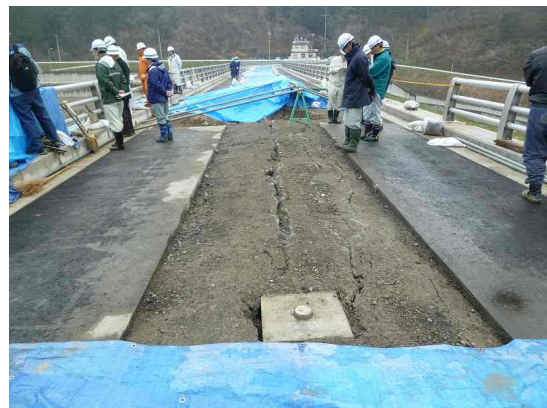
The main effects by the Tohoku quake were cracking on the crest (see Fig. 14) and longitudinal cracking of at least tens of centimetres on upstream surface and downstream surface. By the trench excavation, the crack on the crest was found to be shallow and not to reach at

the top of impervious zone of the dam.

Figure 14. Cracking at crest at Koromokawa No.1 Dam (after removal of asphalt pavement)

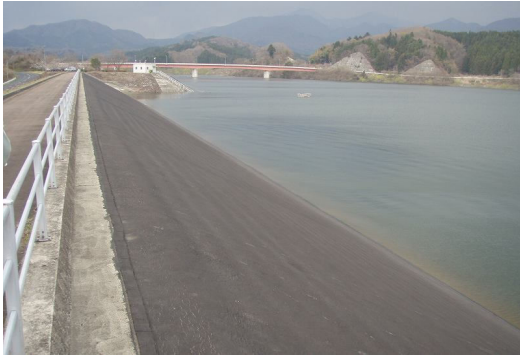
Minamikawa Dam is located in Miyagi Prefecture. The distance to the epicentre is 183 km and the shortest distance to the fault is 85 km. The maximum acceleration recorded at the bottom inspection gallery of Minamikawa Dam was 271 gal. The saddle dam (AFRD, 19.6 m in height, see Fig. 15) of Minamikawa Dam was suffered two rows of cracking on the asphalt facing, one at center and another near right abutment by the quake. The leakage through dam increased from 2 liter/min to 70 liter/min temporarily after the quake, but decreased to 4 liter/min no within one month after the event.

Figure 15. Upstream side of saddle dam of Minamikawa Dam

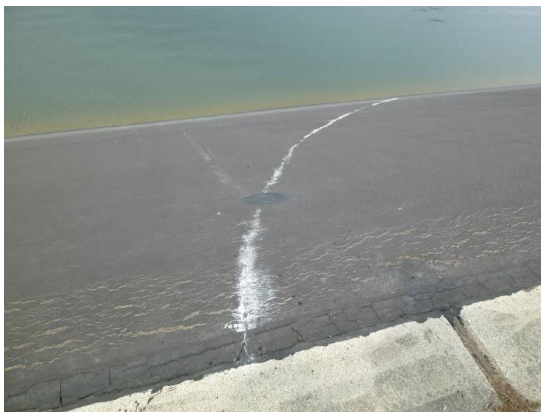
The horizontal displacement is 50 mm, and settlement is 90 mm by the main shock and after shocks, cracks were revealed to penetrate through asphalt face by the coring.

Figure 16. Cracking of asphalt facing at saddle dam of Minamikawa Dam

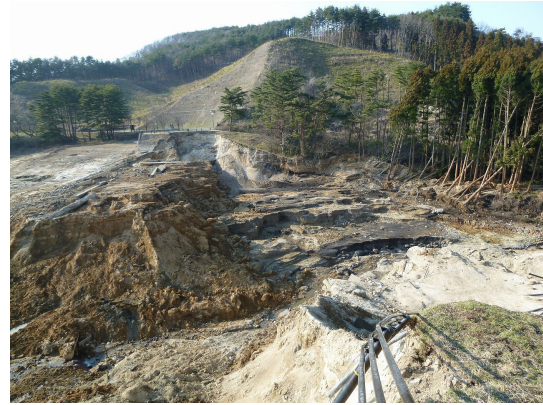
Fujinuma-ike was breached shortly after the earthquake with the loss of eight lives. It is located in the southern Fukushima Prefecture. The epicentral distance is about 240km and the shortest distance to the fault is about 80km. The accelerometer was not installed at the site. The attenuation relationship obtained from KiK-net indicates that PGA at ground surface of the same fault distance is around 0.2 to 0.7g. Fujinuma-ike is an earthfill structure with the height of 18.5 m. The crest length is 133m, crest width is 6m and reservoir capacity is 1.5Mm³. Spillway is ungated.

Construction began in 1937 for irrigation and was suspended during World War II. It was completed in 1949. When the earthquake occurred, the reservoir level was almost full. According to witness, 20 to 25 minutes after the earthquake, the water was overflowing on the crest. Later big discharge occurred and it was breached completely as shown in Fig. 17. The embankment had lost the height to retain water. The review team to find the cause of the failure was set up by the Fukushima Prefecture and the investigation is going on as of November, 2011.

Figure 17. View of breached Fujinuma-ike from right bank
