Damage from Typhoon Talas to Civil Engineering Structures for Hydropower and the Effect of the Sediment Bypass System at Asahi Dam

H. Fukuroi

*Civil Engineering and Architecture Department, The Kansai Electric Power co., Inc,
3-6-16, Nakanoshima, Kita-ku, Osaka, Japan
fukuroi.hajime@a2.kepco.co.jp*

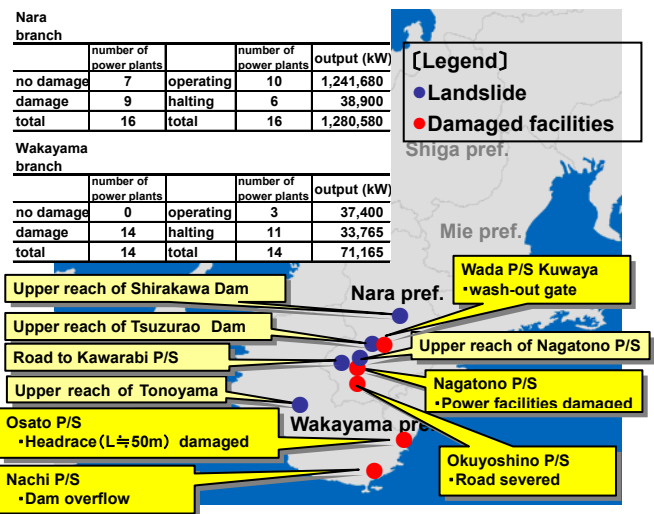
Damaged hydropower stations in Nara and Wakayama branch office are shown in Fig. 3, which indicates that 17 out of 30 power plants were damaged to halt their power operation.

Figure 3. Damage in Nara and Wakayama branch

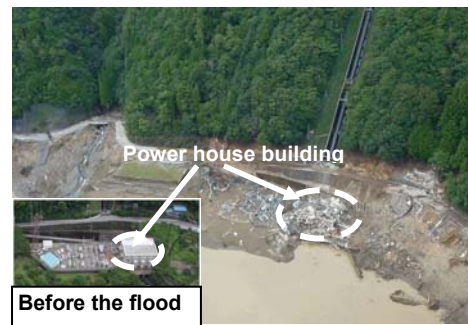
Most of them were caused by debris flow or landslides. One of the most serious damage was occurred in the Nagatono power plant (P=15MW, started in 1937). The building and related facilities of the Nagatono power plant, shown in Fig. 4, were totally washed away by a possible flood caused by the landslide which happened at about 1km downstream of this plant. Compared to as it was before Typhoon Talas, the current status of the site has dramatically changed as if a large tsunami hit there. The landslide triggered waves like a powerful tsunami, which spread to upstream

Figure 4. Collapsed Nagatono power plant

In the aftermath of Typhoon Talas, we have studied a rehabilitation plan for the collapsed Nagatono power plant and the effects of the bypass system on discharged sediment amounts through the tunnel during this flood. Further we continuously collect relevant survey data for verifying long-term operational effects of the sediment bypass system on environmental conservation of the downstream river, focusing on analyzing trends of water quality and sedimentation in conjunction with changes in the ecosystem of the downstream river.

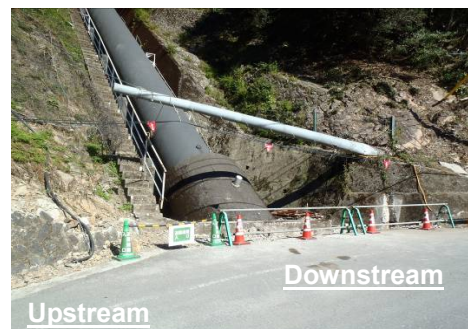
from downstream in a form of hydraulic bore, reached heights of up to 30m high from the riverbed according to our site survey of flood trace height along the river. This fact is also explained by the damaged status of the building and related facilities shown in Fig. 5, indicating that an electric pole next to the penstock fell down toward upstream, as oppose to the flow direction of the river. We have studied the restoration plan for the damaged Nagatono power plant with reference to the survey results such as river cross sectional survey, flood trace height, grain size measurement, etc. and by performing numerical simulations for evaluating riverbed variations in the future.

Figure 5. A leaning pole to upstream

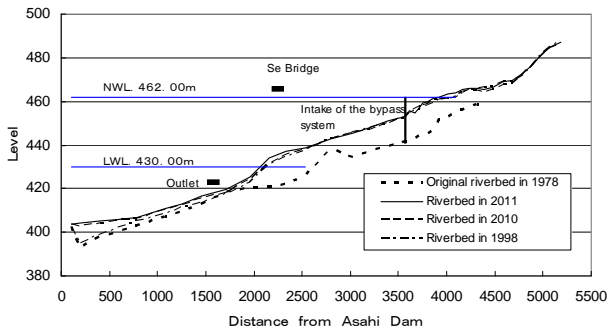
though the riverbed of 2011 as shown in Fig. 12, which was formed in the record flood triggered by Talas, rises higher than before. In particular this flood developed the sedimentation downstream of the Se Bridge at near the L.W.L. of 430 as shown in Fig. 13.

Figure 12. Longitudinal profile of the riverbed in the Asahi reservoir

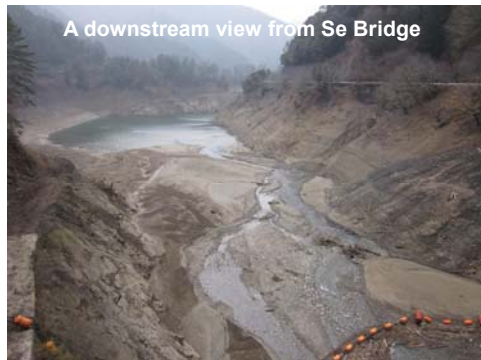
Figure 13. Sedimentation in Asahi Dam

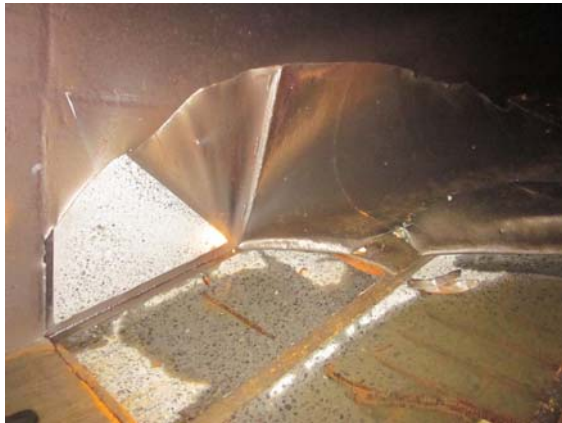
In the course of flooding from Typhoon Talas, a large number of reinforcement bars in the tunnel invert were severed in places and also the tunnel invert lining with concrete was deeply eroded by a maximum of 60cm. This eroded volume of concrete was much larger than the cumulative volume counted up to the previous floods since considerable amounts of bed load passed through the bypass tunnel.

Fig. 16 shows the damaged tunnel section lining with steel sheets (length=19m), a portion of which was torn off due to tremendous debris flows.

Figure 16. View of the damaged tunnel section lining with steel sheets
