# STUDY ON BEHAVIOR OF AFRD DURING EARTHQUAKE AND THE CONDUCTED REINFORCEMENT

The Yashio dam, a 90.5 m high asphalt faced rockfill dam (AFRD), holds an upper reservoir of the Shiobara Pumped Storage Power Plant (PSPP). The 2011 off the Pacific coast of Tohoku Earthquake (The 2011 Tohoku Earthquake) hit the dam and the surrounding area. The maximum acceleration values were about  $50 \times 10^{-2} \text{ m/s}^2$  (50 gal) at the bedrock and 250 gal at the dam crest respectively. Two major cracks occurred at the asphalt facing along the left and the right abutments, while the recorded accelerations were smaller than the acceleration considered at the design stage. Several studies were conducted to pursue the crack mechanism. This paper indicates that cracks may occur at the asphalt facing of AFRD if the dam structure allows strains to be concentrated at some specific facing part in the event of a strong excitation. For the Yashio dam case, we estimated that the cracks occurred in the asphalt facing due to the concentrated strains around the dam crest. The repair works of the asphalt facing were conducted with the consideration of resuming the power plant operation early, durability

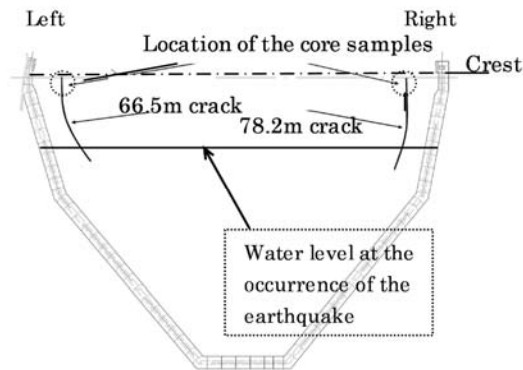
Figure 3. Location of the cracks.

The water leakage occurred after the 2011 Tohoku Earthquake, which indicated some damages in the asphalt facing. A visual inspection was conducted immediately after the earthquake, and two major cracks were found. Then, the cracks below the water level were investigated by divers and underwater cameras. The cracks were about 70 to 80 m-long. These were parallel to the left and the right abutments. The cracks were carefully investigated during the temporary repair work by a visual inspection and using a concrete cutter to take sample pieces from the facing where the crack was too narrow for the visual

inspection. The depths of the cracks were checked by a core drill survey near the dam crest. The cracks were deeper at the higher elevation. The cracks penetrated the asphalt facing near the dam crest and reached the macadam layer (Tsukada et al. 2012). Considering the situation, we estimated that the cracks occurred near the dam crest at first and propagated downward.

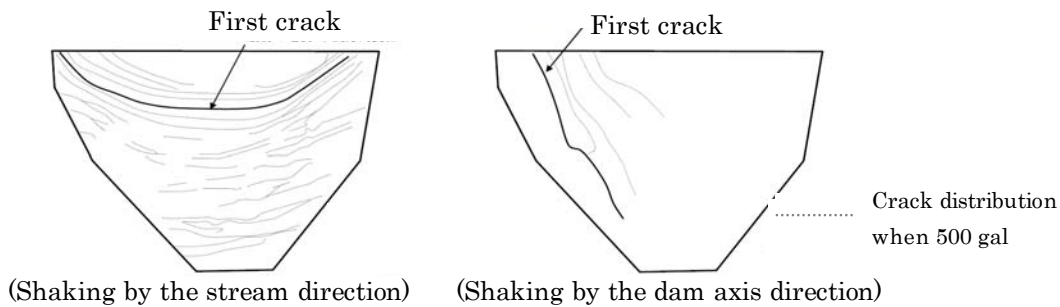
Figure 7. Distribution of cracks by the shaking test.

- The distribution of the surface cracks are shown in Figure 7.
- Horizontal cracks occurred when the shaking direction is the stream. The first crack is located around 1/5-1/4 of the slope length below the dam crest.
- Several cracks occurred parallel with the left abutment when shaking was in the dam axis direction. The first crack is located at 1/8 of the crest length away from the left abutment.
- In the case of shaking by the stream direction, acceleration value causing a first crack was smaller than the one when shaking was in the dam axis direction.

The actual cracks in the facing by the 2011 Tohoku Earthquake showed similar crack propagation of the test results when shaking direction is the dam axis. However, exceeding acceleration was not dam axis direction for the actual dam behavior according to the seismometer records.

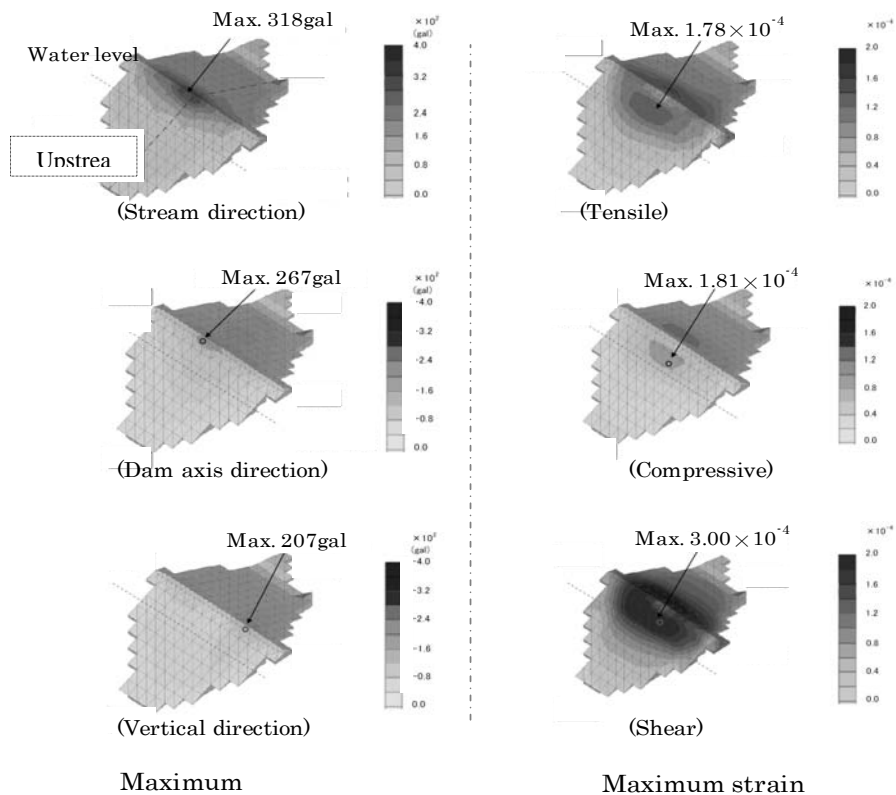
Figure 9. Maximum acceleration and strain at the surface by the analysis.

Maximum strain by the analysis was around 1/5 of the slope length below the dam crest center. Maximum values are  $1.78 \times 10^{-4}$  of tensile strain,  $1.81 \times 10^{-4}$  of compressive strain, and  $2.97 \times 10^{-4}$  of shear strain respectively. The calculated strains are small in comparison with the yield strain of the fine grained asphalt concrete of the facing, while the major cracks occurred by the 2011 Tohoku Earthquake. Further assessment was, therefore, needed to pursue the crack mechanism.

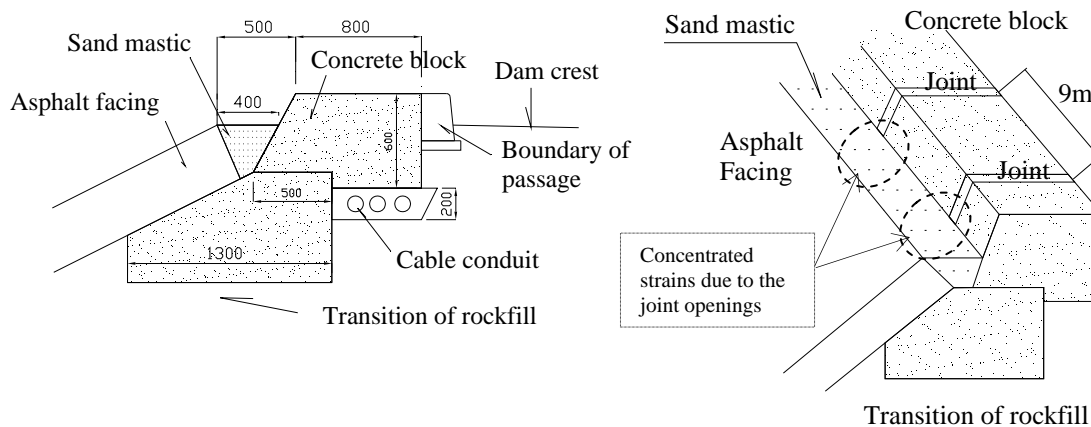
Figure 10. Facing structure at the dam crest.

The asphalt facing structure at the top is shown in Figure 10. The sand mastic connects the asphalt facing and the concrete block. The cracks in the asphalt facing were investigated carefully for further assessment. The cracks in the facing reached the sand mastic and the joints of the concrete block. We measured the openings of the concrete block joints, and confirmed the joint openings where the cracks reached were larger than others. The joint openings during the earthquake were estimated based on the following assumptions.

The results are shown in Table 4. The joint displacements are all greater than the yield tensile strain of the sand mastic. The yield tensile strain of the sand mastic is  $2.5 \times 10^{-2}$  under  $-5^\circ\text{C}$  temperature and strain rate of  $1 \times 10^{-2}$  /sec, which is more flexible than the asphalt concrete. This estimation indicates the strain level may exceed the yield strain if the structures allow the strains to be concentrated at some specific location.

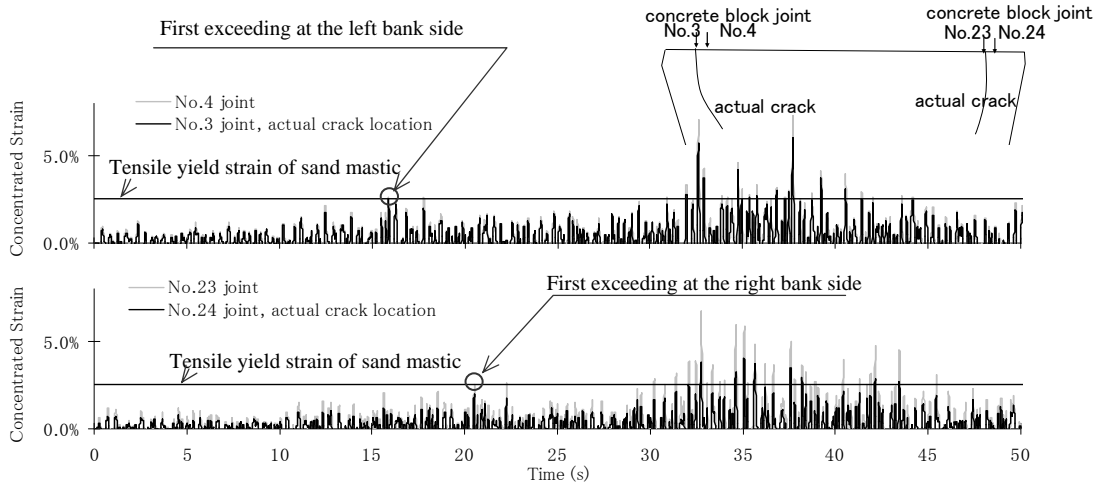
Figure 11. Concentrated strain by estimates at the actual crack location.

The concentrated strain exceeds the tensile yield strain of the sand mastic ( $=2.5 \times 10^{-2}$ ) at the left side at first. The first exceeding strain at the left side was calculated at the No.3 joint where the actual crack occurred. The strain values also exceed the yield level at

other joints of the left side in the next moments. Following this, the strain values at the right side exceed the yield level. The first exceeding strain at the right side was calculated at the No.23 joint, while the actual crack occurred at the next joint. The result shows a reasonable match. The estimated tensile strains at other joints also exceed the yield level in the time history, while there was no remarkable damage in the area. We estimated the first cracks released the stress and the strain.
