# MAINTENANCE OF TERAUCHI DAM SPILLWAY CONCRETE DEGRADED BY ALKALI AGGREGATE REACTION

Shigeki Ichikawa<sup>1</sup>  
Satoshi Inoue<sup>2</sup>  
Katsushi Nagata<sup>3</sup>

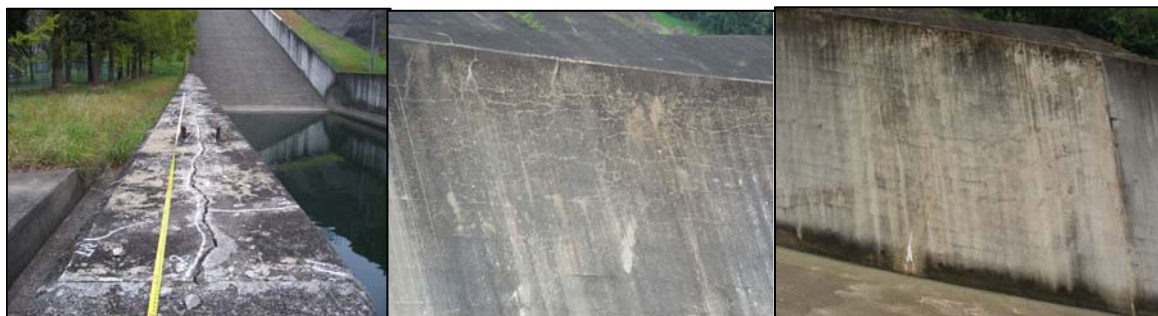
Figure 4. Degradation of Concrete in Flood Spillway.

1) Many of the cracks on the top surfaces of the spillway training wall, which had been repaired in 2001, once again developed into cracks. In some places, new cracks were observed. These cracks were 1 to 5 mm in width (Figure 4 (a)).

2) On the side surface of the spillway training wall, ocher-colored, fine alligator cracks or non-directional cracks (map cracks) were newly generated near the top of the wall (Figure 4 (b)). Other than near those locations, cracks were also generated in places such as joints between cast concrete and cold joints that tended to increase the moisture (Figure 4 (c)).

Given these conditions, it was concluded that map crack were generated in places where there was little constraining force against deformation, such as the side surfaces of the training wall, and that cracks extending along a direction in which there was a constraining force were generated in places such as the top surfaces of the training wall. Also, cracks apparently tended to occur in places such as the top surfaces of the training wall and joints between cast concrete where standing water tended to accumulate.

(a) Cracks on Top Surface of Training Wall

(b) Micro Cracks near Top Surface of Training Wall

(c) Micro Cracks on Side Surface of Training Wall

- 1) Top surfaces of training wall where cracks were generated: Grade II or III
- 2) Sides of training wall and invert, where no cracks were generated: Grade I or II

Based on our examinations, it was decided to implement repair measures for the top surfaces of the training wall of the spillway, where degradation such as cracking was advancing, and the structural soundness evaluation grade was either II or III. As to the type of repair work, it was decided to coat the concrete surface with a material that would restrict the absorption of water, which is a factor in the progression of ASR-caused degradation. For the blocks where there were already cracks along the length of the training wall, it was decided to introduce constraint by applying a pre-stressing force together with the measure taken against the cracks. This was for the reason that the deformation of concrete due to temperature changes and the possibility of future expansion of concrete due to ASR had to be taken into consideration. Pre-stressing was achieved by affixing carbon fiber sheets. The countermeasure against cracking comprised filling cracks with a cement-type grouting material. For the side surface of the training wall, whose degradation was rated at either I or II, only strengthened checks were used as countermeasure, since the cracks were generally narrower than those on the top surfaces, and shielding that portion with surface covering was not very effective, given the ground-water coming from the back.

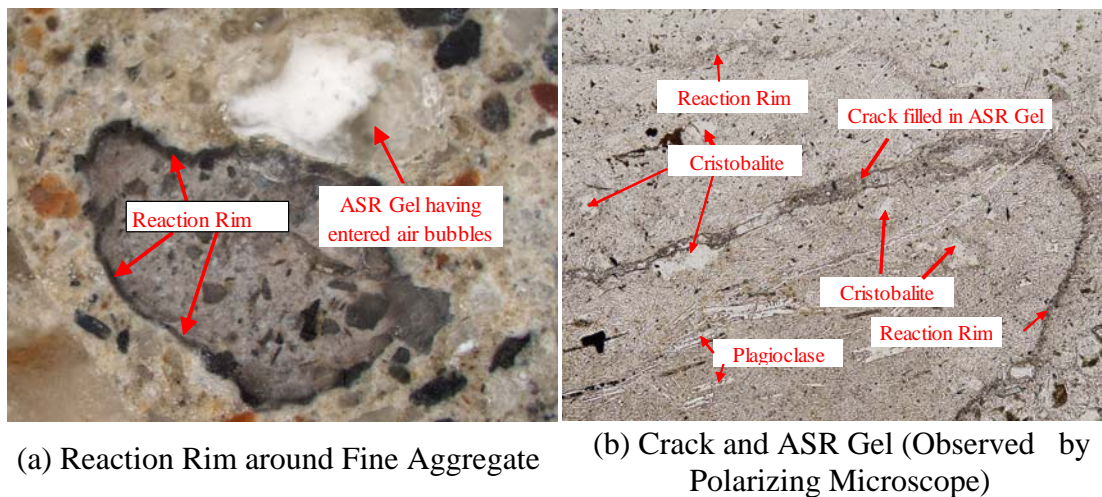
Figure 5. ASR-Caused Degradation Confirmed in Concrete Micro Structure.

Petro-logical Investigation and State of Concrete Micro Structure. Observed by visual observations and polarizing microscope, were as follows (Figure 5):

- 1) Crushed amphibolites were used as coarse aggregate. Nothing found within this aggregate or its periphery was suggestive of concrete degradation.
- 2) Fine aggregate was sand whose main ingredient was clastics derived from volcanic rocks (mainly andesite and welded tuff of rhyolite) and granite. Substances that can cause ASR, such as cristobalite, tridymite and volcanic rocks, including volcanic glass, comprised around 30 to 40% of the mineral.
- 3) In all concrete specimens, including those sampled from locations with no cracks, ASR gel was seeping out or ASR reaction rim was observed. However, there was no instance of ASR gel occurring widely in cement paste, or intruding into air bubbles. These conditions correspond to degree 2 or 3 of the Severity of ASR Classification by Katayama (2008) as shown in Table 1.

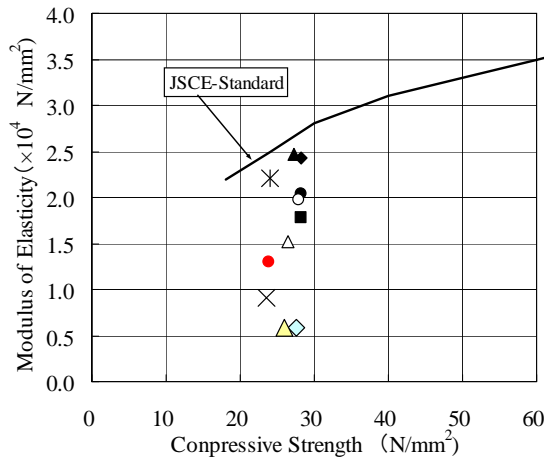
Figure 6. Compression Strength and Modulus of Elasticity.

Relation between Compression Strength and Modulus of Static Elasticity. Concrete that has been degraded by ASR exhibits a modulus of elasticity that generally tends to be lower relative to its compression strength than sound concrete. The relation between unconfined compression strength and modulus of elasticity for the concrete core samples in this study is shown in Figure 6, together with the relation generally observed in sound

concrete provided as Japan Society of Civil Engineers (JSCE) –Standard (JSCE 2008a). As shown, for concrete sampled from the spillway the modulus of elasticity is low relative to the compression strength in comparison to sound concrete, suggesting ASR-caused degradation.

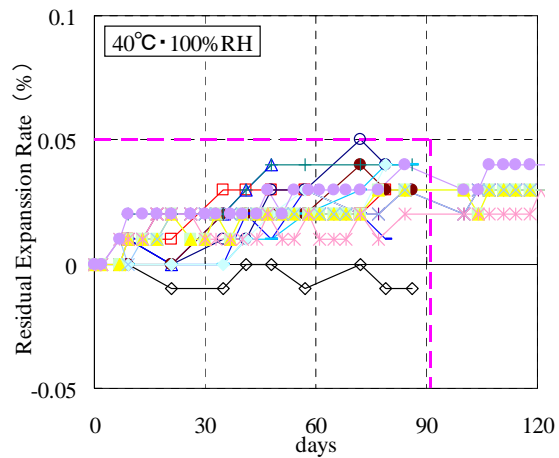
Figure 7. Result of Residual Expansion Test.

Residual Expansion. The residual expansion test results, shown in Figure 7, are generally 0.03 to 0.05%, suggesting the possibility of progressing expansion.

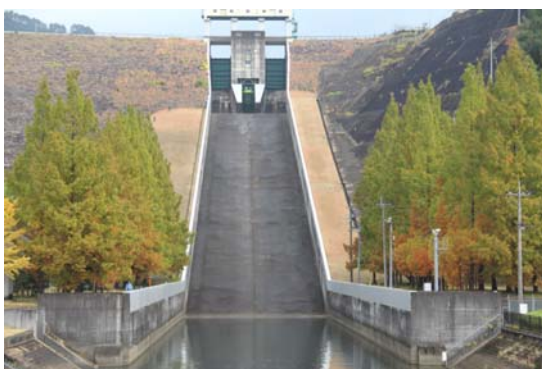
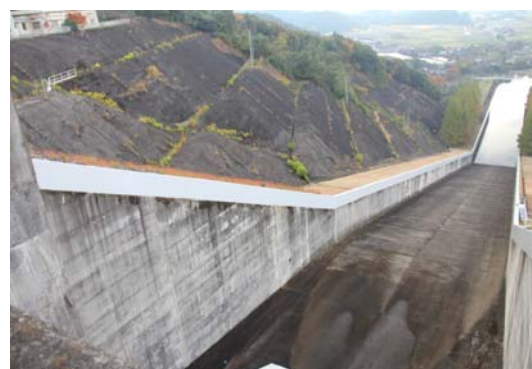
Figure 12. Photos of Spillway with Repair Construction Completed.

(a) Spillway Seen from Downstream

(b) Spillway Seen from Upstream
