RIPRAP DETERIORATION AND ITS INFLUENCE ON SLIP STABILITY OF ROCKFILL DAMS

Hiroki Sakamoto¹
Takashi Sasaki²,
Yoshikazu Yamaguchi³
Takashi Ookawa⁴
Takanori Shimoda⁵

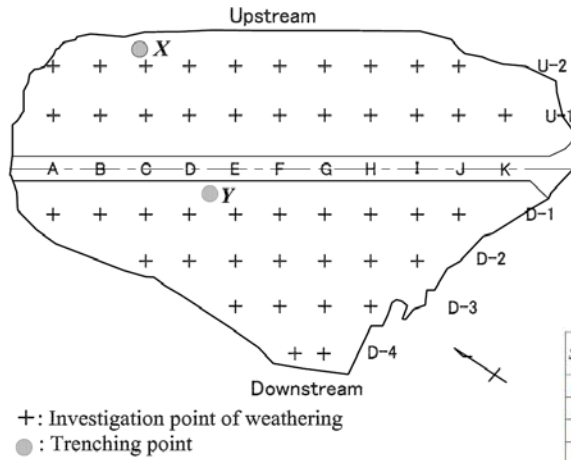
Figure 4. Survey points at Midorikawa dam

Field survey: Weathering status of riprap materials on the upstream and downstream surfaces of the Midorikawa Dam were evaluated at intersections of 20-m interval grids as shown in Figure. 4. The survey area was a 2m × 2 m square centering on the measurement coordinates of each survey location. Each survey area was sketched in detail, and the evaluations, mainly by visual check and hammering, were classified in five degrees shown in Table 1.

As shown in Figure 4, a trench excavation was conducted at the following 2 locations; Point X located on the upstream surface at a lower elevation, where riprap was not much weathered, and Point Y located on the downstream surface at a higher elevation near the

top of dam, where riprap weathering was seriously progressed. The purpose of this trench excavation was to check the status of weathering of rock materials covered by riprap materials. The trench depths are deeper than riprap thickness 1m.

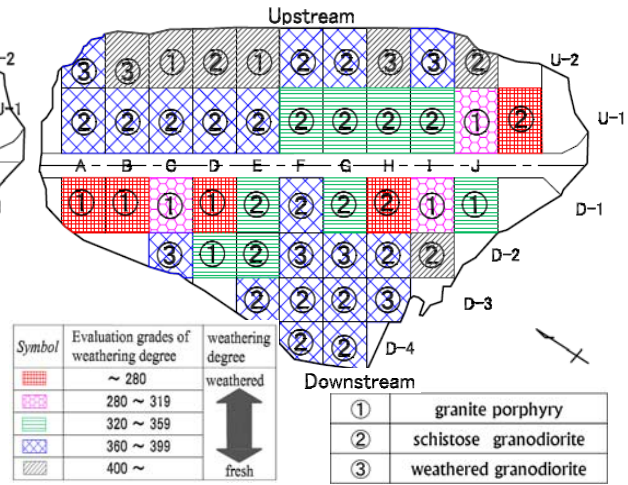
Figure 5. Rock type classification & weathering degree classification

Based on the sketched drawings, the cover area of each rock type was calculated with a planimeter, and the results were summarized by main rock type of each mesh and by weathering degree as shown in Figure 5. By the way, weathering degree classification is based on the field survey results at the time of 1979 and 1985. It is, therefore, not clear if such weathering and deterioration has progressed with time after construction of the dam or such situation already occurred when the dam was constructed.

We analyzed weathering characteristics of riprap by focusing on the relationship between weathering degree and the location. According to Figure 5, it is confirmed that the weathering degrees of the same materials is more advanced in the downstream surface than in the upstream surface. Considering the elevation, weathering degree is more advanced at higher locations in the both of surfaces.

Since the downstream side of the Midorikawa Dam faces southwest, it is exposed to insolation longer than the upstream side. The component ratio of granite porphyry is higher in the material at higher locations. These factors are considered to be causes of weathering and deterioration.

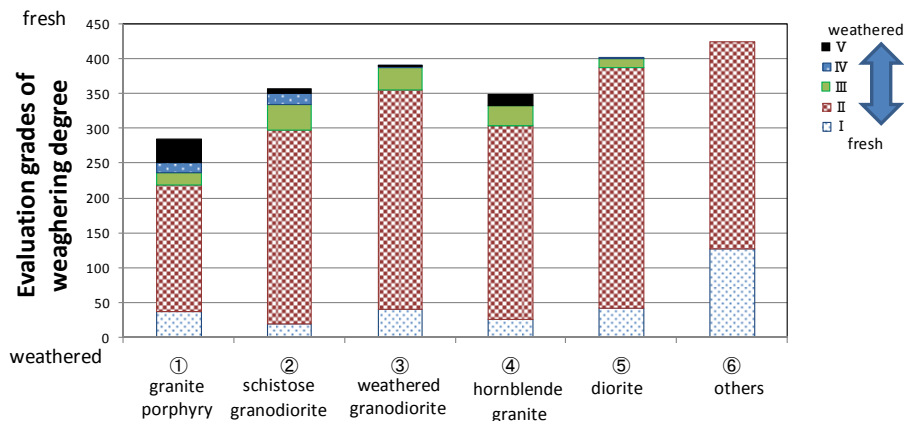
Figure 6. Weathering degree evaluation grades of riprap materials

Survey on the degree of weathering and deterioration: The evaluation grades were calculated by multiplying the classified area by degree of weathering. As a result, the weathering degrees of each rock type were evaluated as shown in Figure 6. From this figure, we confirmed that all types of rock show weathering and deterioration, and the weathering degree of granite porphyry is especially high.

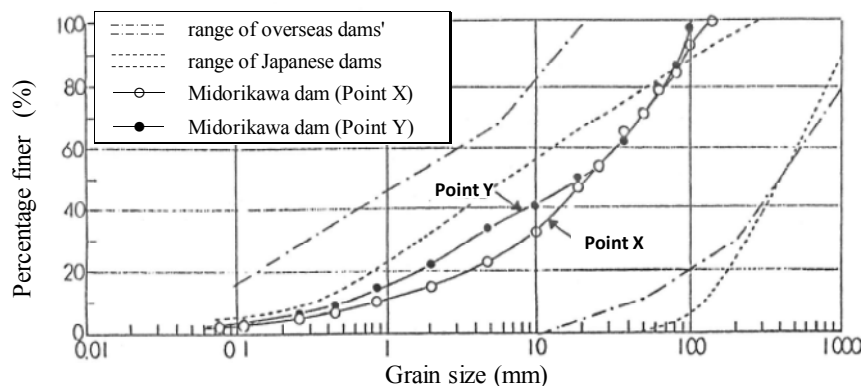
Figure 7. Grain size distributions of rock materials

Grain size analysis and specific gravity and water absorption test: Grain size analysis and specific gravity/water absorption test of these samples were performed. Figure 7 shows the grain size distribution curves, and Table 2 shows the results of specific gravity and water absorption test.

Figure 7 contains the grain size distributions of the rock materials of some overseas and Japanese rockfill dams. The maximum grain size of Midorikawa dam's rock material is 300mm, and the representative distribution curves of Midorikawa dam's rock material fall inside the range of Japanese dams'.

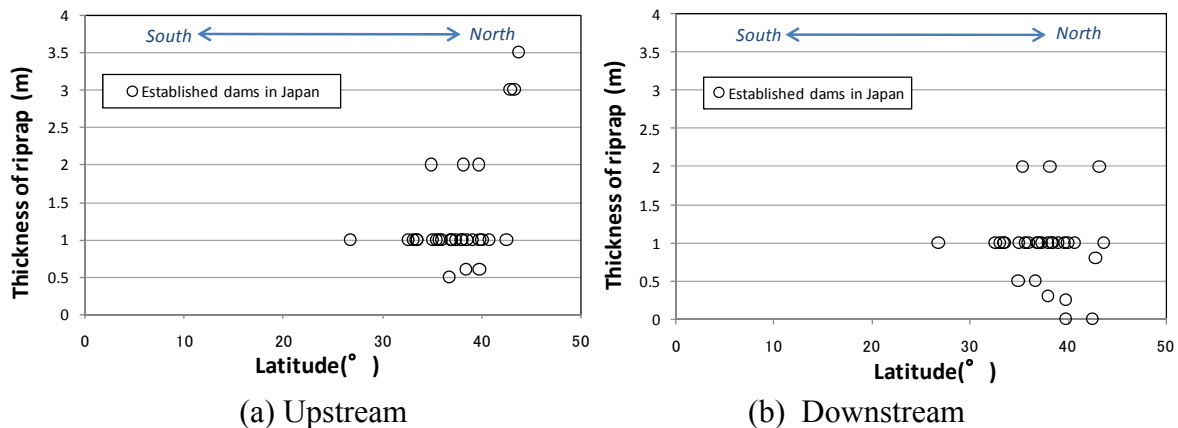
Figure 8. Distribution of thickness of riprap in Japan

We investigated and arranged relations between latitude of rockfill dams in Japan and their riprap thickness, as shown in Figure 8. This figure indicates that thicknesses of upstream riprap were designed as 1m or more in almost dams constructed in the region south of 40 degrees north latitude. The designed value of 1m in the region is considered to be appropriate, considering the survey results at Midorikawa dam and other dams. It can be considered that the riprap with 1m thickness has a significant effect to the dam in Hokkaido region located north of 40 degrees north latitude in preventing deterioration, but trench surveys is necessary to discuss the appropriate value of riprap thickness in Hokkaido region

On the other hand, in more than half of the cases, the thickness of downstream riprap is designed as 1m or more, but in some cases, the thicknesses of downstream riprap were designed as less than 1m. In such cases, the downstream surface is assumed as not affected by waves and change of the reservoir water level, so the design thickness of downstream riprap is set as less than the upstream riprap thickness. However, the survey results of Midorikawa Dam show that the influence of insolation is as great as other weathering factors. Thus, there might be some cases in which weathering and deterioration of downstream riprap has been proceeding faster than in upstream riprap as seen at Midorikawa Dam. Therefore, if thickness of riprap is less than 1m, it is necessary

to pay attention to its weathering and deterioration over time in considering the environmental conditions around such dams.

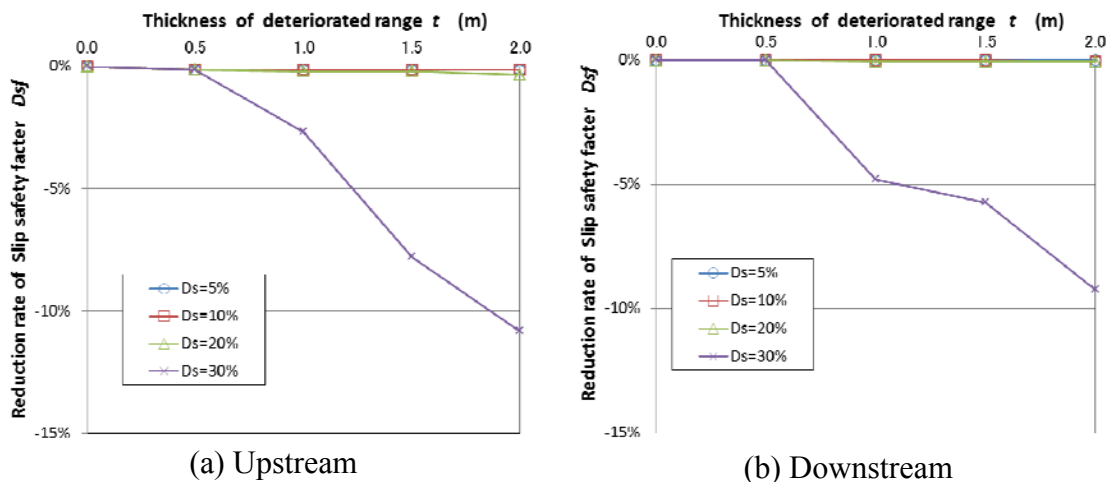
Figure 12. Analysis results

Figure 12 graphically plots the relationships involving the thickness of deterioration range (t), strength reduction rate for the deterioration range (D_s), and reduction rate of slip safety factor (D_{sf}). According to these graphs, when strength reduction rate (D_s) is 20% or less, almost no reduction in slip safety factor occurs, but when the thickness of deterioration range (t) increases under the condition, 30% as the strength reduction ratio, the slip safety factor decreases. The maximum reduction rate of the slip safety factor is 12% under these analysis conditions. We investigated minutely the slip circular arcs whose safety factor is the lowest in every case. Then, in the cases the safety factors of which are decreased, the depths of the arcs of the minimum safety factor are equal to the deterioration ranges. In other words, the slip safety factor decreases easily in the case of a shallow slip circle which passes only through the deterioration range.

On the other hand, the thickness of deterioration range of existing rockfill dams is less than 1m according to the results of the riprap deterioration survey discussed in this paper and other reports of Japanese rockfill dam deterioration surveys. Moreover, strength of the rock material almost equal to that of the filter materials would have been obtained if 10% strength reduction for the rock materials has been considered. These corroborate our view that there is a small possibility that strength reduction by over 30% will occur due to deterioration over time.

It is, therefore, thus concluded that no major reduction in slip safety factor for shallow arcs will occur within the practically conceivable scopes of deterioration range in Japan and strength reduction rate.
