A Practical Consideration on the Damage to Old and Small Irrigation Dams by the 2011 Tohoku Earthquake

K.Ueda & M.Matsuura

*NTC Consultants Co., Ltd., JAPAN (NTC)
uedaka@ae.auone-net.jp*

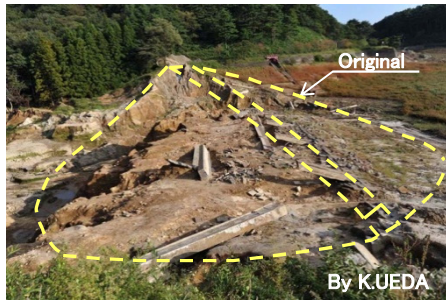
a) Fujinuma-ko

Figure 1. Collapses

would not be taken into consideration, may trigger next massive slides and displacements and finally may cause overtopping as seen in Fujinuma-ko. The soil strength (shear strength) which are directly related to the compaction of soils on top one half and the upstream face of the embankments may be considered to be most essential issues for seismic safety examination. The high frequency up to 80% on the upstream face may be caused by the settlements of the foundations, the failures of the top one half of the embankments and the appurtenances structures. The reduction of soil strength may also be considered under the saturated condition.

Prof. Dr. T.Tanaka and et al. examined the mode of failure of Fujinuma-ko in detail, stating that “Because the shear force which acts during an earthquake is short term response and the embankment is in undrained condition, in order to evaluate the state of damage, it is important to perform analysis by the Modified Newmark method considering the condition that cyclic shear loading is received in saturated undrained condition.” (T.Tanaka,ICOLD,2012) The consideration stated may be reasonable option which should be adopted. Various kinds of methods for safety examination should be applied for the appropriate evaluations case by case. The correlation between the acceleration and the pore pressure in the properly compacted clay was recorded when the earthquake occurred in Gozenyama-dam which have recently completed in Ibaraki-Pref. The significant change of pore pressure which could reduce the bearing capacity of the soil was not found. (M.Iseki,JSIDRE,2012)

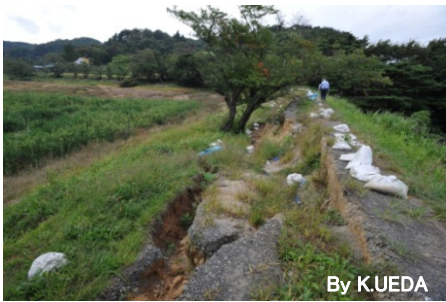
a) Jyanohananka-ike

Figure 2. Slides

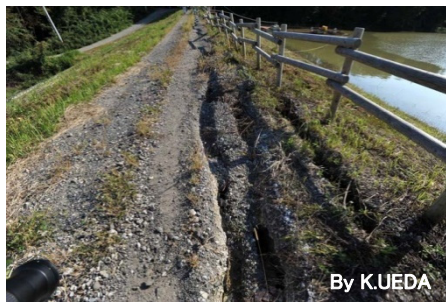
a) Sasahira-ike

Figure 3. Cracks and displacements

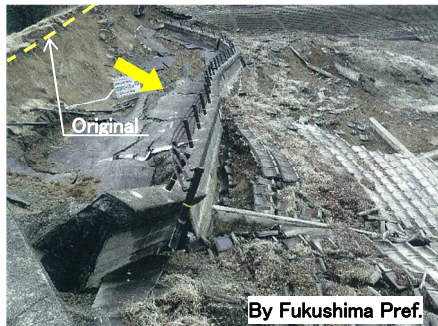
a) Fujinuma Auxiliary dam

Figure 4. Failures of parapets and retaining walls

The parapets, retaining walls, trees and appurtenances of which eigenfrequency are different from that of the massive soils are considered to behave separately and easily to be damaged. The inlet-conduits in the embankment cause serious piping alongside the structures. These structures should be removed.

The parapets and retaining walls on the crests are easily failed due to the difference of seismic behavior. These structures are recommended to be removed.

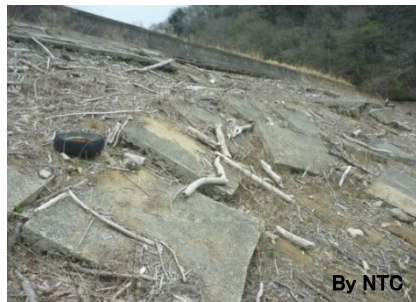
a) Kozuka-dam

Figure 5. Failures of erosion protections and Fall of trees

The erosion protections must be the flexible structure. The protective works for TSUNAMI overflow will not be justified because the occurrence period may be once in thousand years or more.

The erosion protections should be flexible structure.

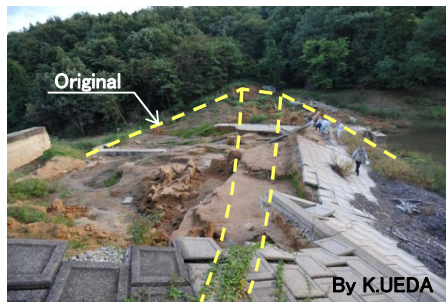
a) Naka-ike

Figure 6. Piping

The cement milk injected in embankments in order to install impervious membranes, cause seep and openings and finally piping after earthquake. Other methods to control the seepage should be considered.

The conduits and cement grout in the embankments have provided water passes by creating seep and opening alongside the structures. The alternation of structures to prevent the pipings should be considered.

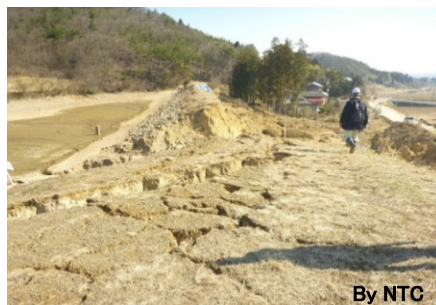
a) Aotashinn-ike

Figure 7. Settlements and Erosion by Tsunami

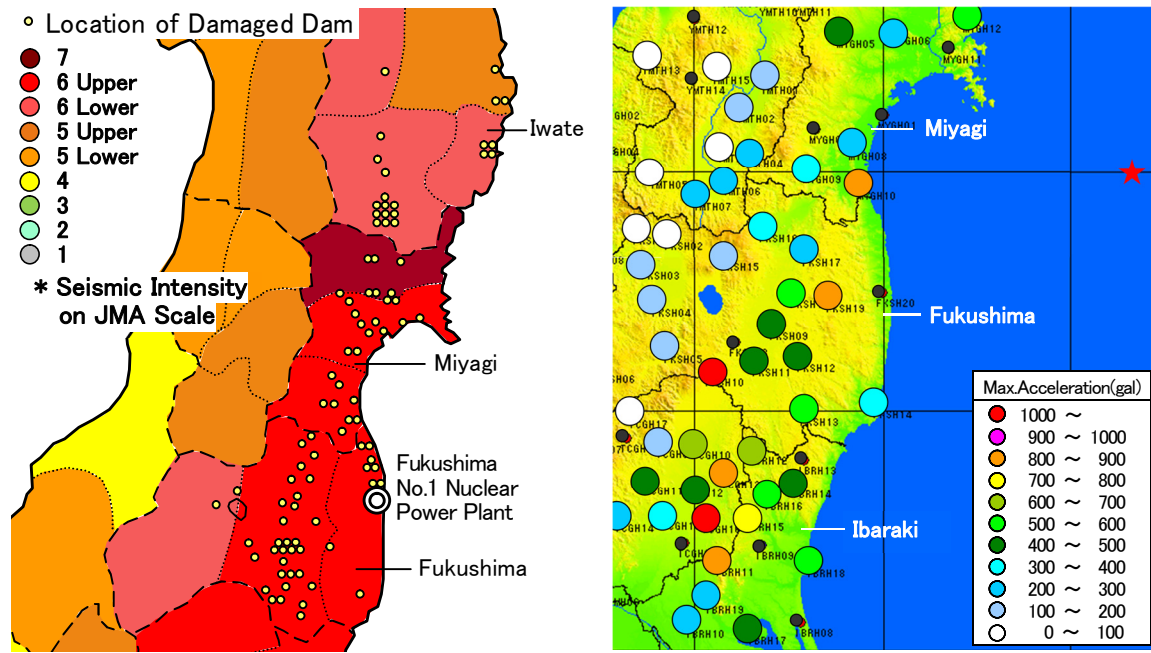
Figure 8. Locations of damaged dams, Seismic Intensity and Max. Acceleration

The locations of the local governments in which 500 severely damaged TAMEIKE are concentrated, the seismic intensities(JMA) and the Max. accelerations observed are shown in Fig.8

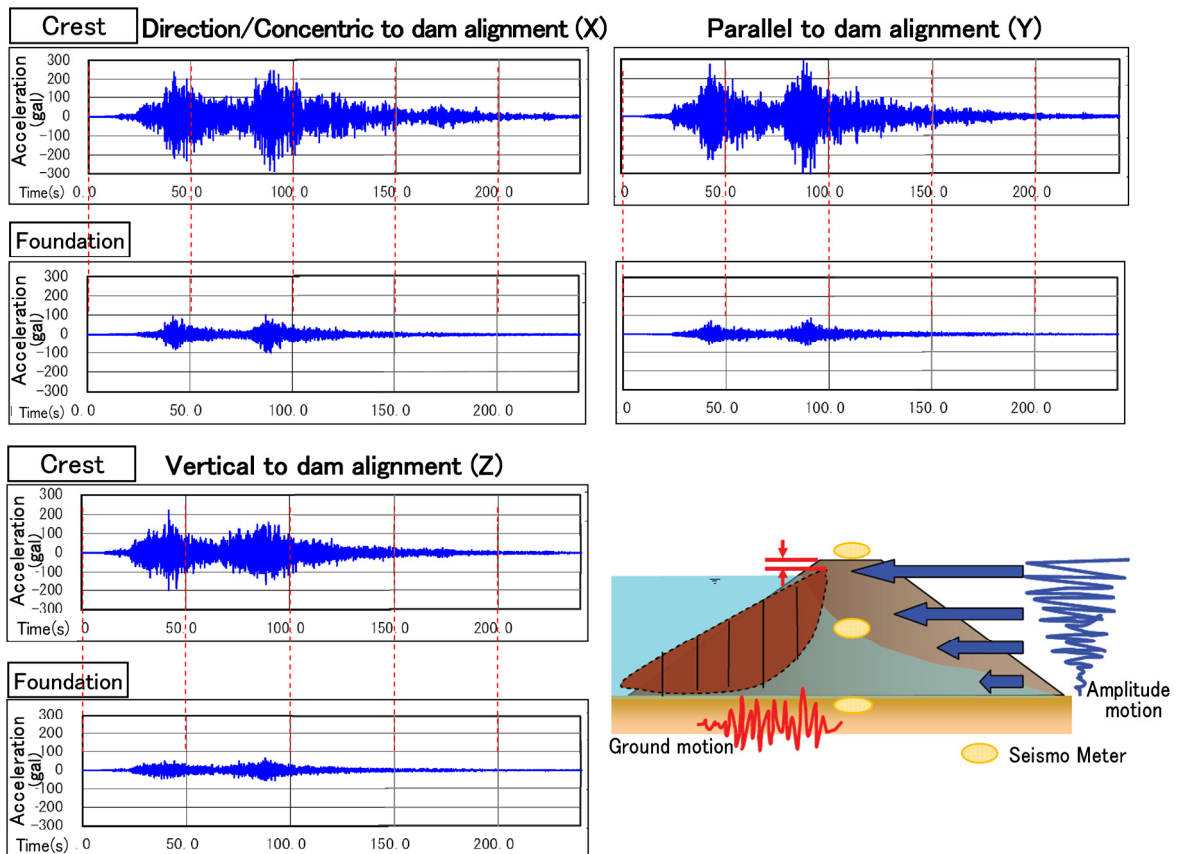
Figure 9. Accelerations observed at the crest and foundation of the embankment

The observed accelerations at the crest and the foundation of a certain large irrigation dam is shown in Fig.9.(T.Miyamori and et al.,2013) The some acceleration which were recorded in large dams, (Surikamigawa, Miharu, Yamanoiri and Gozennyama-Dams) also indicate amplitude motion in the embankment. The ratio of amplifications at the crest to the foundation varies from about 2.3 to 4.8. (JSDE, 2011) Although, these data should be used for dynamic analyses, it is important to keep in mind this characteristic for the safety examination of TAMEIKE.

This amplitude motion and the saturated condition in the upstream face may be the main reason that the defects are concentrated on the crest or on the top one half and the upstream face of embankments. Even small the cracks, slides and displacements which usually
