# SUGGESTIONS FOR DAM CRISIS MANAGEMENT LEARNED THROUGH THE 2011 OFF THE PACIFIC COAST OF TOHOKU EARTHQUAKE

H Okumura<sup>1</sup>, T Matsumoto<sup>1</sup>, and K Koyama<sup>1</sup>

1. Electric Power Development Co., Ltd., Tokyo, Japan

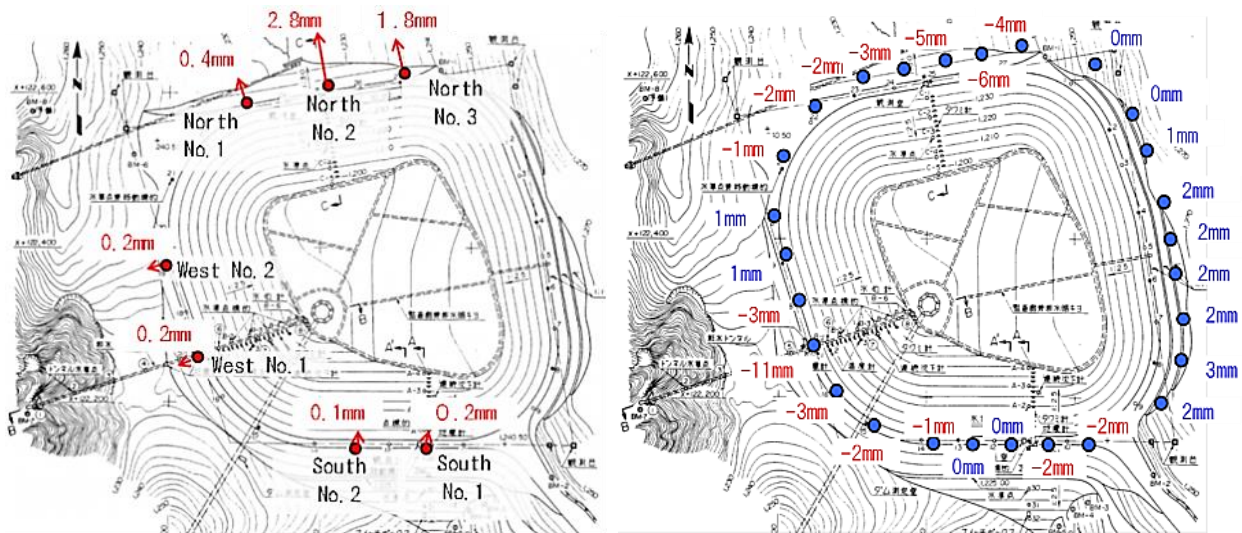
Figure 5. Displacement (Left : in Horizontal Direction, Right : in Vertical Direction)

Maximum accelerations measured during The 2011 Tohoku Earthquake are summarized in Table 2. Maximum  $3.82 \text{ m/s}^2$  on the crown and  $2.10 \text{ m/s}^2$  in the foundation were recorded respectively, either of which were in perpendicular direction to the dam axis. They were the largest record in ever experienced ones at the dam. As for displacement, maximum 3mm in horizontal direction and maximum 11mm in vertical direction were detected as shown in Figure 5.

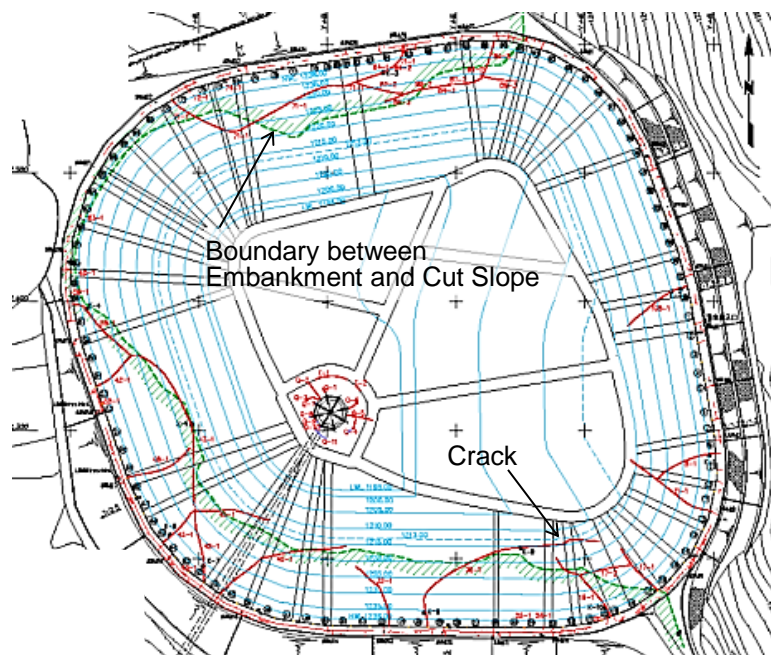
Figure 6. Cracks on the Asphaltic Facing

Furthermore, in the field investigation conducted afterwards, many cracks on the facing surface were found as shown in Figure 6. They were concentrated near the boundary between embankment and cut slope. Widths of the cracks were within 1mm in the daytime, nevertheless, it expanded to 3mm depending on the ambient temperature, and total length of the crack reached to 1,547m. Causes of the cracks were assumed as follows; in general, mechanistic characters of the asphalt material depend on its temperature, and in low temperature circumstance, it tends to lose its resilience. When the earthquake occurred, ambient temperature was recorded around minus 10 degrees Celsius which was low enough for the asphalt material to lose its resilience. Furthermore, there seemed to be considerable difference of displacement caused between on the cut-slope and on the embankment. These are assumed as reasons why cracks were intensively induced near the boundary.

Typical section of the repair works is shown in Figure 9. In this design, impermeability of the facing is satisfied by three elements, which are the asphalt overlay, the (water-proof?) sheet impregnating with asphalt and the asphaltic rubber plugging.

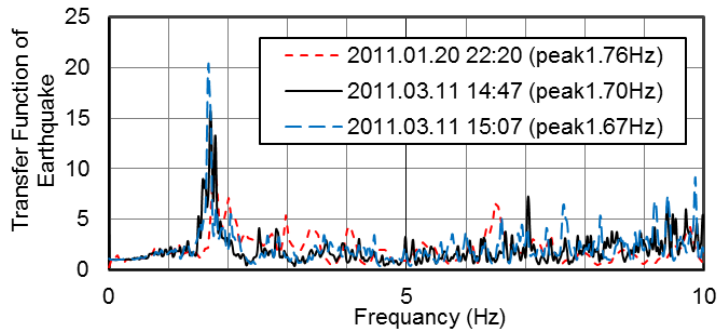
Figure 7. Transfer Function of Earthquake

Safety of the dam body itself was also evaluated just after The 2011 Tohoku Earthquake from the displacement data and seismic response characteristics. Displacements were not so large considering records of the past. Seismic response characteristics were not changed during the earthquakes including aftershocks shown in Figure 7. In the field investigation conducted afterwards, any damages, such as slope sliding, were not founded on the dam body and limb ground. Consequently, it was judged that the dam body was still kept in safe condition and damage occurred only on the asphalt facing.

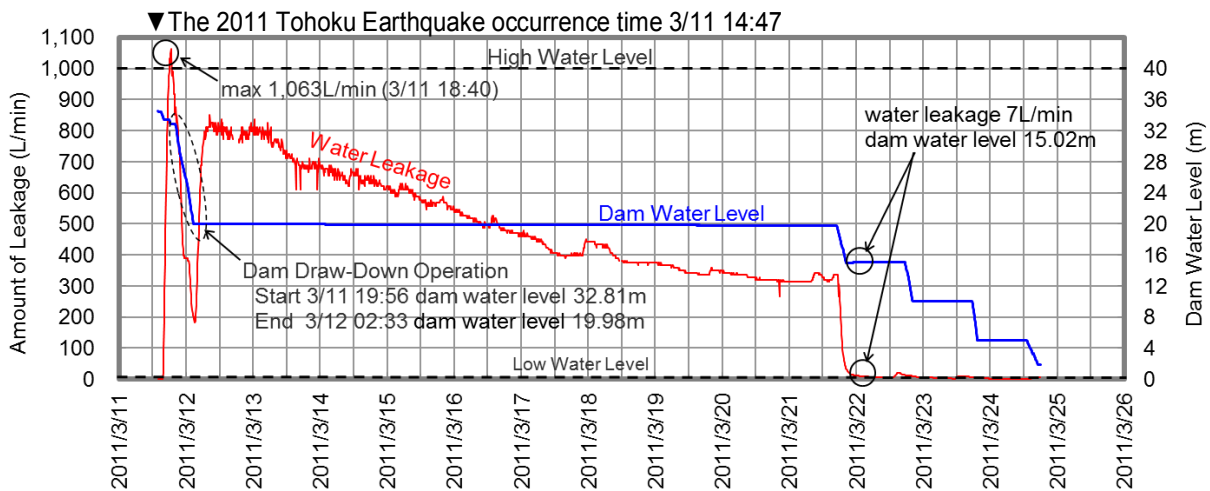
Figure 8. Water Leakage and Dam Water level after the Earthquake

More than 1,000 l/min of water leakage through the cracks was detected in spite that almost zero leakage had continuously been observed until the earthquake occurred. To avoid a possible serious failure, the water level was drawn down to the safe one. Detail is described in the following section 2.3.

As a countermeasure against the water leakage, the draw-down operation was executed immediately by remote control to the safety level to avoid a possible serious failure as shown in Figure 8. With first draw-down operation after the earthquake occurrence (14:47), amount of leakage water could be reduced successfully. Fortunately, the telephone lines were available even just after the earthquake; therefore, we could had discussions between the site office, and the main office including the branch office and external organizations. Although the site office had the authority of decision making for the dam operation, cautious technical considerations were required for it because there were not enough information showing factual state. In this sense, technical discussions by available telephone lines taken between responsible personnel at the site and experts in the head office were very helpful.
