# INSPECTION OF SUBMERGED AREA WITH THE USE OF AN UNDERWATER CAMERA SURVEY VEHICLE

1. Numata Dams Integrated Operation and Maintenance Office, Japan Water Agency, Gunma- , Japan

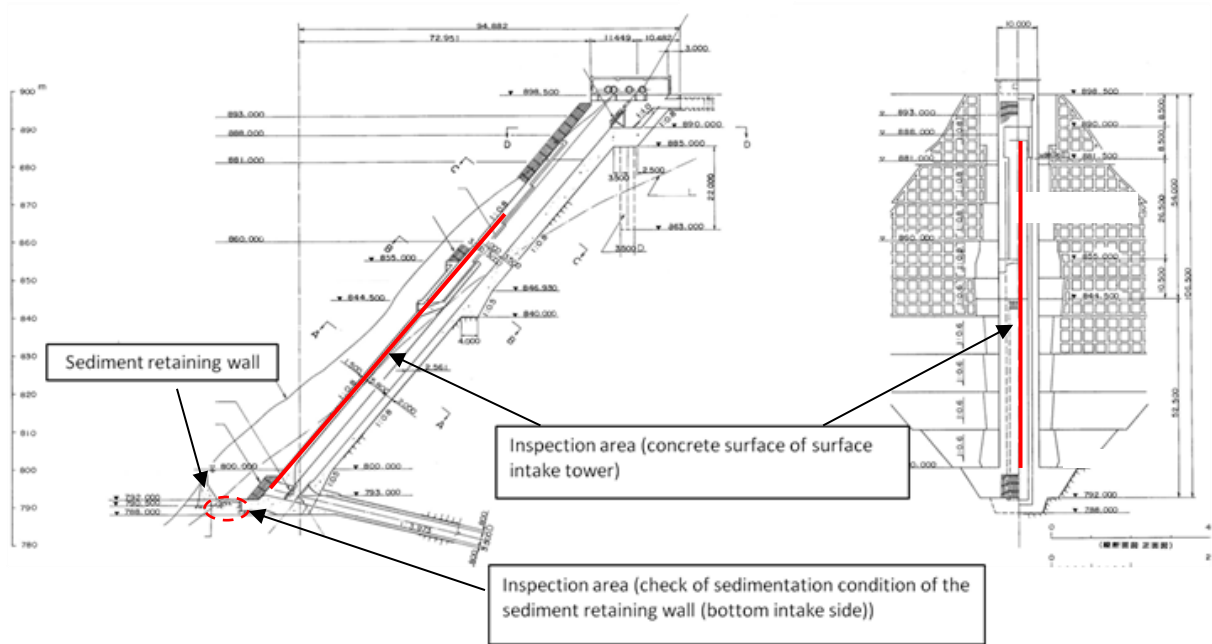
**Figure 11. Inspection Point at the Naramata Dam (3): (h) Inspection area for the concrete surface of the intake tower of the surface intake facility, and (i) the sedimentation at the sediment retaining wall**

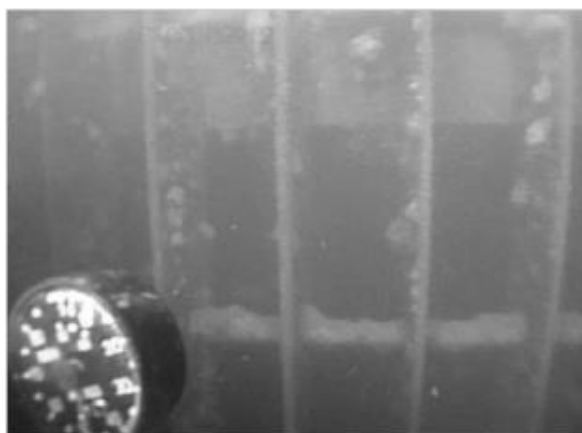
Ordinary steel was used at (a) the guard gate sills of the outlet duct of the outlet works, (b) the water filling pipe screen, and (c) the inlet. Although tubercles were partly seen on the surface, no deformation or damage that would disturb gate operation was observed.

**Figure 12. Screen for the stand-by gate of the outlet works of the Yagisawa Dam**

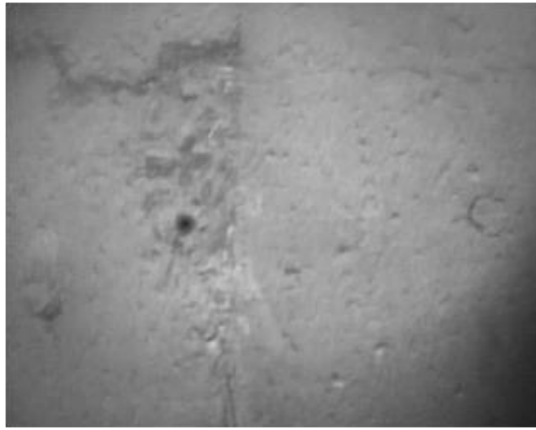
**Figure 13. Condition of the upstream site of the arch dam body of the Yagisawa Dam(819m in elevation ; boundary between 11BL and 12BL)**

The inspection of (d) the concrete of the upstream side of the dam body found cracks estimated to be minute and closed, minor flakes and rock pockets, slight peeling and leaching of surface cement paste, and exposure of rebars (not structural rebars) in the arch dam, as well as minor rock pockets and light peeling and leaching of surface cement paste in the wing dam. It is presumed that these deteriorations do not affect stability of the dam body at this moment and undergo very slow deterioration.

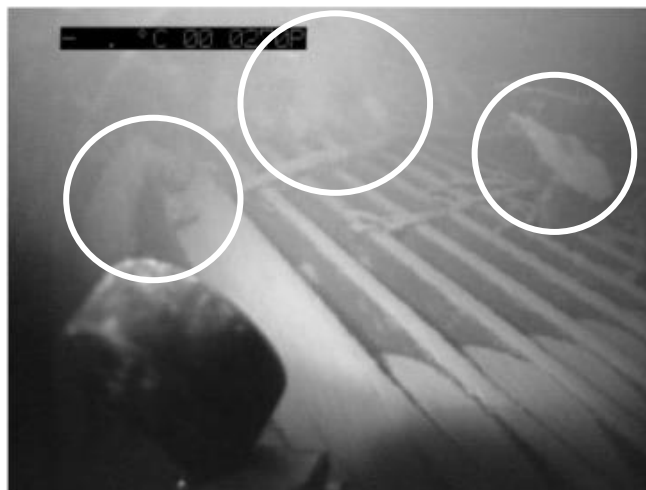
For (e) the sills of the surface intake gate, bottom intake gate, and sluice gate of the Naramata Dam, and (f) surface intake, intermediate section, and bottom intake screens, although sinkers were found above the bottom screen, both the sills and screens were made of stainless steel and thus suffered no corrosion. No deformation or damage that would affect their intake function was found either. For (h) the concrete surface of the intake tower of the surface intake facility, no damage was found. For (i) the bottom intake side of the sediment retaining wall, sediments were deposited on the bottom plates of the retaining wall. However, since the majority of the retaining wall itself (from near the bottom plate to the top) could be checked, it was confirmed that the bottom intake was not buried by the sediments.

**Figure 14. Sinkers above the bottom intake gate**

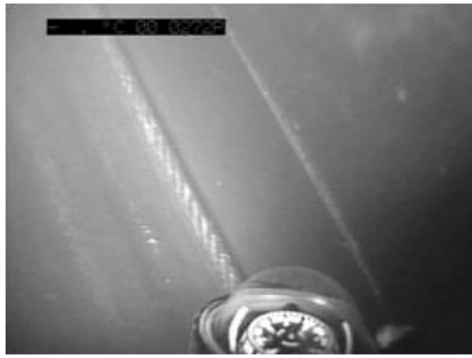
**Figure 15. Sill of the bottom intake gate of the Naramata Dam**

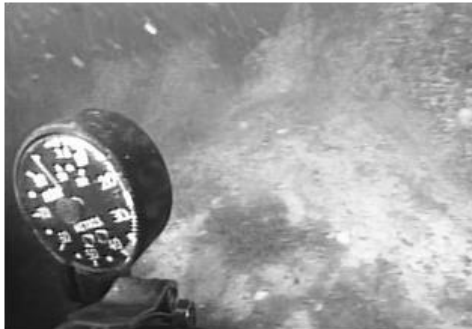
**Figure 16. Sedimentation at the bottom intake side of the sediment retaining wall**
