Efficient repairing and reinforcement method for AFRD damaged by the earthquake

We developed the effective repairing method for asphalt facing of the Yashio dam, asphalt facing rock fill dam (AFRD) constructed for the upper reservoir of the Shiobara pumped storage power plant of Tokyo Electric Power Company Holdings, where cracks occurred by the 2011 Tohoku earthquake, to complete repairing works in a short period so as to resume power generation immediately. The developed repairing method was consisted of asphalt mastic using asphaltic material developed for the purpose of improving deformation performance under a low temperature, hereinafter we call it “low elastic asphalt”, and asphalt impregnated non-woven sheet. We completed the repairing works in about only one month, because we limited the removing area by covering the low elastic asphalt mastic of 10 cm width and 5 cm thickness, as a buffer part absorbing the strain, on the cracks leaving in the layer underneath from the forth layer to the bottom layer of the asphalt facing consisted of seven layers. In addition, it was estimated that the cracks occurred by the strain concentration of the crest concrete block joint connect

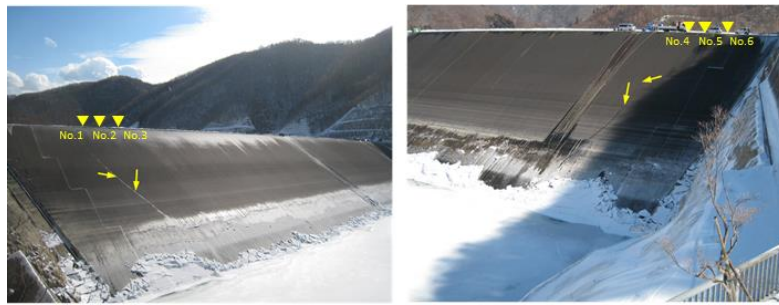
The cracks in the asphalt facing confirmed by inspection are as shown in Figure 3 and Figure 4. There were two cracks of length approximately 70 to 80 m in the left and right bank almost parallel to the both abutments, and a total of six short cracks—of maximum length less than 2 m—were also found. All these corresponded to the position of the joints of the concrete blocks connected to the facing at the crest. From near the crest down to the lowest of the seven layers of the facing, a borehole of diameter 500 mm was drilled into the position of the long crack on each side. From the boring cores obtained, it was confirmed that the cracks near the crest reached the lowest layer (Figure 5). Hence, it became necessary to study repairing methods on the assumption that each crack reached the lowest layer along its entire length.

Figure 3. Asphalt facing of the Yashio dam right after the earthquake

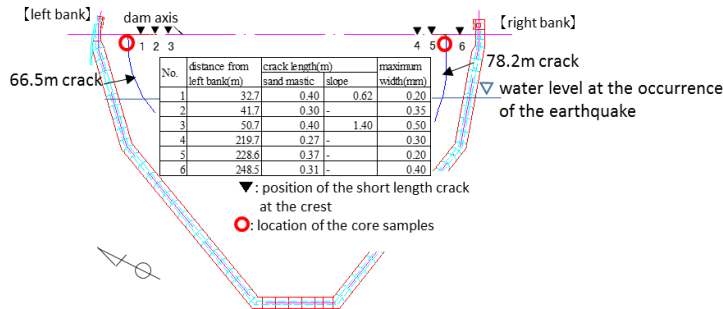
Figure 4. Location of main and minor cracks

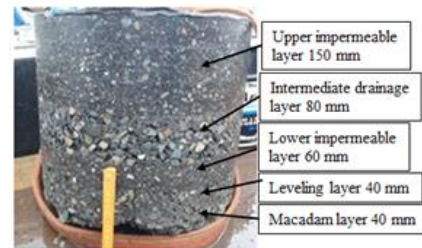
Figure 5. Core sample of the facing

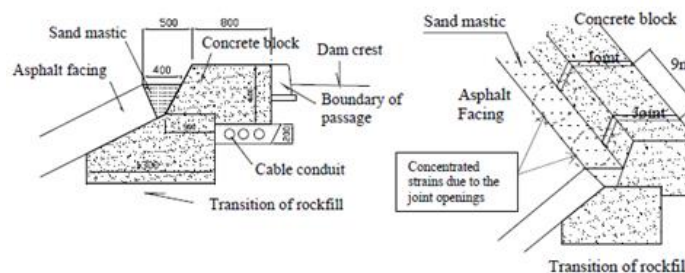
3D FEM dynamic analysis was performed using the equivalent linearization method in order to reproduce the behavior of the Yashio Dam during the earthquake and infer the factors leading to crack occurrence. However, the cause of the cracking could not be determined by this means, since the analysis revealed that the maximum strain occurring in the facing did not match the crack positions, and that the strain was relatively small, being less than one tenth of the fracture strain of the material. Nevertheless, since the cracking corresponded to the position of the joint of the concrete block connected to the crest section, it may be assumed that the concrete block behaved rigidly, causing intensive strain at the joint (as shown in Figure 6); this being the case, then, analytically, where the cracks initially occurred, fracture strain would be exceeded in the facing, and in the sand mastic (with a still higher level of deformation performance) used in the joint. This was therefore inferred to be the cause of cracking (Tsukada, T et al. 2013).

Figure 6. Facing structure at the dam crest
