Study on scouring phenomena at downstream of dam during flood control

Yuichi Kitamura^{1,a}, Shingo Takagi^{2,b}

¹*Chigasaki Research Institute, Electric Power Development Co., Ltd. (J-POWER), Kanagawa, Chigasaki, Japan*

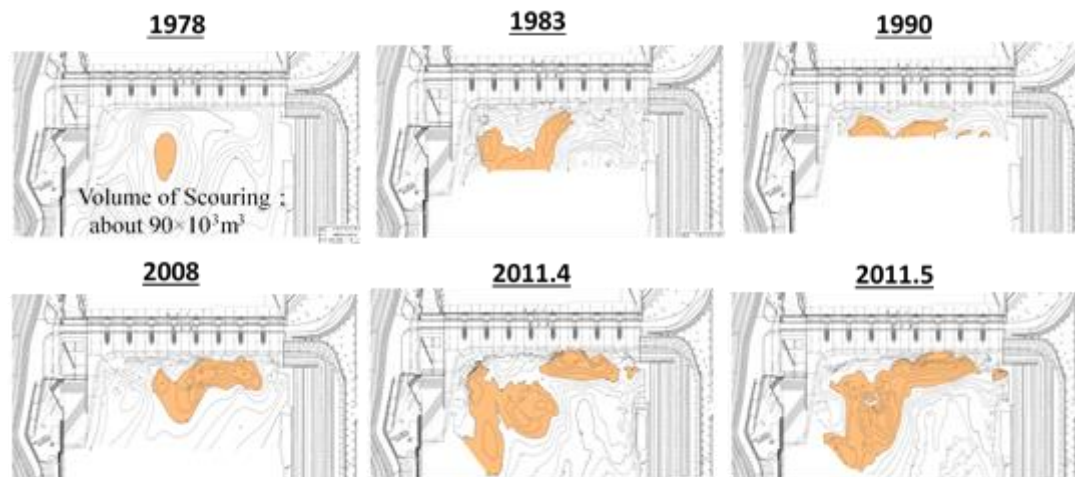
Figure 4. Morphological change in front of Funagira Dam

Between 2010 and 2011, a large flood (6,396 m³/s in September 21, 2011) was discharged continuously and for a long period (153 days). The riverbed was scoured near the conduit foundation bedrock just downstream of Gates 3 and 4. The mitigation work was carried out at the conduit foundation in response to this. In addition, bed protection blocks (12.5-t tetrapods) were placed as

emergency measures on the left bank at just downstream of Gates 1 to 5 in May 2013 (see Figure 5). The downstream area of the dam in 2011 was scoured by a volume of approximately 230,000 m³ with a maximum depth of approximately 13 m for a riverbed height of EL 39.0 m.

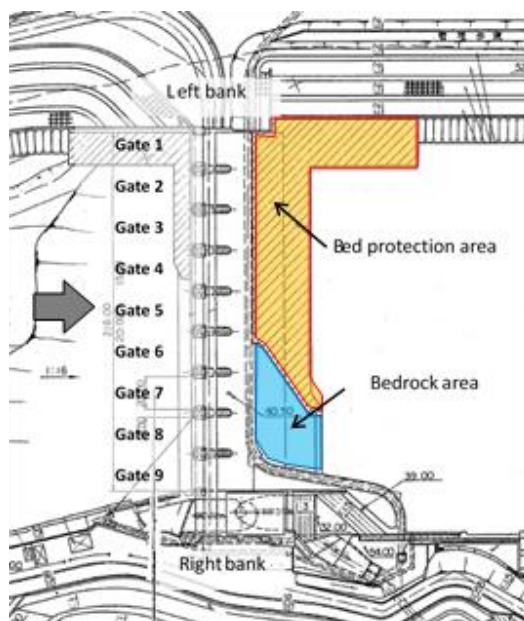
Figure 8. Area of original bed protection measures

As described above, the bed protection blocks were not uniformly placed across the river, but placed along areas of gravel where bedrock was not apparent (Figure 8). The boundary of exposed bedrock and gravel with bed protection blocks had different roughness. It had unstable hydraulic jump which were caused by an uneven riverbed. Therefore, it can be thought that the bed protection blocks placed along the edges of the bedrock area were removed.

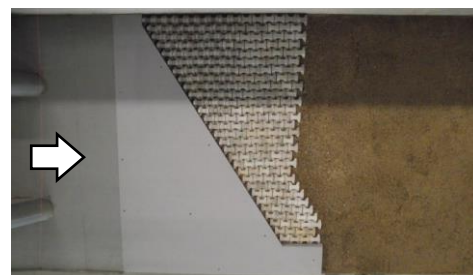
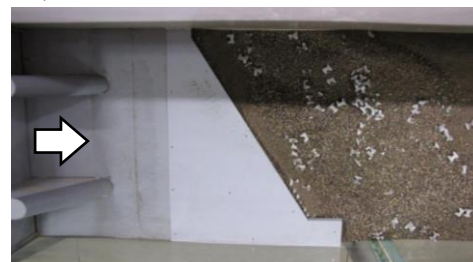
Figure 9. Model test on stability of original bed protection in front of Gate 7

The tests with the vertical 2D hydraulic scale model showed that the bed protection blocks were stable in the case of uniformly placed blocks. On the other hand the blocks were removed in the front of Gate 7 where blocks were decreasing along exposed bedrock. A large morphological change was observed in the model (Figure 9).

The testes showed that some blocks were removed at the edge of bed protection blocks just after the completion of the dam. The gravel around them then began to be scoured. This would reduce the engaging effect of adjacent blocks. The blocks were further removed in a wide area, eventually losing the function of protecting the bedrock with the blocks at the end.

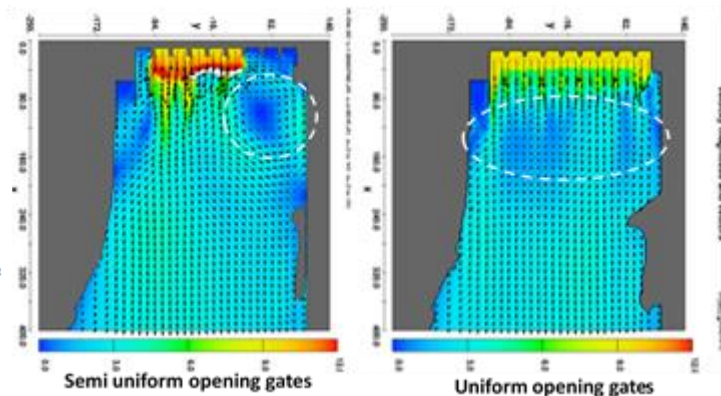
Figure 11. Comparison of flow condition with different opening gates

Downstream of Funagira Dam, in particular, the horizontal swirl flow around the left bank was larger than around the right bank. Figure 11 shows the flow conditions downstream of Funagira Dam computed by a 3D free surface mathematical model. The semi uniform opening gate generates a huge horizontal swirl flow around the left bank of the dam.

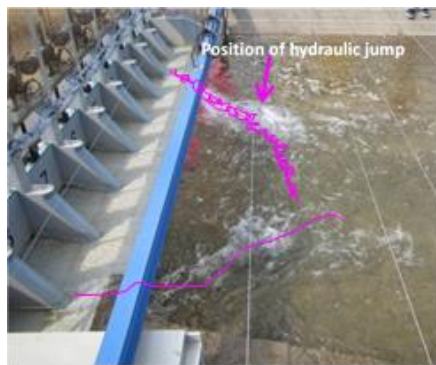
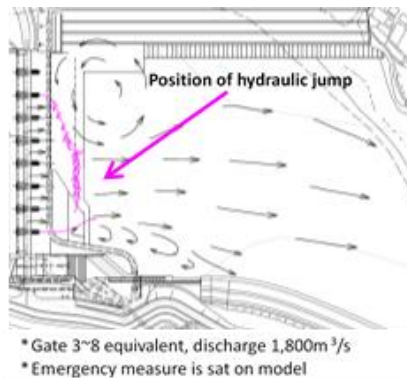
Figure 12. Flow regime of semi uniform opening gate operation

The tests using the 3D model showed that the horizontal swirl flow proceeded upstream towards the left bank, changed direction at the lower edge of the apron. Then it became parallel to the dam axis (Figure 12). It formed a diagonally downward flow after joining the flow of water discharged from the

gates. It finally created a critical flow for the protection blocks and scoured on the riverbed unlike a normal hydraulic jump. The velocity at the downstream with semi uniform opening gate became larger than the fully uniform one. The velocity at downstream of opening gate became especially high velocity and the direction of flow became toward downstream (Figure 13).

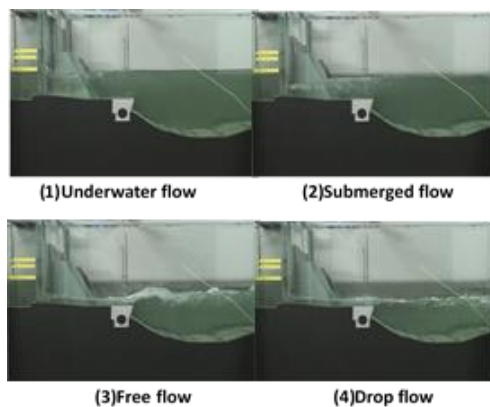
Figure 14. Types of hydraulic jump in front of Gate 7 with different downstream water levels

The vertical 2D hydraulic scale model tests allowed to investigate the relationship between the discharged water from the gates and the downstream water level. Figure 14 shows that different types of hydraulic jump are formed according to the downstream water level. They are (1) an underwater flow, (2) a submerged flow, (3) a free flow, and (4) a drop flow (overflow) for a constant discharge rate. The underwater flow is mostly appearing during the design discharge, and the other flows are appearing until middle class discharge. The drop flow will generate the high velocity near bottom.

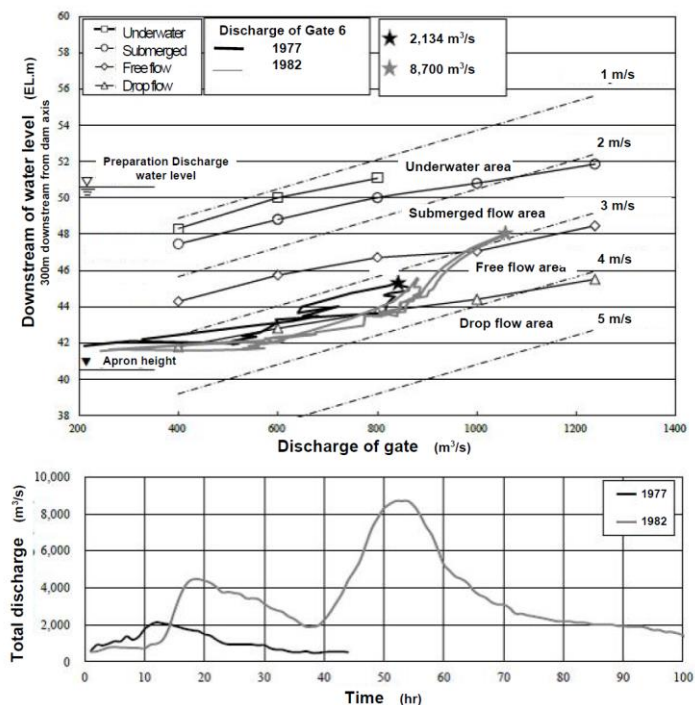
Figure 15. Transition of hydraulic jump in front of Gate 6 with discharge and water level

Figure 15 shows the different types of hydraulic jump as a function of the downstream water level and as a function of the Gate 6 discharge rate. It shows that the lower the downstream water level, the more different types of hydraulic jump are appearing. Also, drop flow appears in the case of the lowest downstream water level.

The flood of 2,134 m³/s in 1978 and the largest flood of 8,700 m³/s in 1982 generated similar types of hydraulic jump until 800 m³/s discharge of Gate 6 in the Figure 15. It means that the downstream water level is low at the beginning of discharge with any class of flood discharge, and that it facilitates scouring of the riverbed at the initial discharge operation. It is the reason that Funagira Dam was seriously scoured during the small flood in 1978.

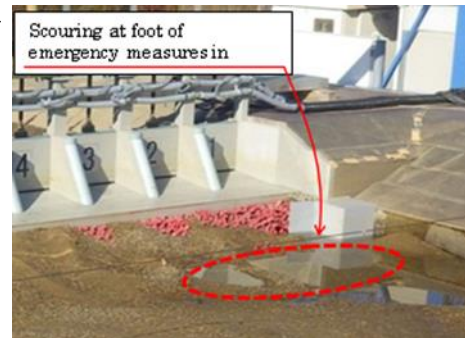
Figure 17. Stability test of emergency measures after design flood with fully equivalent gate operation

built up and kept relatively stable with a discharge in a range from approximately 7,200 m³/s to 8,000 m³/s in the model. However, the discharge exceeded 8,000 m³/s that leads free flow with all the gates full opening. It is shown in the discharge operation of Funagira Dam in Figure 16. This period lead the scouring in front of Gates 1 to 4 and of Gate 9 at the foot of emergency measures. Particularly, the left and right banks were largely scoured (downstream of Gates 1, 2, and 9) (Figure 17), referring to the report of J-POWER (2014).

In the situation with emergency measures, the left and right banks can be scoured when water is discharged, even in a uniform opening gate, at a rate of a minimum of 8,000 m³/s. So we have determined that some permanent mitigation measures (hereinafter referred to as “long-term measures”) must be implemented as quickly as possible to obtain the restoration protection.

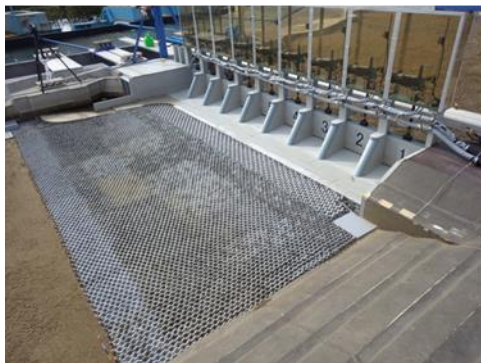
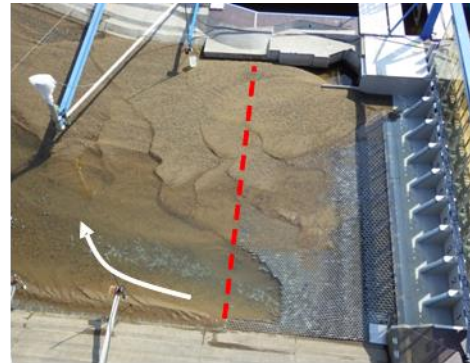
Figure 19. Stability of recovery plan after design flood 11,130m³/s

In the tests with a design flood, the recovery plan had an oscillating hydraulic jump instead of a steady jump. The more sediment was deposited along the right bank in this plan. This plan showed some scouring in front of left side of gates, and removal in the protection blocks and the implemented consolidation blocks placed along the left bank (Figure 19).

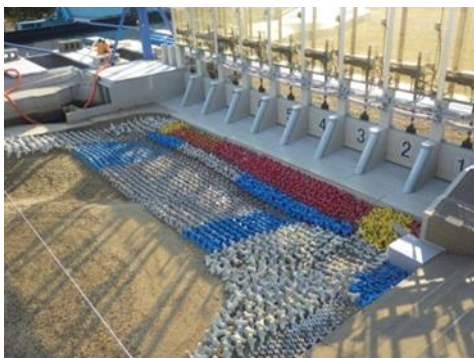
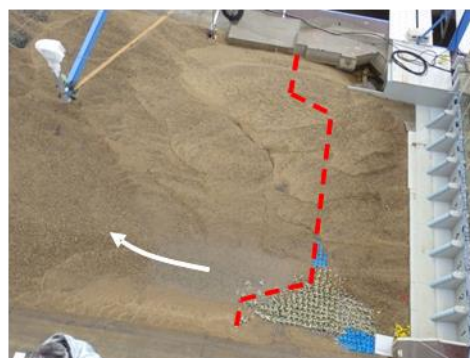
Figure 20. Stability of maintenance plan after design flood 11,130m³/s

By the way the maintenance plan also had a morphological change in downstream of the dam. But this plan had a steady hydraulic jump because the present riverbed led as a stilling basin. This plan showed a superior effect during design flood. (Figure 20).

The maintenance plan has finally been chosen as a long-term measure. This plan planned also the shorter construction period, too. The construction has started in October 2015, and second period has started in September 2016 and it will be finished in May 2018.

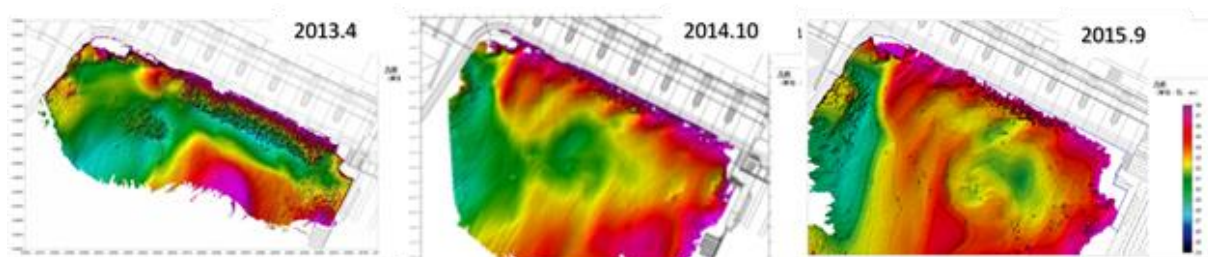
Figure 22. Field observation of morphological changes with multi-beam sonar

The tests were carried for establishing of management standards, and the maintenance plan was modified to be more stable. Figure 21 shows the latest long-term measure design. The field observations of morphological changes is important at the downstream of the dam. Figure 22 shows the morphological change of the riverbed in front of Funagira Dam after starting the uniform opening gate of water discharge on June 2014, referring to the report of J-POWER (2016).
