# Inspection of construction joints in the concrete dam body by the impact elastic wave method

Shigeki Ichikawa<sup>1,a</sup>, Toshiro Kamada<sup>2,b</sup>, Tomonobu Sugiura<sup>3,c</sup>, Naoyoshi Hayashi<sup>4,d</sup>

<sup>1</sup>*Dam Engineering Division, Water Resources Engineering Department, Japan Water Agency, Saitama, Japan*

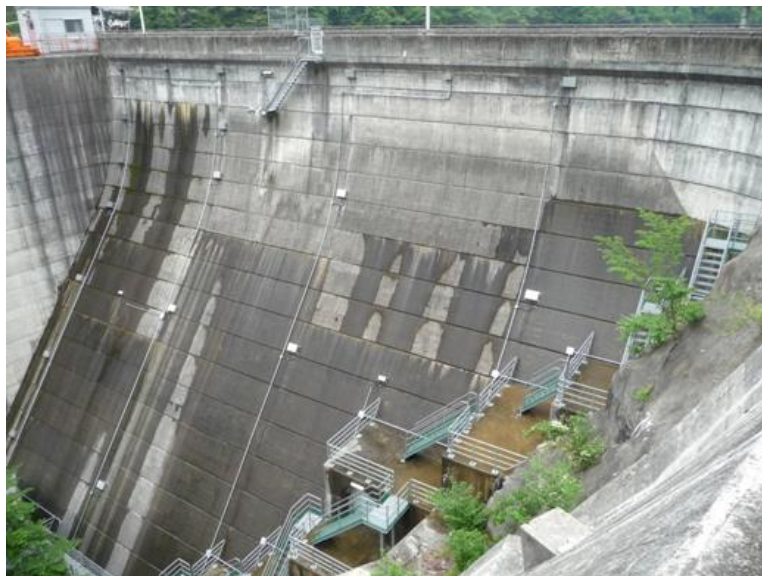
Figure 1. The target dam

The survey target dam is a concrete gravity dam with a height of 42 m and a crest length of 138 m constructed 41 years ago. Figure 1. shows the downstream face with some leakage.

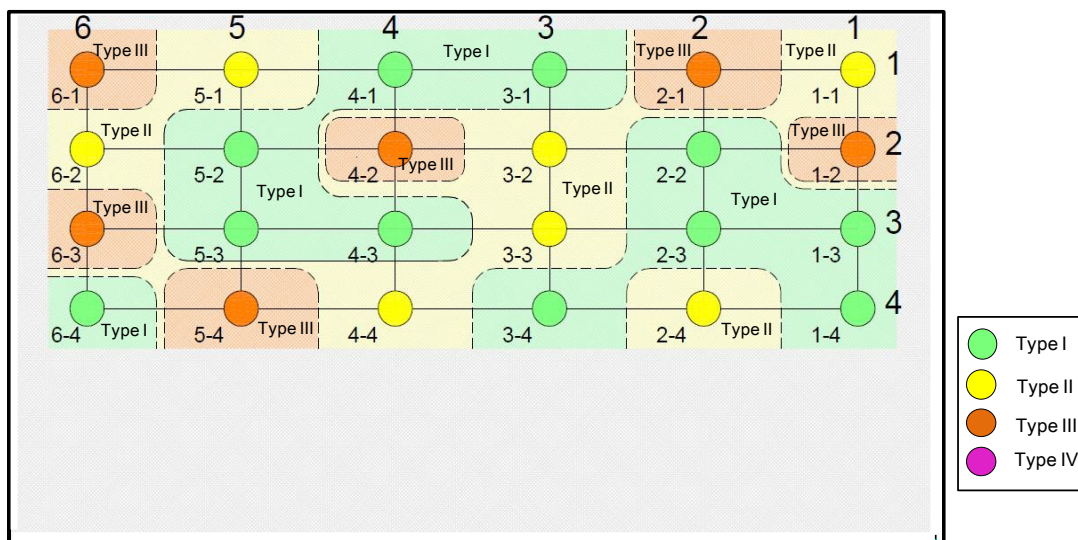
**Figure 6. Sample Estimation of the State of a Horizontal Construction Joint**

- Conducting estimation of the state on all measuring points on the construction joints provides information on the points on the grid pattern. As described earlier, the impact elastic wave system used in this survey measures the state of the area 1 to 2 m around each measuring point. Therefore, as Figure 6. shows, the surface state of the horizontal construction joint was estimated while considering the state of the neighboring points on the grid. The pitch of the grid was 2 m along the axis of the dam and 1 m in the upstream – downstream direction, which were nearly consistent with the detection range of the measurement system. Thus, the measurement covered the entire grid. A grid pitch set to 2 m or more, for example, would have left unexplored areas, which would have lowered the accuracy of the estimation.

By calculating the areal rate from the distribution of each type on the horizontal construction joint using the method described in the previous section, it is possible to quantitatively indicate the state of each construction joint. Table 3. shows the areal rate of each state type, which was obtained by calculating the area of each type indicated in Figure 6. using the area calculation function of the computer-aided design (CAD) software.

| State Type | Type I | Type II | Type III | Type IV |
|---|---|---|---|---|
| Rate | 44.1% | 35.2% | 20.6% | 0.0% |
