Applying CFD analysis to scouring river bed caused by discharge flow from the dam and estimating effectiveness of some countermeasures

K. Hirao, F. Watanabe, S. Ohmori & T. Tsukada

TEPCO Research Institute, Tokyo Electric Power Company Holdings, Inc., Tokyo, Japan

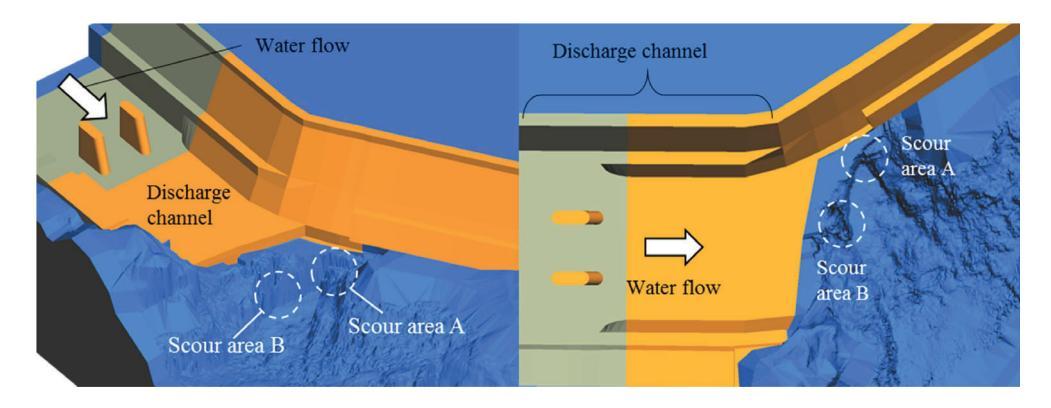
Figure 1 shows two scour areas named A and B. They indicate where we observed at the downstream area, A is the left side, B is downward from the discharge channel.

Figure 1. Observed scour area

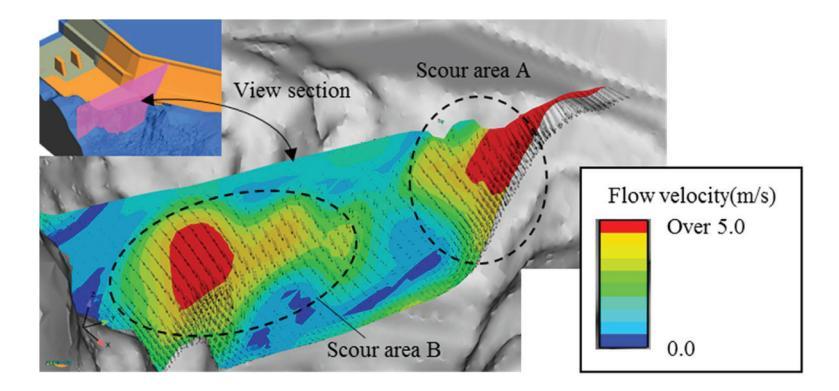
Figure 2 shows the distribution of flow velocity arround the scour area.

Results from CFD show that the scour area A and B is faster than the other area, and the maximum flow velocity is about 9m/s arround the scour area A. In addition, the discharge water flow in the scour area directly.

Figure 2. The distribution of flow velocity arround the scour area

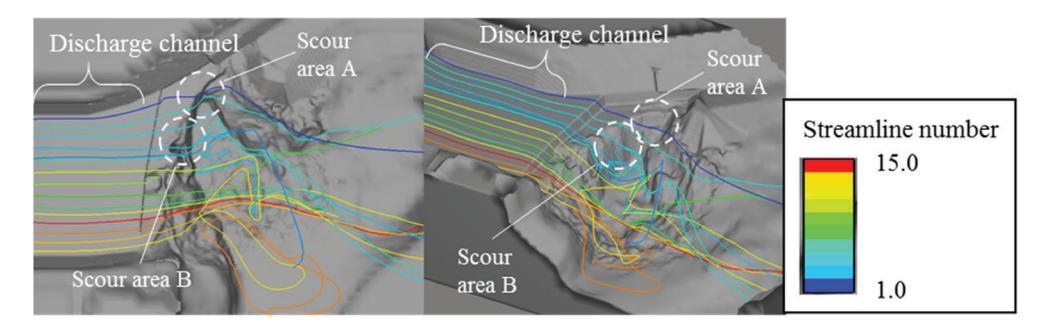
Figure 3 shows the streamline of the discharge flow.

As a result of CFD analysis, it shows that a part of the discharge water flow rotationaly toward the scour area.

According to the above results, we clarify that rotational or three-dimensional (3-D) water flow induced by complicated riverbed shape and the discharge water flowed directly in the scour area could be the cause of the scour.

Figure 3. Analysis result described by streamline

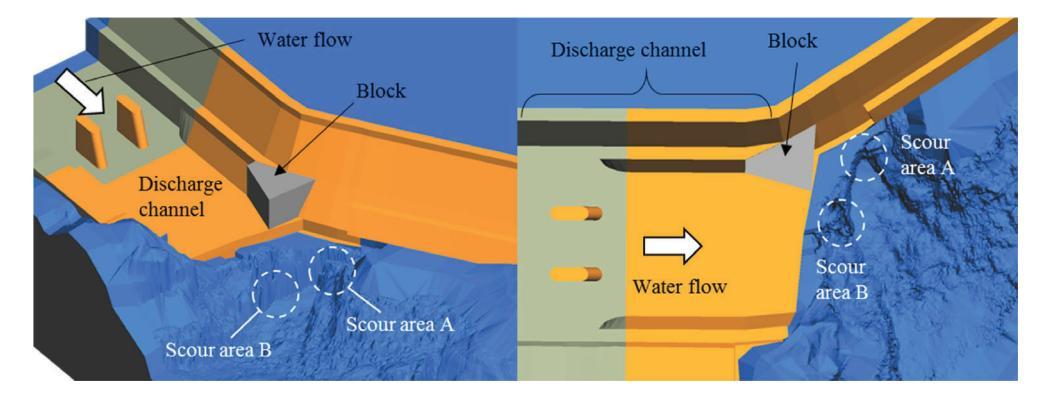
Figure 4. One countermeasure plan

At first, for the purpose of reducing this flow, we examine some countermeasures to change the flow direction at the discharge channel edge.

Specially, Figure 4 shows a case setting up the block.

Last year, we installed a simple block in the discharge channel of our plant, and then we are confirming the effect now. In addition, the flow condition is improved like results of CFD analysis.

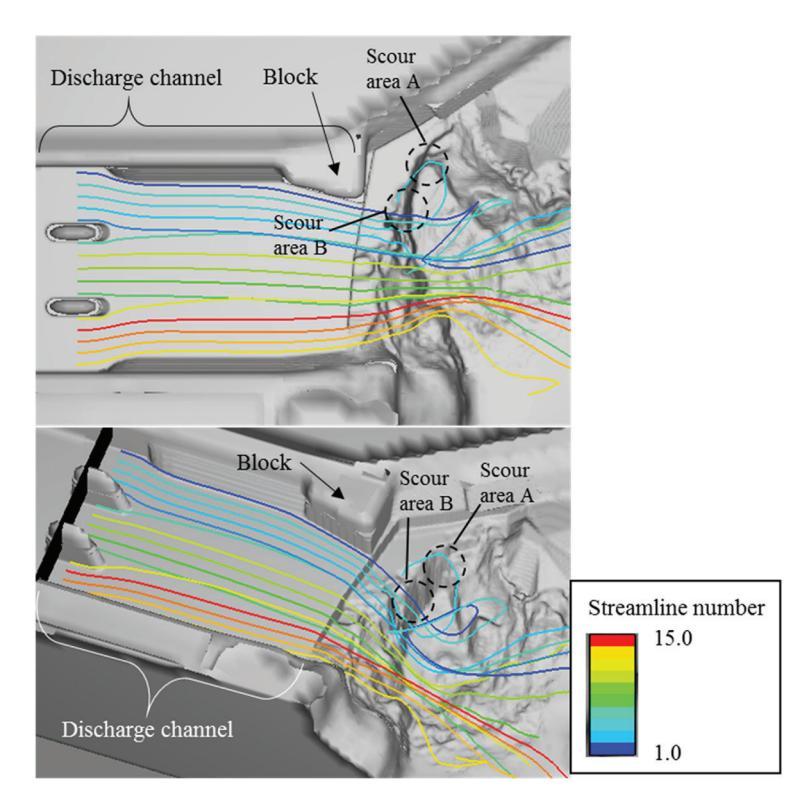
Figure 5 shows the streamline of the discharge flow on the countermeasure plan (Figure 4).

As a result of analysis, it shows that the almost discharge water don't flow directly toward the scour area, and the main stream can shift to the right side at the discharge channel edge.

On the other hand, it also shows some discharge flow separated from the main stream, and make 'secondary flow' toward the scour area.

Figure 5. Analysis result described by streamline on the countermeasure plan (Figure 4)

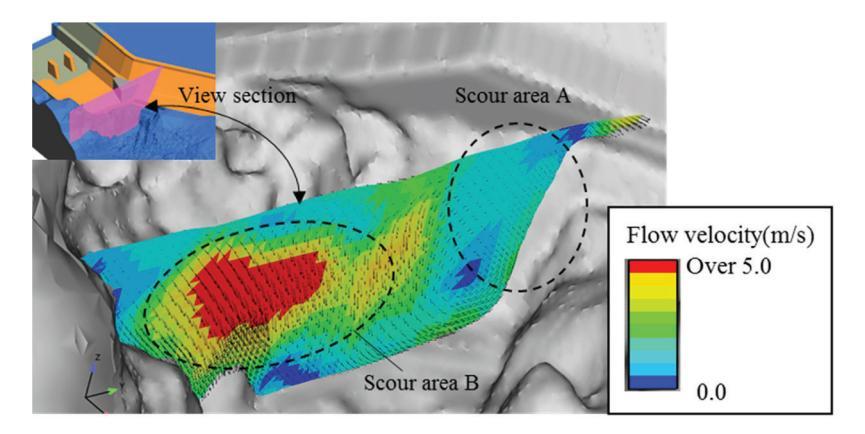
Next, Figure 6 shows the distribution of flow velocity arround the scour area in the countermeasure plan (Figure 4).

The above-mentioned secondary flow pass through the scour area B, and upflow along the wall near the scour area. Then, this flow velocity is about 2m/s near the scour area A and slower than the case of no block (4–9m/s). For these results, these countermeasures could

reduce water to flow into the scour area, so we evaluate it could be effective countermeasures against the scour area A.

Figure 6. The distribution of flow velocity arround the scour area in the countermeasure plan (Figure 4)
