River Environment Improvement Method by Sediment Transport Experiment in the Downstream Reach of a Dam

Hiroshi Ogawa

*Director, Shimokubo Dam Operation and Maintenance Office,
Japan Water Agency, Japan*

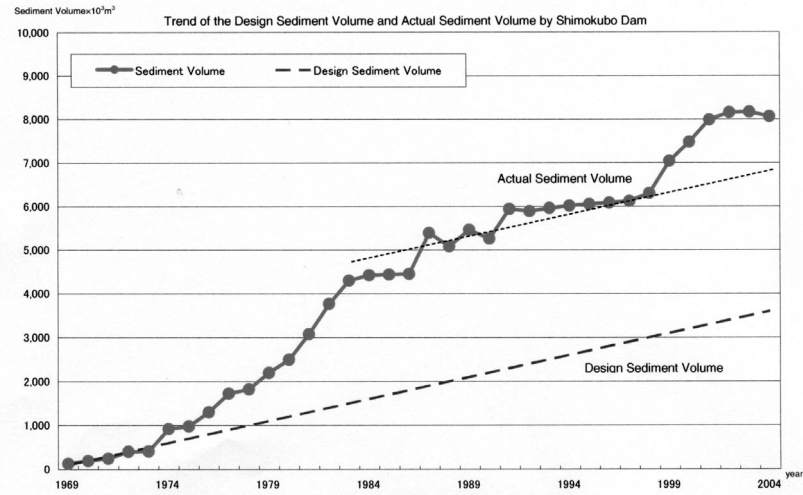
Fig. 2 Change in Sediment Volume

The Shimokubo Dam has been operated 36 years after completing construction. There is a tendency that the amount of sediment in the reservoir extremely increases after a relatively large flood. The amount of sediment accumulated by the end of 2004 was $8,057 \times 10^3 \text{ m}^3$ that was 81% of the reservoir's design sediment capacity $10,000 \times 10^3 \text{ m}^3$. The actual sedimentation is progressing with a speed 2.2 times faster than that of initially predicted. (Fig. 2)

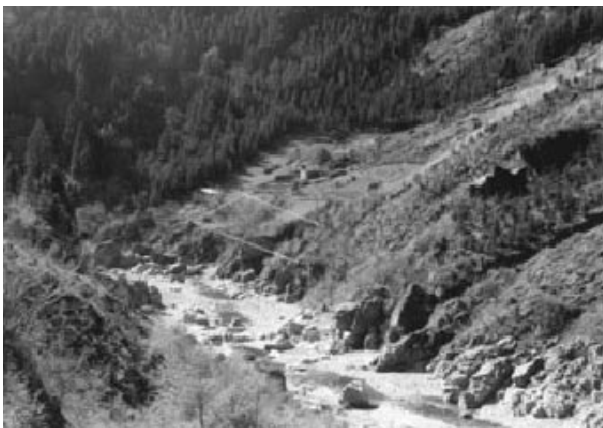
Photo 1 (a) Before Dam Construction (in the 1950s)

There were gravel areas on the riverbed in Sanba Keki Kyo before dam construction as seen in Photo 1 (a). However, after dam construction, the sediment material on the riverbed was washed away by floods and no sediment material has been supplied and, as a result, the riverbed has been degrading and the gravel areas recently disappeared as seen in Photo 1 (b).

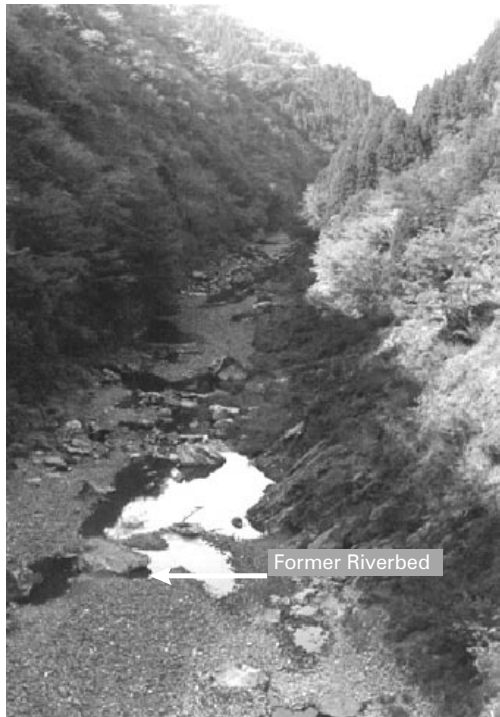
Photo 2 (a) Immediately after Dam Construction (1969)

When comparing Photo 2 (a), showing the river condition immediately before dam construction, with Photo 2 (b) of recent river condition, it can be estimated from the size of the large piece of rock in these photos and site survey result that the riverbed has degraded approximately 2 m. For this reason, a landscape improvement target is set up to restore the diminished gravel areas to the original state and the degraded riverbed up to an approximately 2 m height from the present elevation (called the riverbed restoration target).

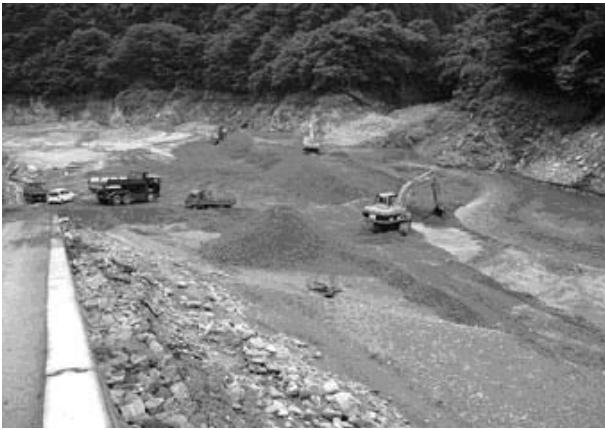
Photo 3 Mining of Sediment Material

The sediment transport experiment has been conducted since 2003. In the experiment, sediment material deposited in the sediment trap dam within the reservoir is taken, transported to and dumped into the downstream of the dam by dump trucks. The dumped sediment material is washed away by discharge from the reservoir. The sediment trap dam is located 8.5 km upstream of the Shimokubo Dam. When the reservoir level rises higher than the limited water level of E.L. 283.8 m during the flood season (July through September), sediment material can be mined. (Photo 3-6, Fig. 3)

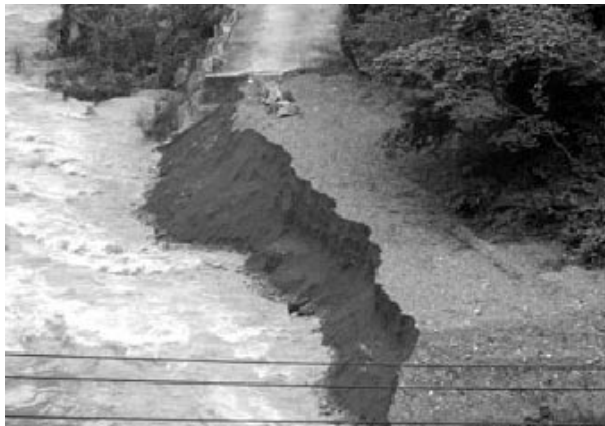
Photo 7 Flow Condition on 11 Oct 2004 ($Q = 40 \text{ m}^3/\text{s}$)

released during a period of October 10 through 15 to handle the flood caused by Typhoon No. 22 in 2004. Approximately 800 m³ of the remaining sediment material was washed away by the reservoir discharge having a maximum figure of about 300 m³/s for a 2-hour period released during a period from October 19 to 26 to handle the flood caused by Typhoon No. 23 in 2004.

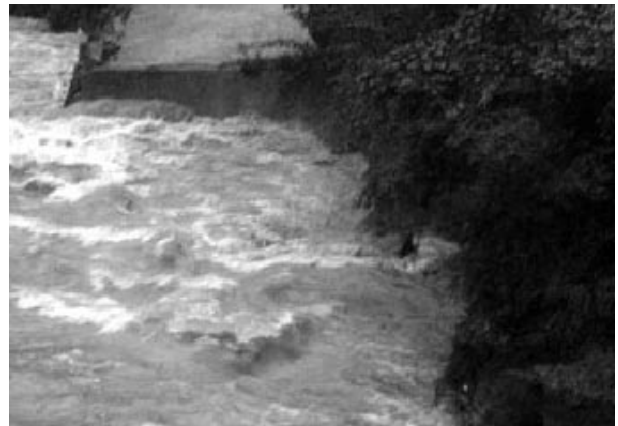
Photo 8 Flow Condition on 22 Oct 2004 ($Q = 100 \text{ m}^3/\text{s}$)

The third dumping of an approximately 2,000 m³ sediment material was carried out on March 25, 2005. In this experiment the sediment material was pushed till the middle of the river so that the material could be washed away even by a relatively small amount of reservoir discharge. For the purpose of crest gate inspection, an approximately 5 m³/s one-hour period reservoir discharge was conducted on May 8, 2005. A small amount of the sediment material was washed away by this discharge. (Table 4, Photo 8, 9)

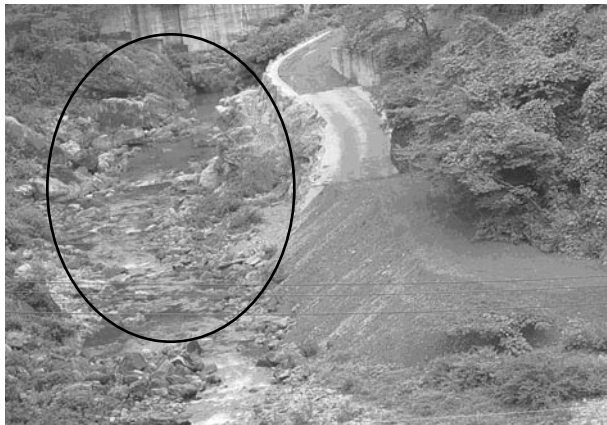
Photo 9 Riverbed before Sediment Transport Experiment (July 2003)

Restoration of riverbed material can be seen in the river section downstream of the sediment material dumping place due to the effects of the dumped sediment material. However, it is feared that the riverbed material restored only by the above-mentioned dumping method and the amount dumped might be washed away when the river section receives a magnitude of reservoir discharge that handles a certain size of floods or a design maximum discharge (discharge in the range of 500 m³/s to 800 m³/s).

It would be necessary to examine the shape of piled up material and the amount of material to be dumped to suit the amount of reservoir discharge and the discharge duration. (Photo 9, 10)

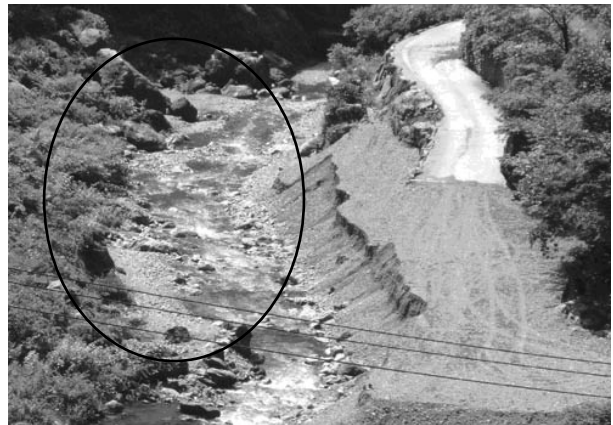
Photo 10 Present Riverbed Condition (May 2005)
Note: Restoration of riverbed material can be seen.

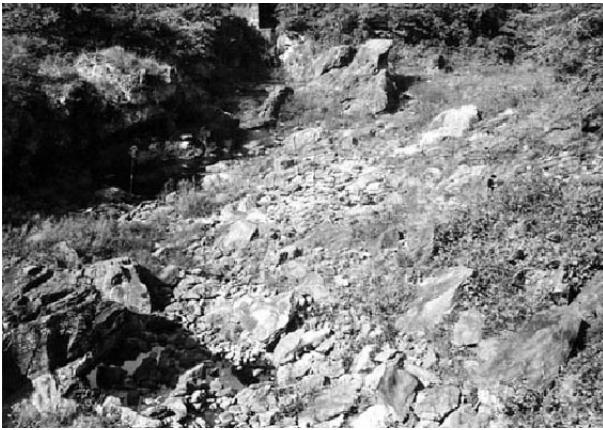
Photo 11 Sanba Seki Kyo in 1997

It is considered that the cleansing effects of the river flow increased because of the reason that the river water contained dumped sediment material. Photos 11 and 12 show the riverbed conditions before and after conducting the sediment transport experiment. It can be seen that the previous dark surface of Sanba Seki became a shiny surface by the cleansing effect.

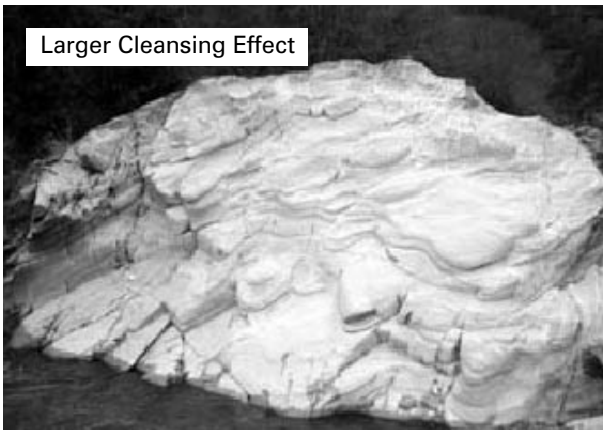
Photo 13 Downstream-side Surface

The cleansing effect is larger at the downstream side of rock than the upstream side that is hit by the river flow. Because river flow mixes sediment material in behind the rock with the turbulent water. Photos 13 and 14 show the upstream-side surface and downstream-side surface of rock. It can be seen the great difference in the cleansing effect. Photo 15 is the side view of the rock.

Larger Cleansing Effect

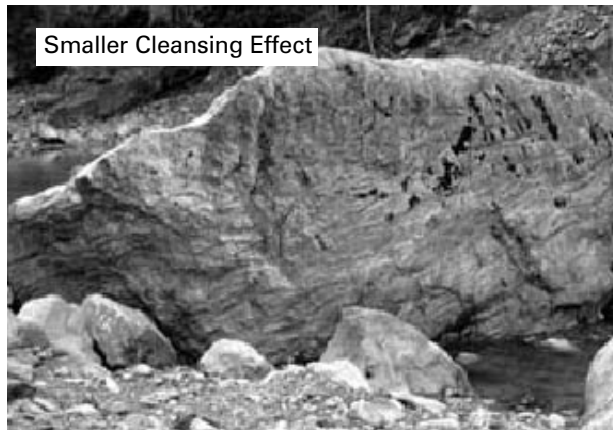
Photo 14 Upstream-side Surface

Smaller Cleansing Effect

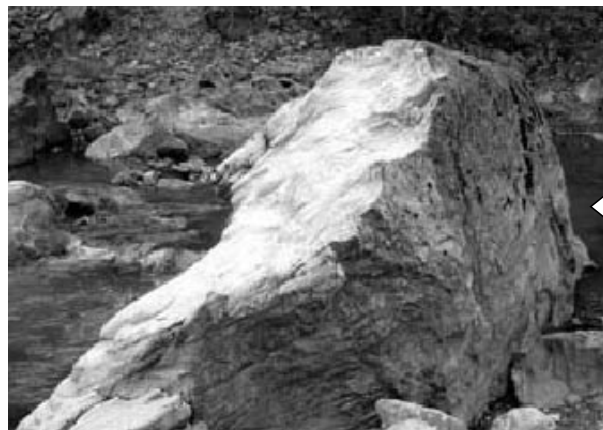
Photo 15 Side View of Rock

Flow Direction
