Comprehensive Sediment Management in the Kurobe River

Hirokatsu Kanazawa

*Director, Kurobe Office of River, Hokuriku Regional Development Bureau,
Ministry of Land, Infrastructure and Transport, Japan*

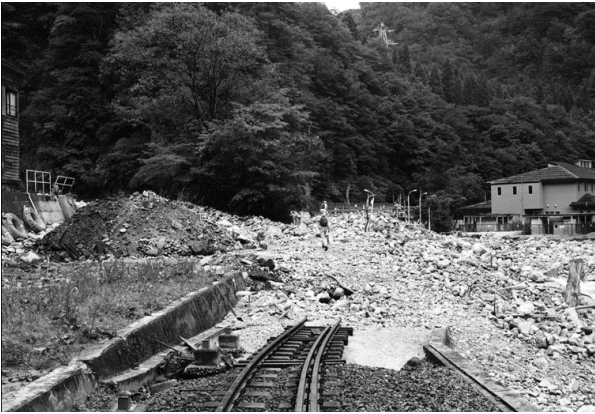
Photo 1 Damage inflicted on the Nekomata Station of the Kurobe Gorge Railway in July 1995

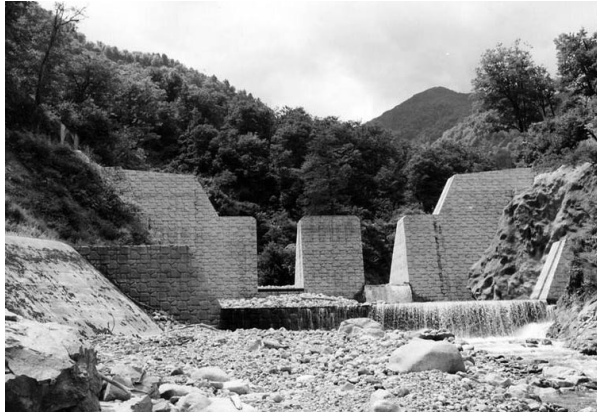
Photo 2 Establishment of slit-type sabo dam
(Kokurobedani sabo-dam No.1)

With the aim of preventing earth-flow disasters, a sabo dam is built on a mountain stream where there is a large outflow of sediment so that the quantity of sediment runoff can be controlled. However, to avoid the excessive capture of soil at times of normal flow, slit sabo dams such as that shown in Photo 2 have come into use. Slit sabo dams effectively check large quantities of sediment discharge at times of flooding, while supplying sediment downwards from between the slits at normal times.

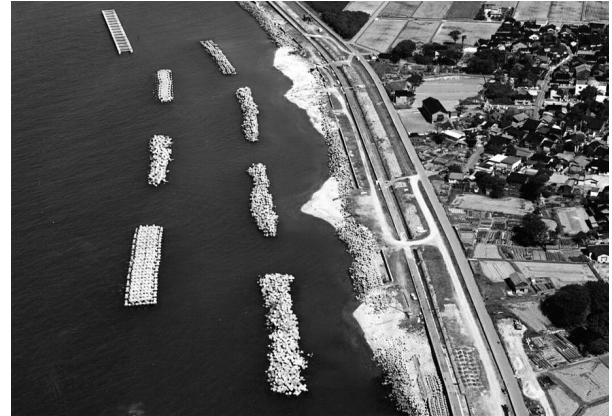
Photo 3 Establishment of offshore breakwaters
(Yoshiwara District in Nyuzen Town)

Kurobe River mouth is steep, it is assumed that much of sediment during discharged times of flooding is transported deep under the sea and beach sediment contributes little to maintaining the coastal area. Thus, as Photo 3 indicates, coastal protection facilities such as offshore breakwaters and artificial reefs have been constructed to prevent coastal erosion and beach drifting.

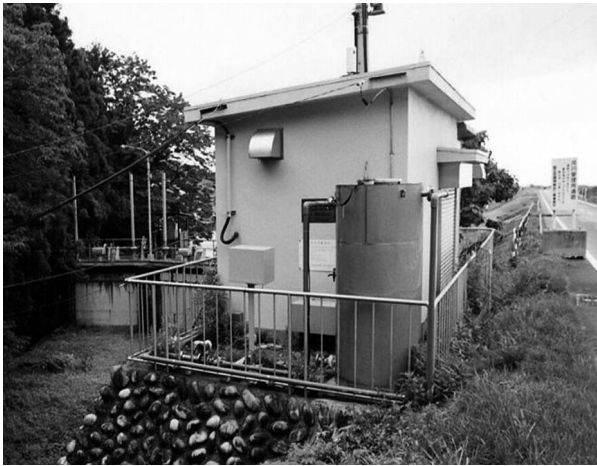
Photo 4 Real-time suspended sediment densitometer

and direct sampling of sediment discharge using a backhoe

In conducting sediment management, it is vital that the movement of sediment be grasped as basic information. Unlike water, however, it is quite difficult to establish the quality and quantity of discharged sediment. In the Kurobe River and its coastal environment, various attempts have been made to understand sediment movement. Photo 4 and Figure 3 illustrate a real-time suspended sediment densitometer and its schematic diagram.

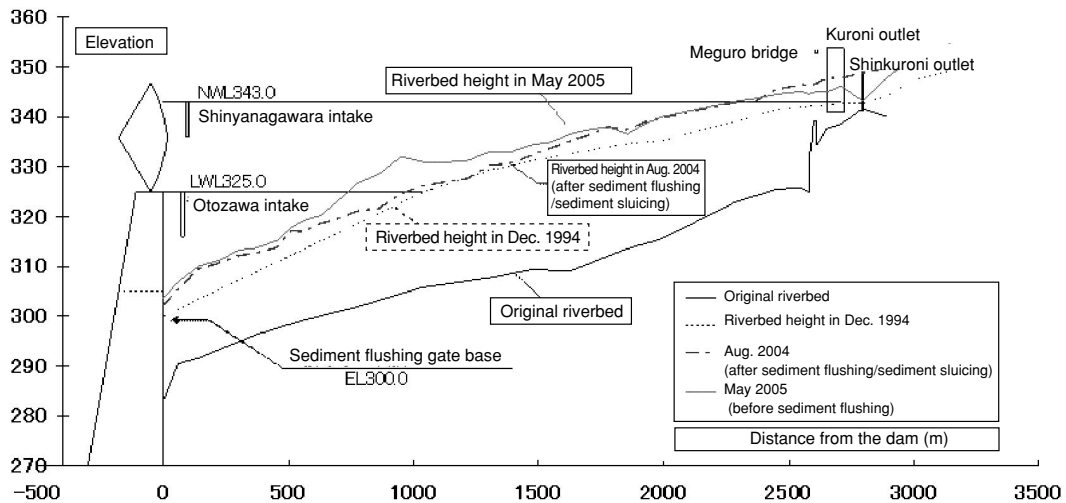
Figure 5 Sediment profile of the Dashidaira Dam (May 2005)

Specifically in the case of the Dashidaira Dam, the amount of sediment accumulating after the last sediment flushing (or sediment sluicing) operation until May of the following year is assigned as the target volume. The target volume for the dam for 2005 is estimated as 540 thousand m³. Meanwhile, the target volume for the Unazuki Dam is 0 m³, as it is considered that the current height of the riverbed is still below that of the estimated stable riverbed in the Unazuki Dam Reservoir. Figures 5 and 6 demonstrate the shape of sedimentation in the Dashidaira Dam and the Unazuki Dam.

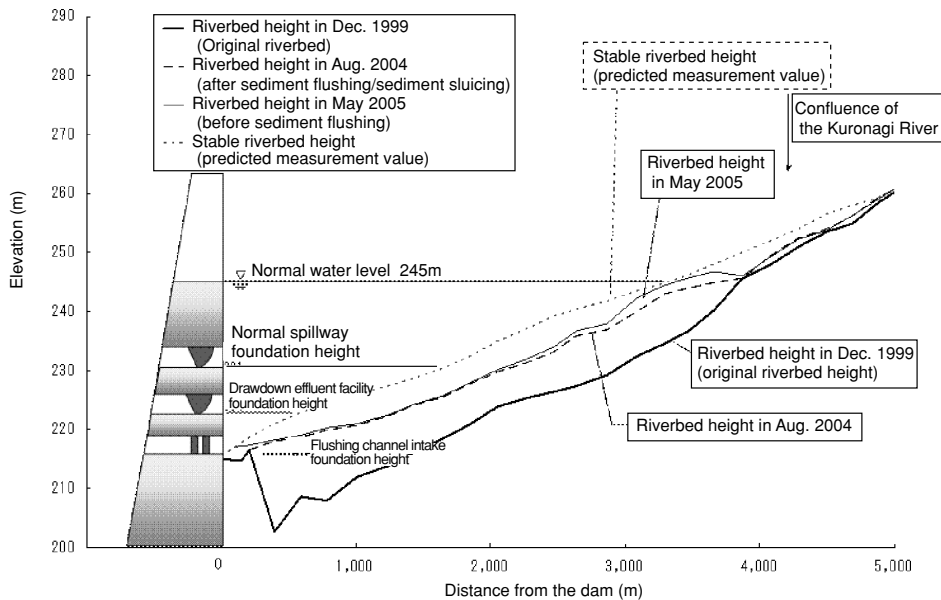
Figure 6 Sediment profile of the Unazuki Dam (May 2005)

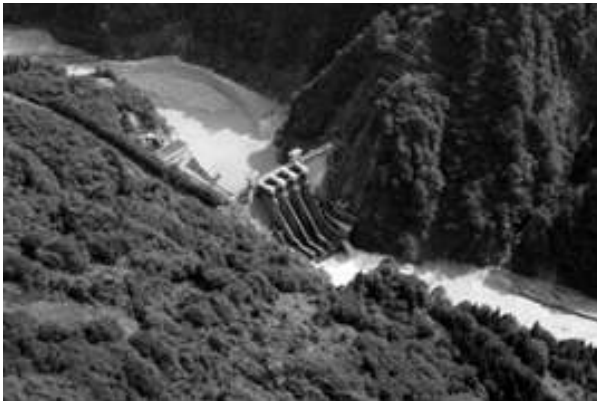
Photo 5 Dashidaira Dam (during the free flow operation)

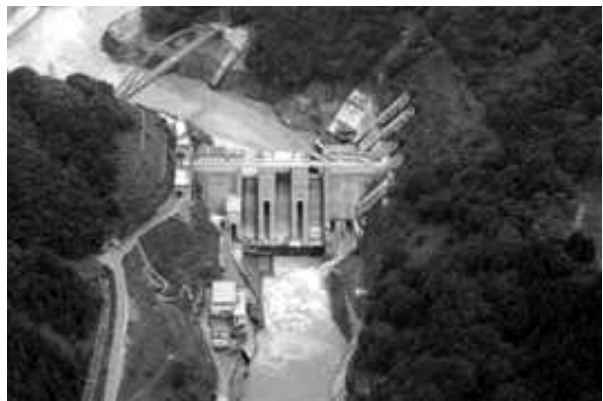
Photo 6 Unazuki Dam (during the drawdown operation)

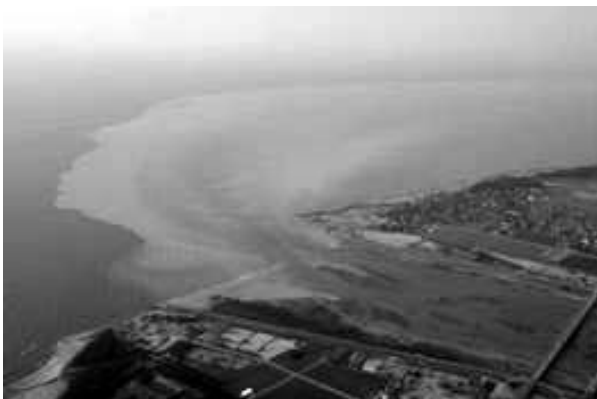
Photo 7 Kurobe River mouth during the drawdown operation

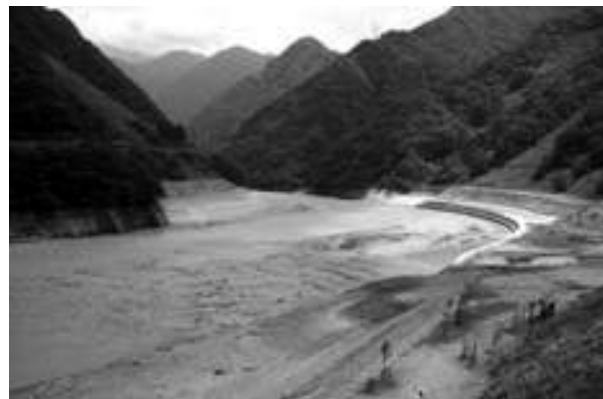
Photo 8 Unazuki Dam reservoir during the sediment flushing operation

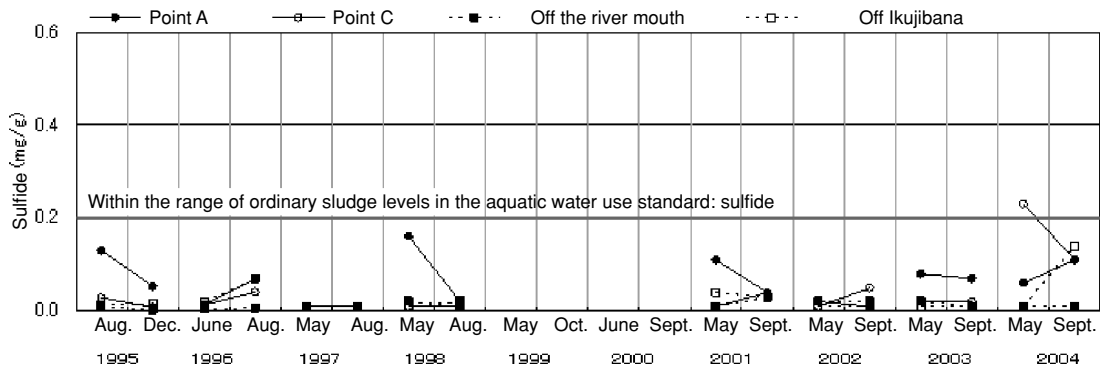
Figure 13 Marine sediment analysis results (sulfide)

the major marine indices, have not so far exceeded ordinary sludge levels in terms of the aquatic water use standard. Figures 12 and 13 demonstrate the survey results of COD and sulfide.

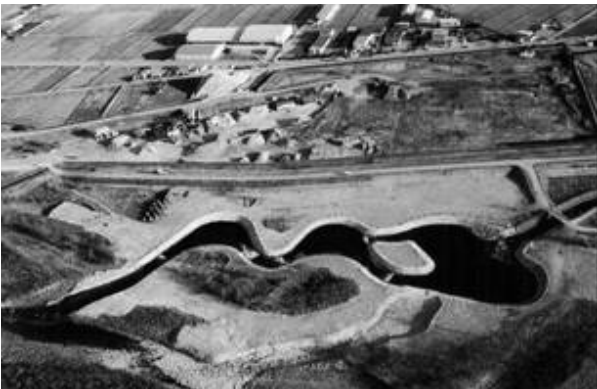
Photo 9 Evacuation facility for fish (resting water channel)

measures up to this point is the installation of an evacuation facility for fish, the (yasuragi suiro or resting water channel) shown in Photo 9. In this system, a foreland stream near the junction of the Kurobe main river and its branch river was improved to secure a freshwater zone into which fish can evacuate as the turbidity of the main river rises. As an evacuation facility for ayu (sweet fish), a positive result has been recognized.
