Sediment Management Measures at the Miwa Dam

Yasushi Enomura

*Director, Mibugawa River Comprehensive Development Office,
Ministry of Land, Infrastructure and Transport, Japan*

1. Outline of the Miwa Dam Redevelopment Project

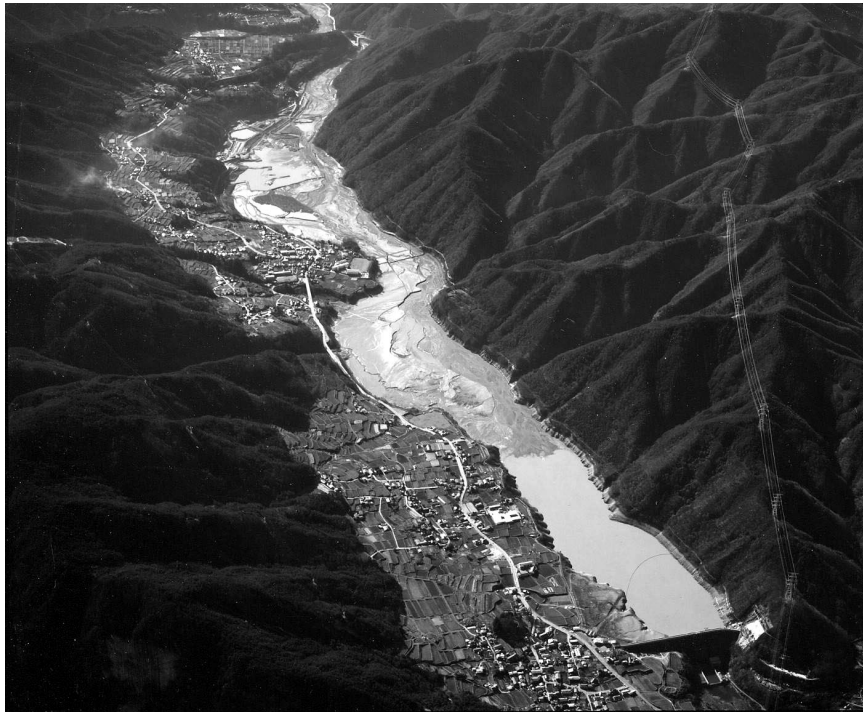
Photo-1 Miwa Dam during dewatering (the photo taken in 1989)

important. Photo 1 illustrates the sedimentation, and Figure 2 is a chart of yearly sediment change.

Yet, the flood-induced sediment inflow has brought about such an accumulation of sedimentation that effective storage capacity is barely secured. If large-scale flooding occurred, it is possible that there would be damage to the flood control and water supply functions of the Miwa Dam. Thus, excavation in the reservoir as well as measures to prevent further sedimentation (permanent sediment management) are vitally

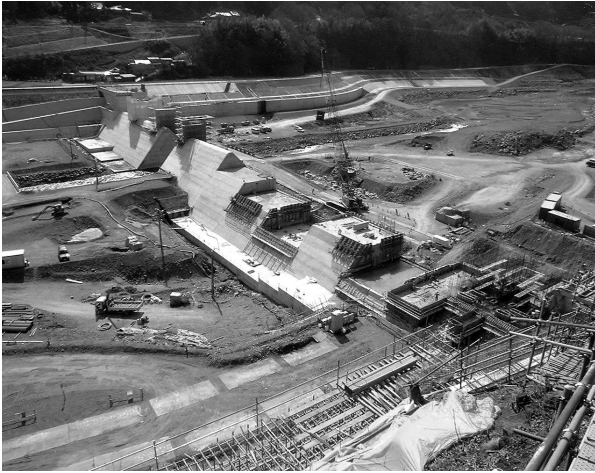
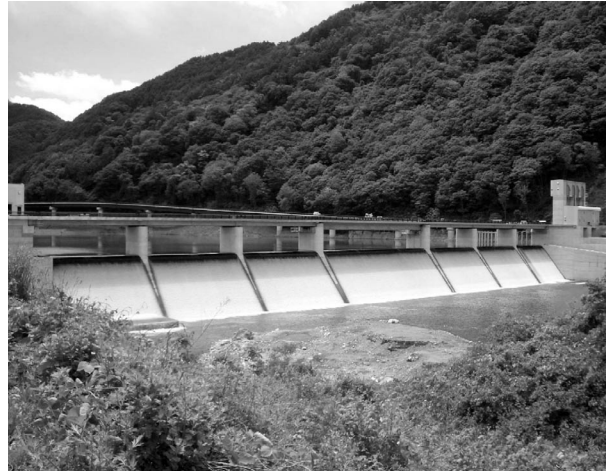
Because it was necessary to carry out work on the diversion weir inside the reservoir, the execution period was restricted to six months during the non-flood season between October and March. Construction efficiency is also affected by the fluctuation in the reservoir level. For this reason, the reservoir level was lowered during the non-flood period to secure the construction term while the reduced energy output was compensated for by the power plant on the Miwa Dam. Furthermore, to facilitate concrete placement under circumstances where the average temperature was below zero, an appropriate winter concreting measure (use of warm water for mixing and jet heater after placement) was adopted to ensure high quality. Photos 2 and 3 show the diversion weir under construction and after completion.

Photo-2 Construction of the diversion weir

Photo-3 Current diversion weir

The diversion weir installed in the upstream reaches of the Miwa Dam reservoir is a concrete gravity structure 20.5 m in height and 244.5 m in length. The construction works were begun in October 2001 and nearly 53,800 m³ of concrete was placed into the body of the structure in February 2005. By the end of fiscal 2004, the bypass channel on the left side connecting

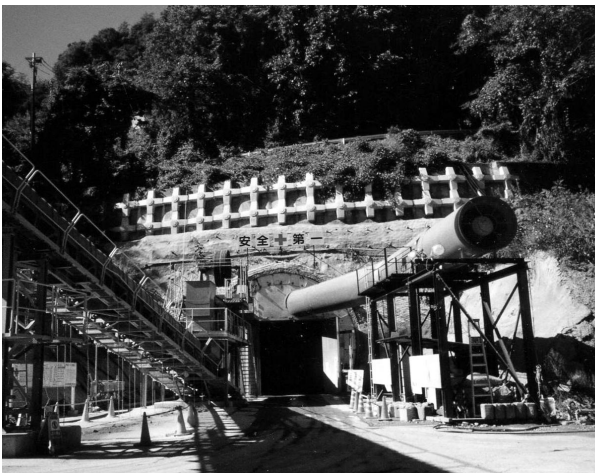
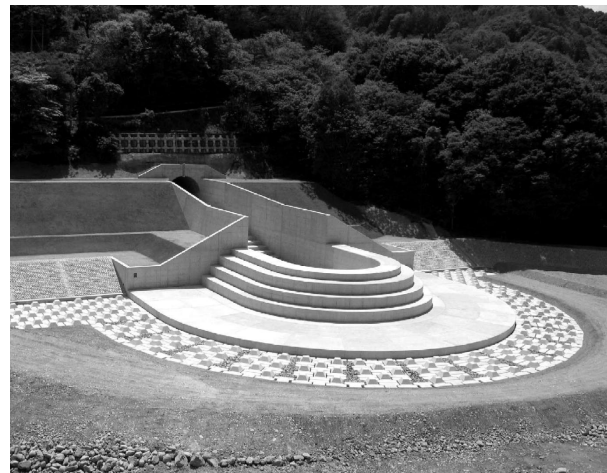
Photo-4 Construction of the tunnel entrance

Photo-5 Current tunnel entrance

Later, the tunnel was lined and the concrete floor slabs were placed. Work on the tunnel outfall was begun in June 2004 and was completed by the end of May, 2005. Photographs 4 and 5 illustrate the flood bypass tunnel under construction and after completion.

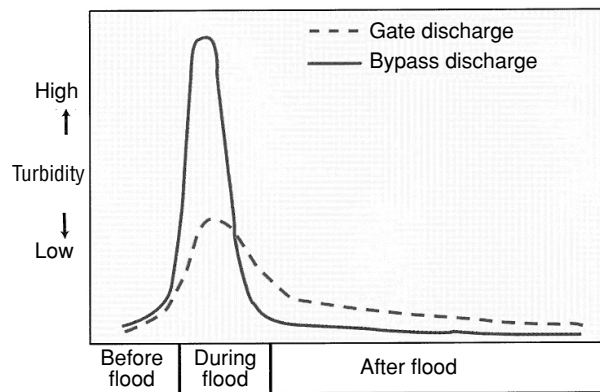
Figure-5 Conceptual diagram of change of turbid water

In comparison with conventional gate discharge through a reservoir, the water washed down by the bypass discharge is of higher turbidity (see Figure 5). Therefore, it is expected that the turbidity of water in the reservoir will be reduced so that the time taken to discharge turbid water from the dam after flooding should be shortened. These effects are being evaluated.
