A CLEAR WATER BYPASS PIPELINE SYSTEM MITIGATES TURBID WATER DISCHARGE FROM A DAM

Hideto Namiki

Japan Water Agency, Arakawa Dam Construction Operation and Management Office,

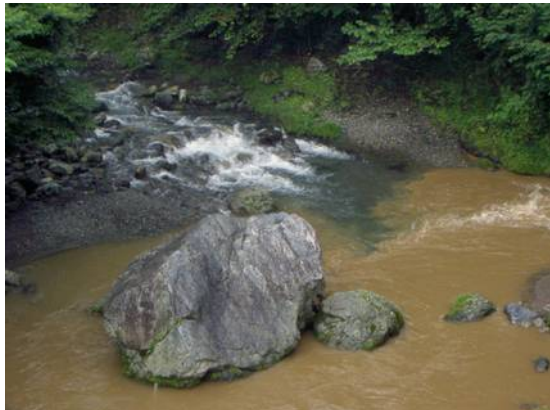
Fig.2 Turbid Inflow

The dam was completed in 1999 and soon experienced high turbidity of inflow due to intense rainfall from typhoons. Most of the entire catchment area was steep forested slopes,

some poorly maintained, and heavy rain resulted in severe soil erosion. (Fig.2)

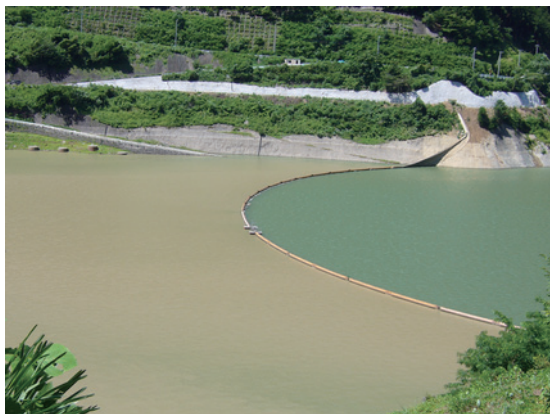
Fig.3 Floating Turbidity Curtain

Before the dam construction, the inflow of turbid water was thought to be manageable with a floating turbidity curtain and an intake tower with depth-selective withdrawal. (Fig.3) However, the recession of forestry resulted in poor forest maintenance and unexpected inflow levels of highly turbid water. In addition, an increase in wildlife population damaged the forest and the ground surface.

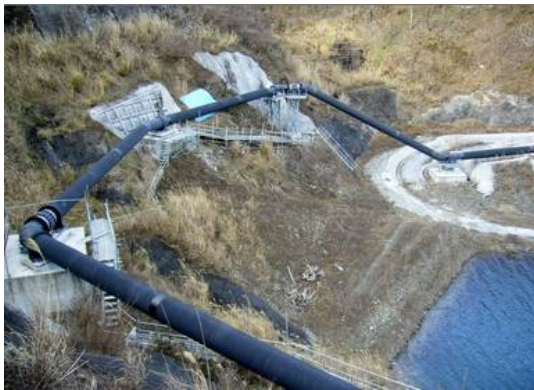
Fig.7 Steel Pipe Section (1)

The most suitable type of pipe for each section was selected from steel pipe, fiber-reinforced plastic mortar pipe (FRPM) and polyethylene pipe. This was the first project in Japan to use polyethylene pipe in suspension as a permanent structure. The suspended section is fixed to the ground only at the ends. The material is flexible enough to follow changes in water level, and the middle of the suspended section stays 2 meters beneath the water surface to allow boats and flotsam to pass it over. Also, rotation joints adjacent to the fixed end points allow the pipe to swing up and down, avoiding internal stress in the pipe. We are sure that the suspended pipeline is a breakthrough as a way for a pipeline to cross water area at low cost. (Fig.7~Fig.14)

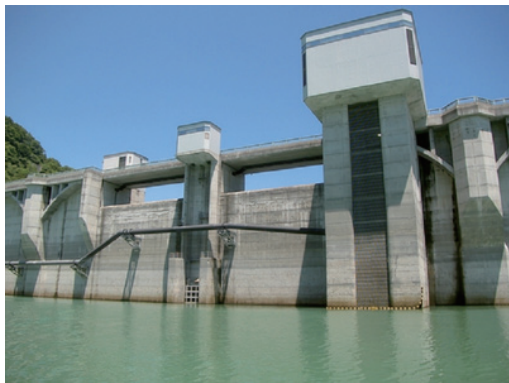
Fig.15 Outlet (1)
(Intake Tower)

As power generation is one of the purposes of the Urayama Dam, it is necessary that the operation of the bypass pipeline does not reduce power generation. Therefore the outlet had to be installed upstream of the power station to avoid any head loss. (Fig.15)

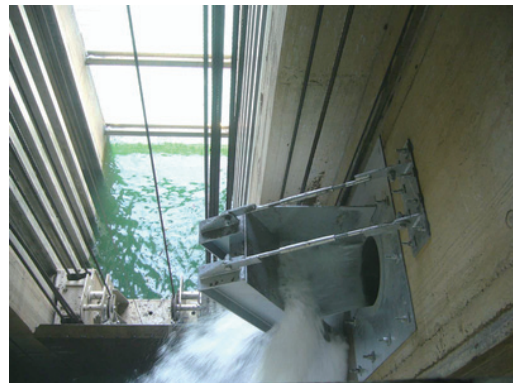
Fig.16 Outlet (2)
(Inside the Intake Tower)

The outlet was located in a selective intake tower in the reservoir. The tower had been originally equipped with gates that allowed the separation of the water inside from reservoir water. Water from the bypass pipeline is poured directly into the inside of the tower, without mixing with turbid reservoir water. (Fig.16)

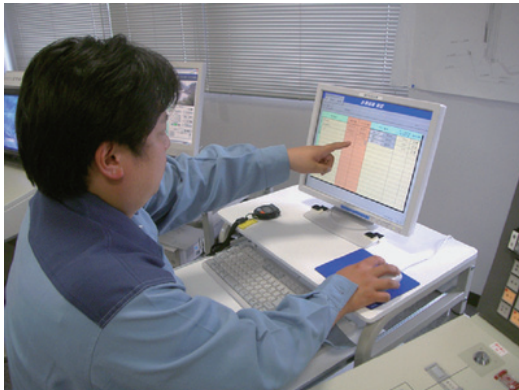
Fig.17 Remote Control System
(Operation Room)

The outlet is equipped with a regulating valve. To ensure safe operation and to save human resources, the flow is remotely controlled from the operation room of the project office. Fundamental live data such as turbidity at the intake is periodically collected through a data telemetry system. Furthermore, the accumulated data can be checked on the Internet. (Fig.17)

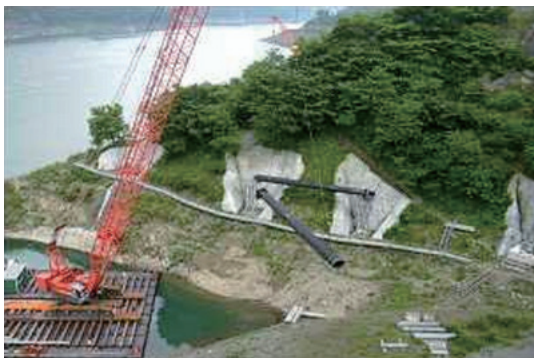
Fig.18 Construction Work
(A Crane on the Pontoon)

We carried out the construction of the bypass system in harmony with the operation of the dam, getting consensus approval from all the organizations concerned. More than half of the pipeline route was inaccessible from existing roads. We transported materials such as pipes with a tug boat and pontoons and placed or assembled them with cranes fixed on the pontoons, controlling the reservoir water level so as to make the work possible.

As a result, we did not have to construct any temporary roads at all. Thus construction work conducted in parallel with dam operation brought us great benefits both in terms of cost reduction and environmental conservation. (Fig.18)

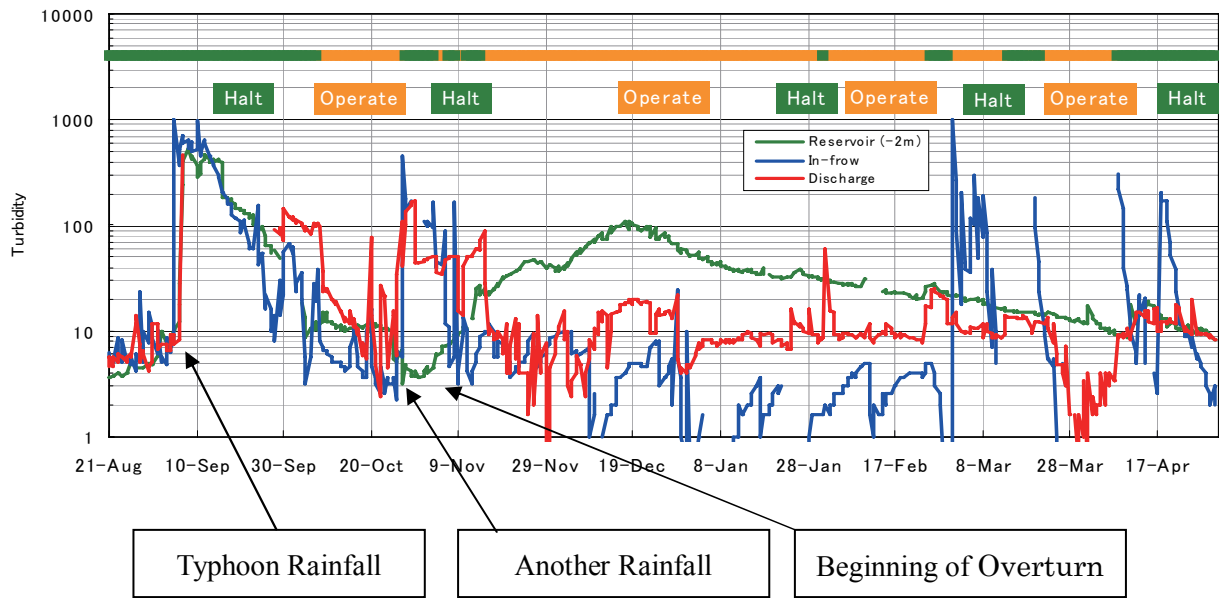
Fig.19 Inflow, Reservoir and Discharge Turbidity (NTU)

The bypass system was completed in March 2007 and the opportunity for practical operation soon arrived. In September 2007, the dam was hit by a huge typhoon that brought 583 mm of rain in only 64 hours. Inflow turbidity measured over 1000 NTU at the maximum. As a result, the turbidity of the reservoir rose to 538 NTU at the surface (-2 m depth) and discharge turbidity exceeded acceptable levels downstream.

The bypass system began to operate on October 8th, after the turbidity of the inflow fell sufficiently and sediment in the intake basin was removed. Then we turned operation on and off because another rainfall raised the turbidity of the inflow.

It took about a week to completely replace the turbid water in the intake tower and discharge pipe with a clean flow from the bypass system. After that, the discharge water showed low turbidity. The operation demonstrated the functionality of the clear water bypass pipeline system and the appropriateness of its design.

A month after the start of bypass operation, the autumn overturn of the reservoir began as the air temperature declined. This lifted suspended particles, which had gradually been settling in accordance with Stokes' Law, making the turbidity almost uniform from the bottom to the surface. Even after the overturn, the turbidity of discharged water was less than 20 NTU, while that of reservoir water was as much as 110 NTU.

Acceptable turbidity for the tap water purification plant and the industrial water purification plant downstream of the dam is 20 NTU. From the viewpoint of avoiding interference with purification processes or water use, it can be said that the clear water bypass pipeline worked successfully. (Fig.19~Fig.22)
