KYUSHU ELECTRIC'S ACTIONS TOWARDS BIODIVERSITY CONSERVATION IN DAM CONSTRUCTION FOR A LARGE-SCALE PUMPED STORAGE HYDROELECTRIC POWER STATION

Civil Engineering & Architecture Sec., Omarugawa Hydro Power Plant Construction Office,
Kyushu Electric Power Co., Inc.

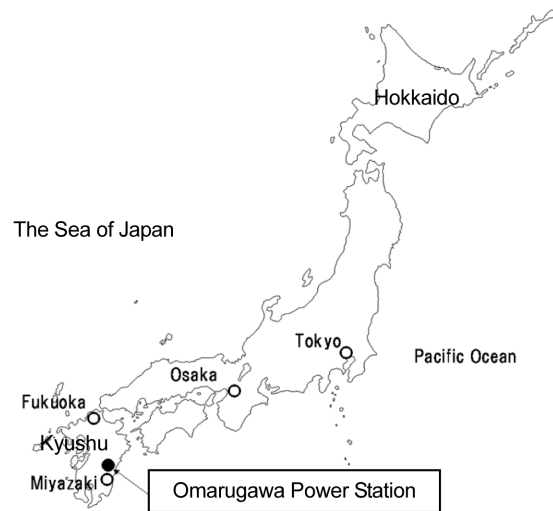
Figure 1. Location of the Omarugawa Power Station in Miyazaki Prefecture, Japan

Based on the plan, the upper regulating reservoir was created by constructing an upper dam (asphalt-faced impervious walls, rockfill type; height 65.5m) at the uppermost stream of Oseuchitani River, a tributary of Omaru River, while the lower regulating reservoir was created by constructing a lower dam (concrete gravity type; height 47.5 m) in the mid-stream of Omaru River. These two reservoirs were linked by a 2.8 km-pipe to pump up river water to the head of 646 m and to be used for power generation. Fig. 1 shows the location of the plan, and Fig. 2 the top view of the plan.

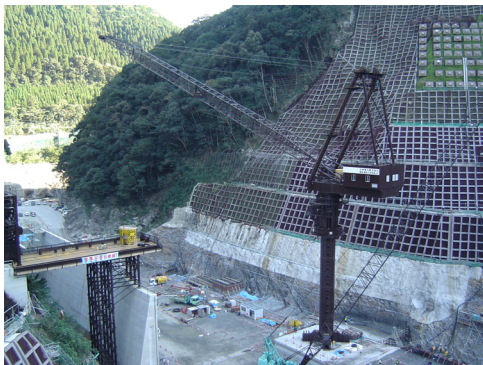
Item	Content
Noise measure	Use of motor-driven equipment	Applicable to transfer car, boring machine, etc.
	Use of low-noise equipment	Applicable to vibrator and crawler crane, etc.
	Restrictions on equipment used	Limited use of small breaker and pick hammer, etc. (at nighttime during critical period)
		Limited use of whistle and siren, etc.
Visual measure	Restriction on lamp height	Limited lighting from high locations
	Restriction on lit area	Reduced lit area based on work conditions
	Installation of hood/louwer	Preventing light leakage from sodium lamps and adjusting beam direction
	Lighting direction	Lamps arranged to avoid shining on nesting area
	Use of localized lighting	Localized lighting during grouting
	Installation of low-brightness nets	Applicable to scaffold and concrete structures
	Adoption of low-brightness painting	Applicable to machinery such as tower crane and temporary building (Photo 3)

Photo 3. Low-brightness painting of tower crane

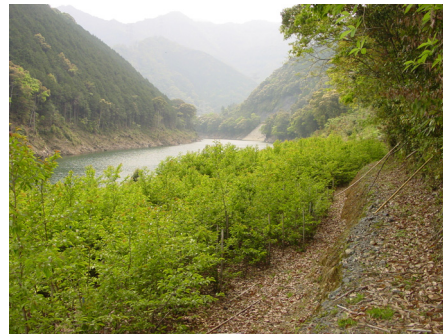
Photo 5. *Alnus trabeculosa* growing after transplantation

The transplanted trees are currently monitored and have been confirmed as growing satisfactorily (Photo 5).
