Application of Global Positioning System for Dam Deformation Monitoring

H. Arizono, H. Okumura & H. Onishi
Electric Power Development Co., Ltd, Tokyo, Japan
hiroki_arizono@jpower.co.jp

Keywords: GPS, dam deformation monitoring, renovation of dam safety monitoring

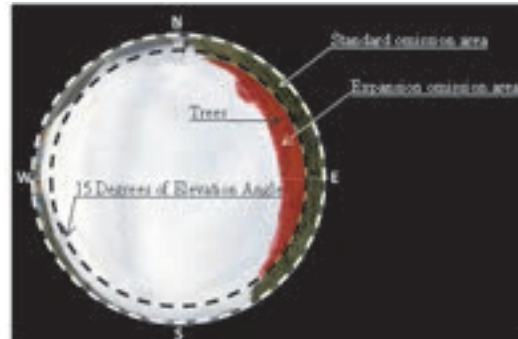
Figure 3. Upward Half-sphere View from K-2

A specific condition at Numappara site was revealed in the initial stage of the observation using the K-2 benchmark. Fig. 3 shows a upward half-sphere view from the K-2 benchmark. Usually, GPS signals from the direction near the ground surface, mostly in the area lower than 15 degrees of elevation angle, are omitted from the analysis to prevent negative influence to the data by noise or reflection at around the surface. However, growing trees on the east side of K-2 exceeds the standard omission area as shown in Fig. 3. It was serious concern that the signals through the trees were strongly disturbed or deteriorated by moisture in and around the trees. After check of the signals at the site, the data processing methods was improved to expand omission area as shown in Fig.3.

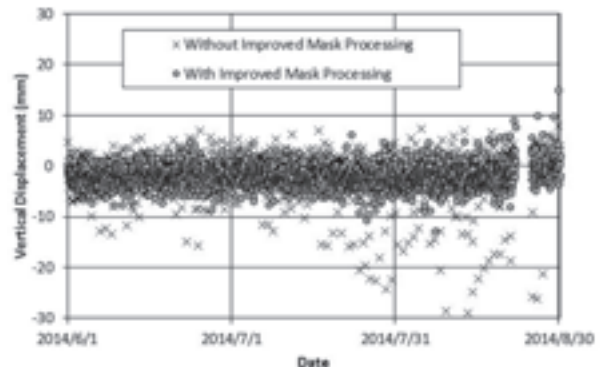
Figure 4. Comparison of Analysis Method

Fig. 4 shows a comparison of analysis results with and without the improved mask processing. The result indicates a clear difference of data dispersion between two groups and better convergence of the data in case of the improved mask processing (Hisano, A., et al. 2015).

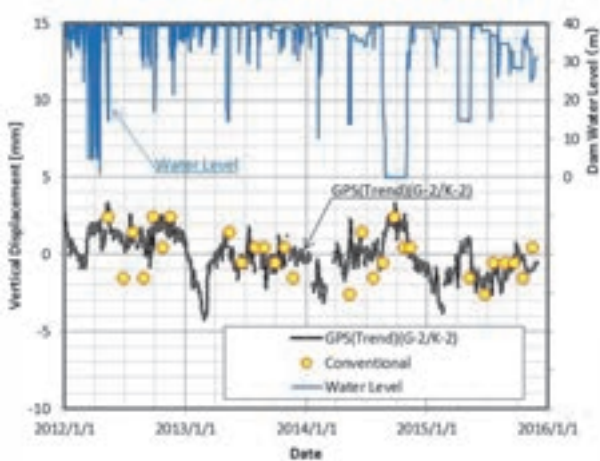
Figure 5. Comparison of GPS/Conventional Survey

J-Power has conducted the deformation survey of the dam body by two methods; GPS and the conventional manual survey, in parallel so as to check and verify reliability of the data. Fig. 5 shows the observation results comparing two sorts of the data; surveyed by GPS and by conventional manual survey. Both the data show comparatively good conformity as shown in Fig. 5. When the 2011 Off the Pacific Coast of Tohoku Earthquake occurred, the asphalt surface of the dam was damaged, and a considerable amount of leakage was caused accordingly. Not only the leakage data but the dam deformation data by GPS were continuously transmitted to the site administration office, even though

the access road to the dam was closed due to the heavy snow, which was very useful to know the dam's state just after the earthquake.

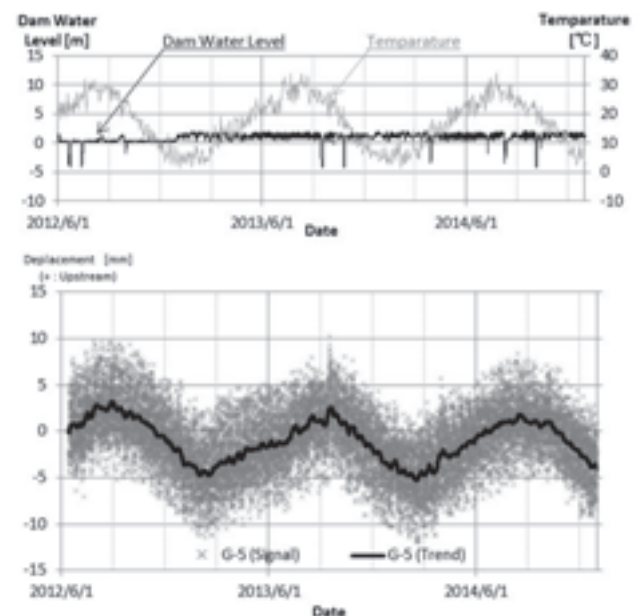
Figure 11. Observation Result at Funagira Dam

A survey result of the upstream-downstream displacement at the point G-5 is given in Fig. 11. The trend line shows around 8 mm of yearly periodical displacement. The amplitude and cycle of the movement are steady and constant throughout the observation period. The influence by water drawdown is assumed to be negligible because of its limited depth; 2.2m.

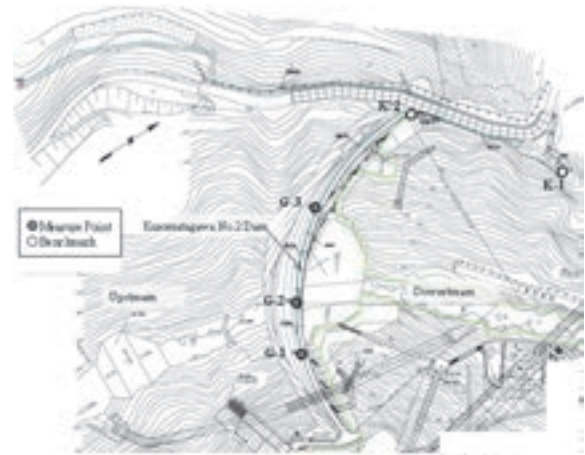
Figure 12. GPS Equipment Layout at Kuromatagawa No.2 dam

As shown in Fig. 12, GPS survey unit at Kuromatagawa No.2 dam is composed of 3 measure points and 2 benchmarks. The dam is located in the heavy snowfall mountainous area, therefore, the sensors for the measure points and the benchmarks were designed to be workable under the heavy snowfall and icy condition in winter. The sensor poles were also designed to be higher than the expected snow depth at the site. Standard height of the poles was 4.0 m.

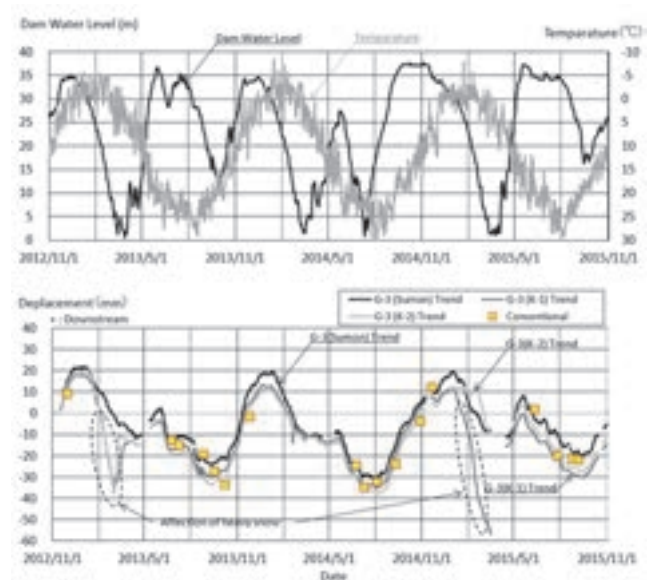
Figure 13. Observation Result at Kuromatagawa No.2 Dam

Application of GPS enabled the observation of the dam in all seasons including winter period in which the access and works at the site are difficult as same as that in Numappara dam due to heavy snow. Fig. 13 shows an observation result of the upstream-downstream displacement. The figure indicates three results of displacement based on the local benchmarks (K-1, K-2) and the national GPS-based Control Station named "Sumon" which is located around 10 km away from the dam site. The lines show high correlation with temperature and reservoir water level, like that the dam body moves to the upstream along with the temperature rising and moves to the downstream along with the water level rising. The results by GPS well conform to those data observed by the conventional manual survey.

The results obtained by the local benchmarks K-1 and K-2 in Fig. 13 show different trend in winter seasons of year 2013 and 2015 comparing with that in 2014. The reason is assumed that the local benchmarks were affected by heavy snow pressure during the winter and restored to the original condition along with snow melting. Both 2013 and 2015 are known as years having snowy winters.

The result suggests that the national GPS-based Control Station is useful for verification of availability and accuracy of the local benchmarks and measure points in heavy snowfall region.

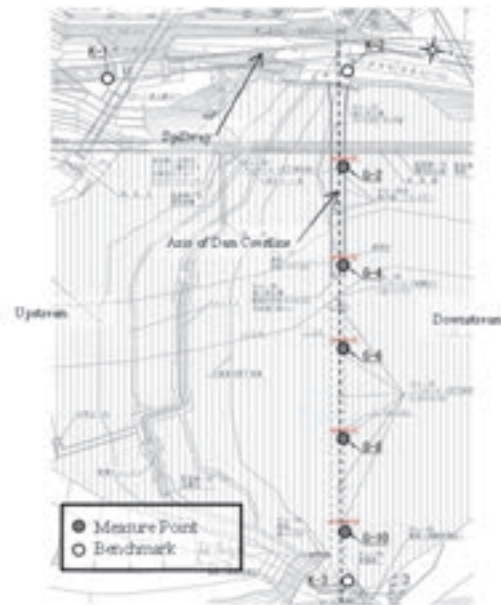
Figure 14. GPS Equipment Layout at Miboro dam

GPS survey unit at Miboro dam is composed of 5 measure points and 3 benchmarks as shown in Fig. 14. Since the dam also is located in the heavy snowfall area similarly to Kuromatagawa No.2 dam, the sensors for the measure points and the benchmarks were designed to be workable under the heavy snowfall and icy condition as well. Height of the sensor poles was set as 3.5 m considering the expected snow depth at the site.

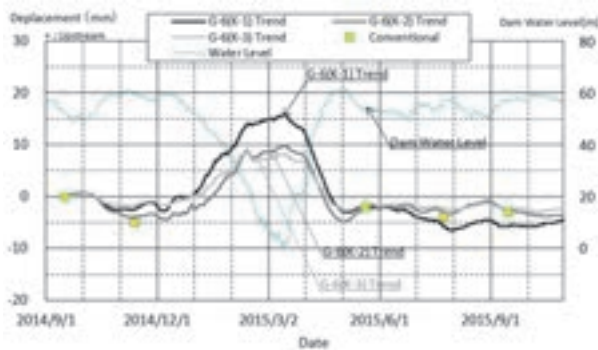
Figure 15. Observation Result at Miboro Dam

Fig. 15 shows an observation result of upstream-downstream displacement. It shows a clear trend that the dam body moves to the upstream when the reservoir water level is lowering. The measured data by GPS basically conform to the data by the conventional manual survey.

Two benchmarks, K-2 and K-3, of three are installed on the dam abutment at both right and left sides and another one, K-1, is on the spillway structure at the upstream rock foundation. Fig. 15 shows the displacement trends at G-6 point by three benchmarks and a considerable difference between K-2/K-3 and K-1. It is assumed that K-2 and K-3 were also affected by the movement of the dam body along with water level. K-1 kept its stable position independently with the firm foundation.

Miboro dam is a typical annual operation reservoir among the five cases. The water level is lowered to around the lowest level by the end of winter for impounding snow melting water in spring season to utilize the river water effectively. On the contrary, the water level is kept comparatively stable high water level throughout the year except winter. A difficulty of the survey in winter season is a common problem at the sites located in deep snowfall region. Therefore, the dam behaviours during winter season were not been made cleared until GPS was adopted. The relationship between the dam behaviour and water level fluctuation throughout a year is understandable by GPS.
