VINGT TROISIÈME CONGRÈS  
DES GRANDS BARRAGES  
*Brasilia, Mai 2009*

## **OUTLINE AND EFFECTS OF PERMANENT SEDIMENT MANAGEMENT MEASURES FOR MIWA DAM \***

This paper summarizes the project outline and trial run of the flood bypass tunnel that was completed in May 2005.

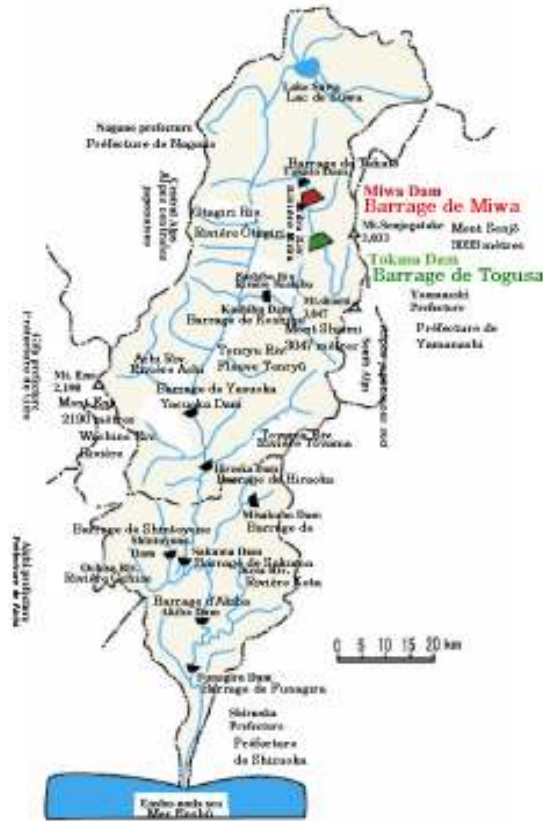
Fig. 1  
Tenryu River Basin  
*Cours du fleuve Tenryû*

The Mibu River basin is located in Ina City. Fig1 shows the basin of Tenryu River.

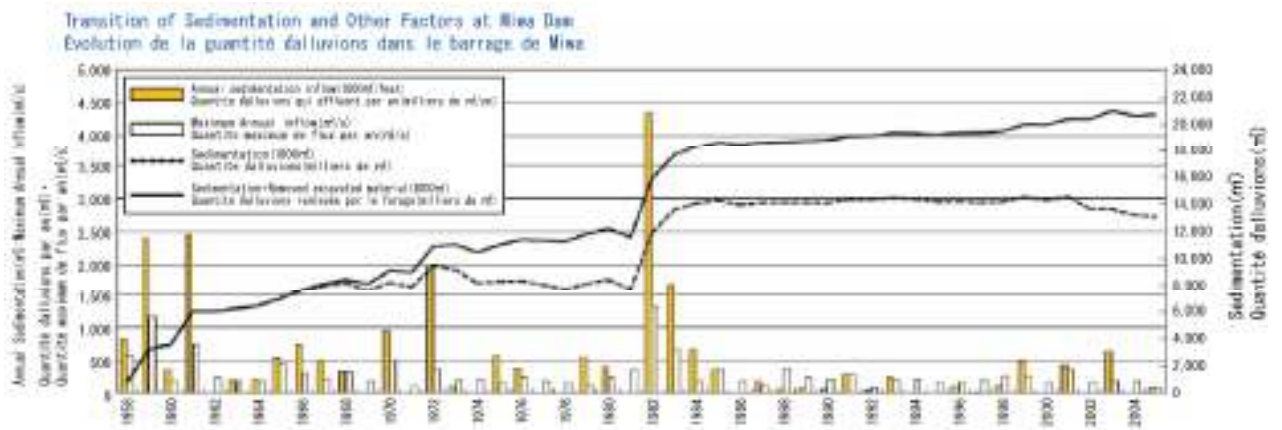
Fig. 3  
 Transition in Sedimentation and Related Factors at Miwa Dam  
 Évolution de la quantité d'alluvions déposée au barrage de Miwa

The flood control plan at the time of constructing Miwa Dam assumed the maximum inflow for 100-year probable flood to be 1,200 m<sup>3</sup>/s and the maximum outflow to be 300m<sup>3</sup>/s. Also, for the purpose of flood prevention of Mibu River and Tenryu River, sediment capacity of about 6.6 million m<sup>3</sup> was planned and secured, which corresponds to a 40-year sediment level. In August 1959, however, right before the completion of construction, a heavy flood which recorded flood discharge that almost reached the design high water discharge with a maximum flow of 1,182 m<sup>3</sup>/s, occurred. Within 3 years starting from this event to the “Showa 36 (1961) Disaster,” one of the most destructive floods in Ina Valley’s history, a total of about 6.8 million m<sup>3</sup> of soil flowed in the reservoir, and this already exceeded the design sediment capacity. In 1982, the largest flood of Mibu River that recorded the flood discharge of 1,321 m<sup>3</sup>/s exceeding the design high water discharge at the Miwa Dam occurred, resulting in about 4.3 m<sup>3</sup> new sediment only within this year, and the succeeding flood in 1983 delivered of about 1.6 million m<sup>3</sup> sediment.

Such repeated floods have brought an enormous quantity of soil into the Miwa Dam reservoir, which has amounted up to about 20 million m<sup>3</sup> since the completion of the dam.

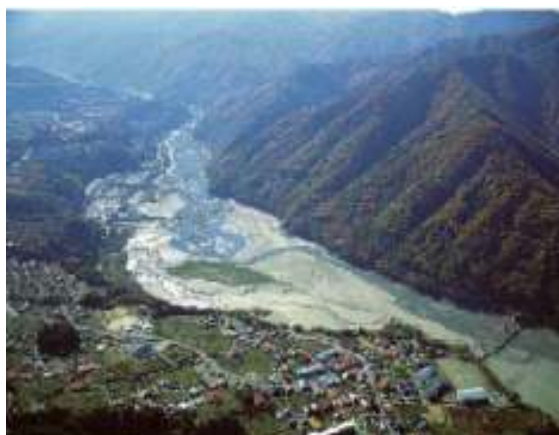
Miwa Dam Reservoir (1999)

During this period, emergency measures such as excavation and removal of sediment have been carried out in the reservoir, but they have proved insufficient for a large amount of soil flowing in. Therefore, drastic solutions have been necessary. Fig. 2 shows the transition in sediment volume, while Fig. 3 indicates the longitudinal changes of sedimentation. Photo 1 is the situation of sedimentation in 1999.

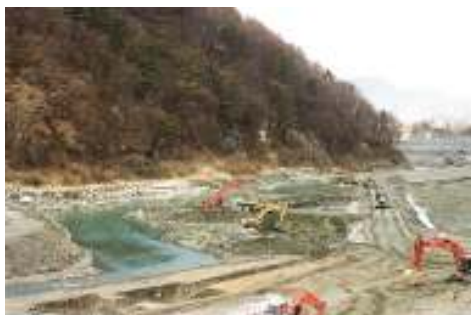
Photo 2

Excavation of Reservoir Sediment  
*Excavations des alluvions du lac de rétention*

Sediment excavation is conducted for maintaining the existing flood control and water utilization functions of Miwa Dam by removing the sediment in the reservoir. In the beginning, slurry transport was mainly considered, but the actual excavation was planned to be carried out when the reservoir's water level gets lower, aiming at the low cost of land excavation and transportation by dump trucks. Before, about 2 million m<sup>3</sup> has been excavated and the removed material was effectively reused for improving local agricultural fields. (Photos 2,3)

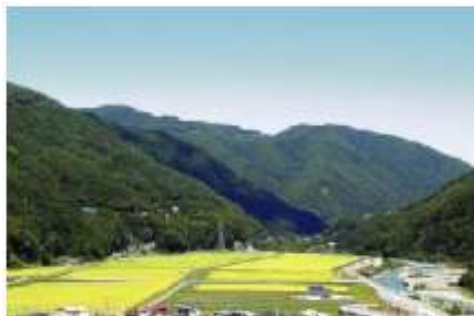
Photo 3

Improving Farm Fields in Ichinose Area  
*Installation en champs du district de Ichinose*

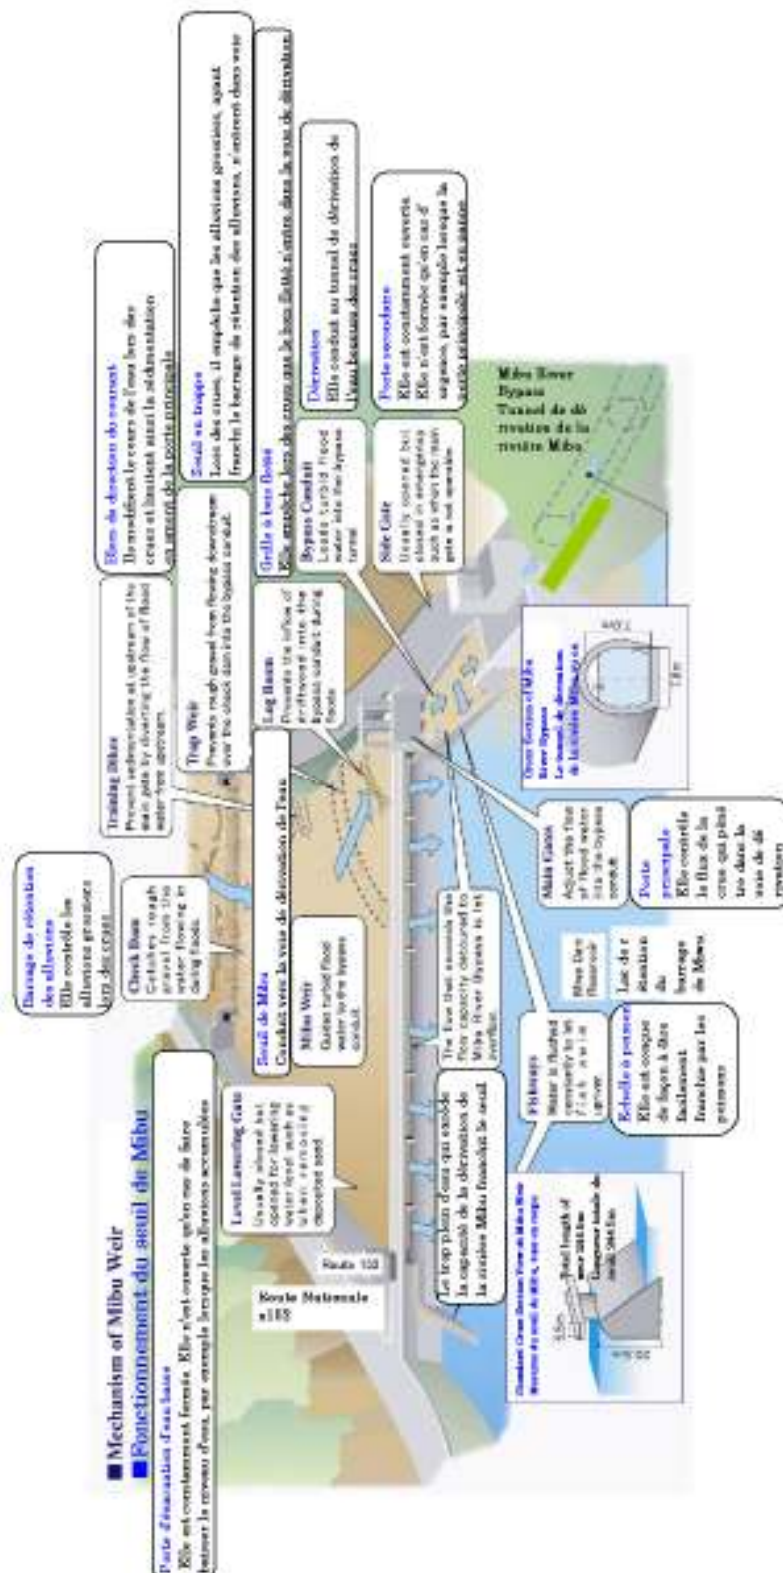
Fig. 5  
 Mechanism of Permanent Sediment Management Measure  
 Fonctionnement des mesures pérennes anti-alluvions

Permanent sediment management measure consisted of the construction of a “flood bypass tunnel” designed to reduce inflow of wash load into the reservoir, and “intra-reservoir sediment management facilities” for discharging wash load after sedimentation when the flood water is led into the reservoir without bypassing for the purpose of water level recovery and flood control in connection with water utilization. (Fig. 4, 5, Table 1)

Before flood bypassing, rough gravel carried in the flood water is trapped at the check dam at first, and finer sand are let flow downstream.

Next, the diversion weir diverts the fine sand (wash load) flowing from the check dam at into the bypass tunnel together with the flood water. On the upstream side of the diversion weir, a trap weir (submerged dike), installed under water, in front of the gate, captures rough objects passing over the check dam to prevent them from flowing into the bypass tunnel. The gate set at the bypass tunnel inlet adjusts the outflow to allow the flood water to flow at maximum of 300 m<sup>3</sup>/s.

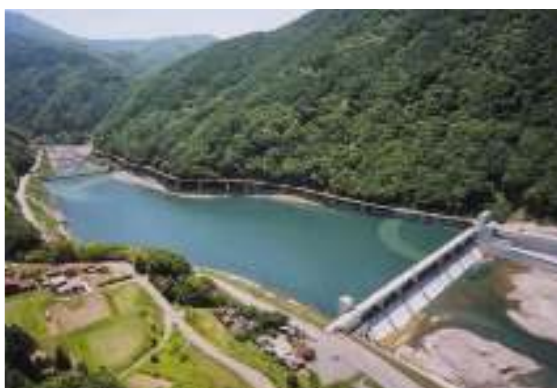
Photo 4

Mibu Weir (diversion weir) and Lake Hase  
*Seuil de Mibu et Lac de Hase*

Consequently, the 525,000 m<sup>3</sup> of wash load reaching the diversion weir consists only of fine particles, of which an annual average of 399,000 m<sup>3</sup> is discharged through the flood bypass tunnel that has a discharge capacity of 300 m<sup>3</sup>/s, an amount that corresponds to the design effluent flow of Miwa Dam. For such water utilization purposes as water level recovery and flood control, an annual average of 126,000 m<sup>3</sup> of wash load flows into the dam's reservoir over the diversion weir when floods occur. Of this, a total of 105,000 m<sup>3</sup> is planned to be discharged, of which 21,000 m<sup>3</sup> is discharged from the spillway on the dam body and 79,000 m<sup>3</sup> by the intra-reservoir sediment management facilities, which will be mentioned later in this paper. Furthermore, the 26,000 m<sup>3</sup> deposited in the reservoir is to be managed by the sediment storage capacity. (Fig. 7 – Photo 4, 5)

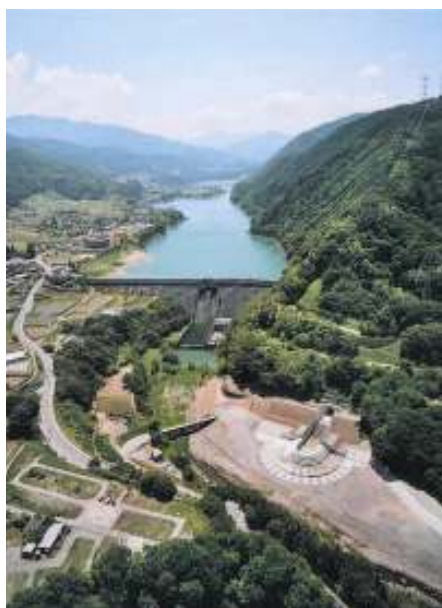
Photo 5  
Miwa Dam and Tunnel Outlet  
*Barrage de Miwa et embouchure*

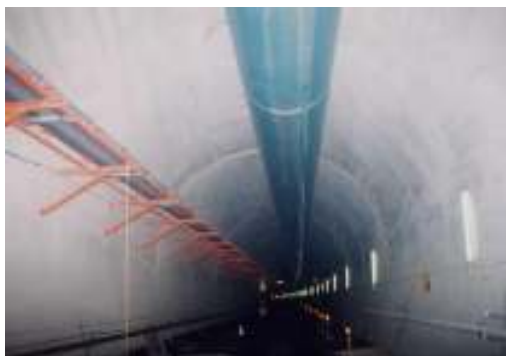
Photo 6  
Belt Conveyor (left) and  
Blower Duct (right)

The construction commenced in January 2001 and was completed in March 2005. The tunnel measuring 4,308.1 m in total length, 7 m in height, 7.8 m in width, and 47 m<sup>2</sup> in cross-sectional area was excavated by NATM. From the standpoint of improved working environment, reduced construction period, and enhanced safety conditions, following the VE suggestion provided at the project bid, the excavated material was carried out with a continuous belt conveyor system in stead of the original idea of using dump trucks for transporting the material. This method resulted in higher efficiency and cost reduction. (Photo 6, 7)

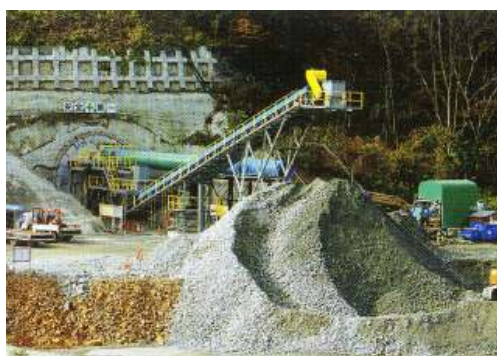
Photo 7  
Removal of Excavated Material  
*Gravats issues des fouilles*

The excavated material carried out from the tunnel was about 280,000 m<sup>3</sup>, which was effectively utilized for public construction works (road embankment, land formation materials) of neighboring local municipalities, again reducing the involved cost.

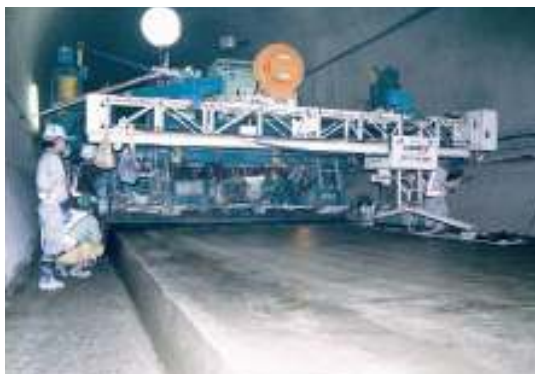
Photo 8  
Construction by Slipform  
*La méthode de bétonnage  
"coffrage glissant"*

For concrete casting of the tunnel floor, in place of conventional pump casting, a slipform system was adopted. This system paved the tunnel with a unit of machines that continuously conducts supply, spreading, compaction, forming, and surface finishing of concrete with higher cement content, which resulted in improved workability and reduction in construction period. (Photo 8)

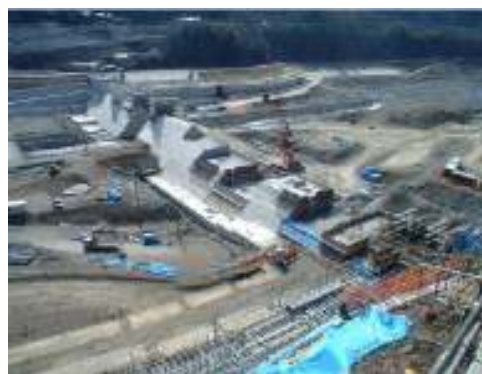
Photo 9  
Construction of Concrete  
Diversion Weir  
*Seuil de dérivation en béton en cours  
de construction*

The construction of the diversion weir was commenced in October 2001 and completed in March 2005. About 53,700 m<sup>3</sup> of concrete was cast for the weir body, and about 18,500 m<sup>3</sup> of concrete was used for the bypass conduit that leads flood water to the bypass tunnel. Fishways were provided on the right and left side as an environmentally friendly measure for the river fish. (Photo 9)

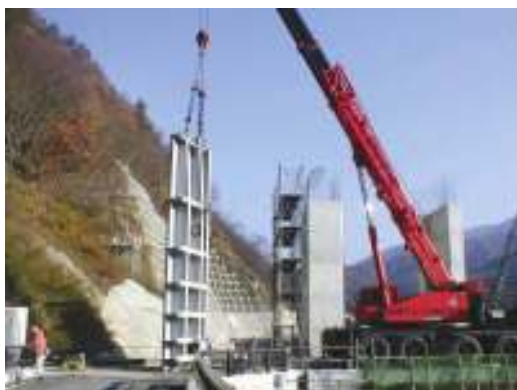
Photo 10

Installation of Main Gate Door with Crane  
*Installation de la porte principale*

The gate construction was commenced in September 2004 and completed in March 2005. The main gate door divided into 2 blocks and the sub gate door divided into 3 blocks were delivered from the production plant, craned and placed to the specified position, and welded. With regard to the gate opening and closing, bending rack was adopted for the main gates, and motor wire rope winch for the gate from the standpoint of reliability, maintainability, safety, and cost reduction. (Photo 10)

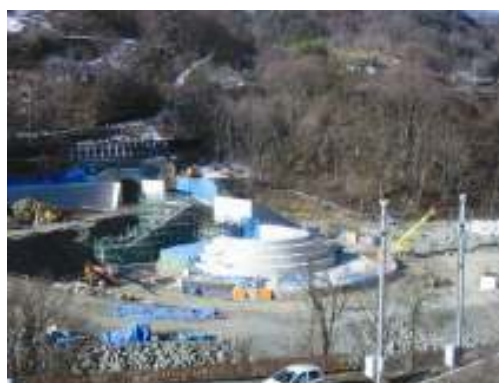
Photo 11

Construction of Tunnel Outlet  
*Embouchure en cours de travaux*

The construction of bypass tunnel outlet involved earthwork volume of 44,800 m<sup>3</sup>, cast concrete of 8,200 m<sup>3</sup>, and revetment work for 170 m, and was completed in May 2005. The shape and functions of energy dissipaters were designed on the basis of the simulation model of "secondary dam hydraulic jump type energy dissipater" for hydraulic and model testing conducted by the Public Works Research Institute from 1990 to 1992. This method involves energy dissipation of the bypassed water with the apron steps inside the training wall and

the secondary dam at the bottom. The water then flows over the secondary dam's sides and the semi-circular-shaped sill to be discharged into Mibu River.(Photo11)

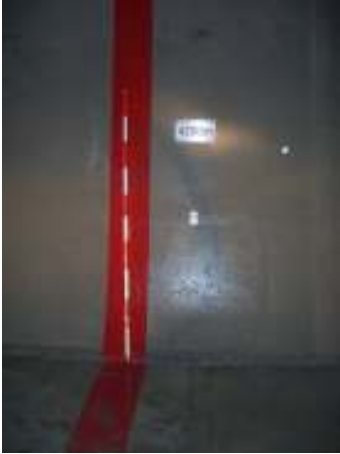
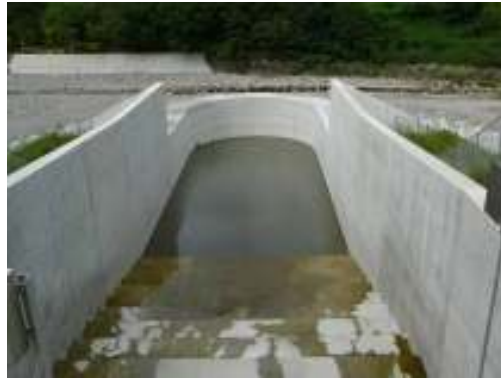
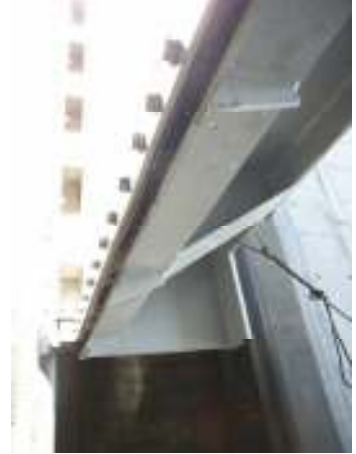
Photo 11

Status Inside Mibu River Bypass  
(Shortly after discharge on July 20)  
*Intérieur de la dérivation de la rivière  
Mibu (le 20 juillet immédiatement  
après la fin du flux)*

Status of Mibu River Bypass Tunnel Outlet  
(On August 17, one month after discharge)  
*Sortie de la dérivation de la rivière Mibu  
(le 17 août environ un mois après le flux)*

Status of Bypass Main Gate  
(On August 20, one month  
after discharge)  
*Porte principale de la  
dérivation (le 20 août  
environ un mois après le flux)*

Inside Tunnel, Energy Dissipater, and Main Gate  
*Intérieur du tunnel, bloc de réduction d'énergie, porte principale*

After the test discharge, no deformation or displacement in the tunnel's lining or outlet as well as in Mibu Weir was observed. No signs of wear were found in the gate as well, and these results confirmed the tunnel's soundness.
