COMMISSION INTERNATIONALE  
DES GRANDS BARRAGES

-----  
VINGT-CINQUIÈME CONGRÈS  
DES GRANDS BARRAGES  
*Stavanger, Juin 2015*  
-----

**FLOOD CONTROL FOR TYPHOON 18 AT THE YODO RIVER SYSTEM IN  
2013 - AVOIDANCE OF CATASTROPHE  
THROUGH COORDINATED OPERATION OF 7 DAMS (\*)**

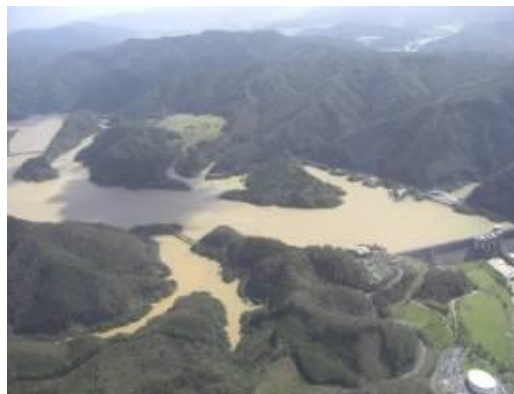
Fig. 1

Hiyoshi dam utilizing its full capacity

At this time, the Hiyoshi dam upstream was utilizing its dam capacity to the fullest and was storing floodwater to implement flood control (disaster prevention operations). Additionally, if the water level is high were the 3 rivers, the Katsura river, Uji river, and Kizu river merge at the overflow location, it will be affected in making flow difficult, and even at the Uji river, the Seta river barrage was completely closed and the Amagase dam was undertaking flood control and additionally, the dam group upstream of Kizu river (Takayama dam, Murou dam, Shorenji dam, Nunome dam and Hinachi dam) were also coordinating to lower the water level at this confluence point of the 3 rivers. (Fig. 1, Fig. 2)

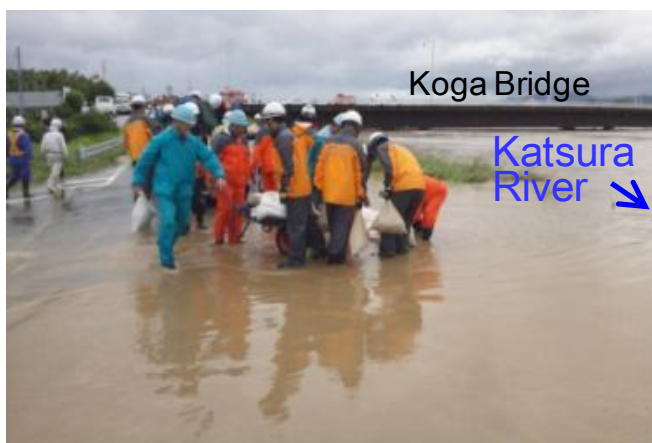
Fig. 3  
Flood control activities by flood fighting corps  
*Actions de lutte contre les inondations par les brigades de lutte*

Because it was possible to utilize all the facilities in Yodo river system to full capacity for flood control, the overflow downstream of the Katsura river was held to a level where stacked sandbags were able to avoid the worst case of collapse of embankment. (Fig. 3)

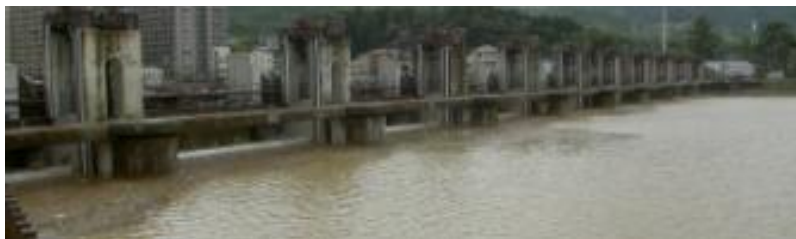
Fig. 7

Seta river barrage fully closed for the first time in 41 years  
*Première fermeture complète du déversoir de la Seta-Gawa en 41 ans*

As a result, the Amagase dam retained approximately 8,700,000 m<sup>3</sup> during the flood and the reservoir water level reached 78.18m that is approximately 30 cm beneath the s.w.l. of 78.50 m, designed highest level but was able to lower the water level of the Uji river and the point where the 3 rivers merge. (Fig. 7, Fig. 8)

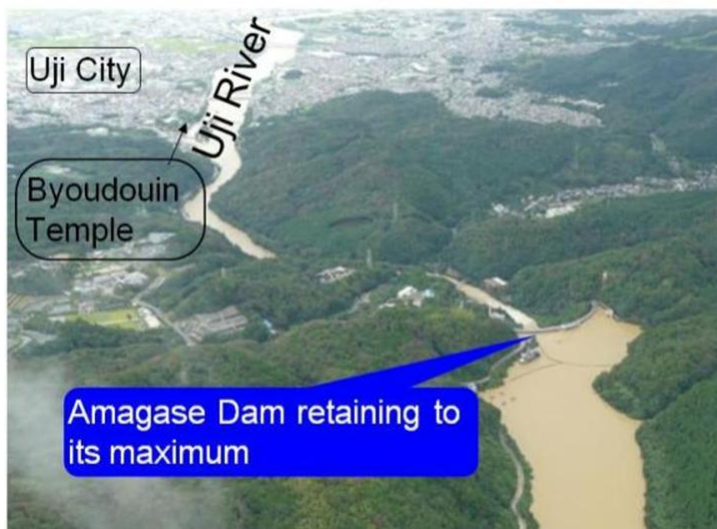
Amagase dam retaining to its maximum  
*Remplissage total du barrage d'Amagase*

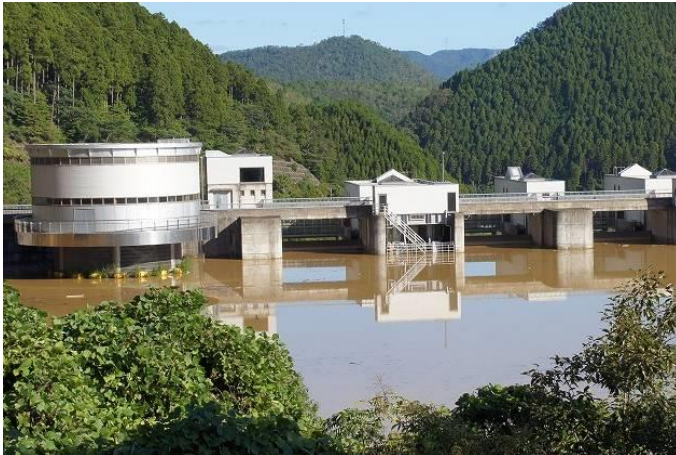
Fig. 9  
Hiyoshi dam utilized at full capacity  
*Utilisation maximale de la capacité de rétention du barrage d'Hiyoshi*

After this, confirming that the water level at Kameoka Hozu bridge point and Arashiyama point at the downstream of the dam had subsided, discharge was increased through emergency flood disaster prevention operations (Fig. 9, Fig. 10).

As a result, Hiyoshi dam retained approximately 44,600,000 m<sup>3</sup> of water in the dam reservoir until water level rose to El. 201.87 m exceeding the s.w.l., however, it is estimated that the water level of the Katsura river was lowered and enabled the lowering of the water level at the three rivers merging point.

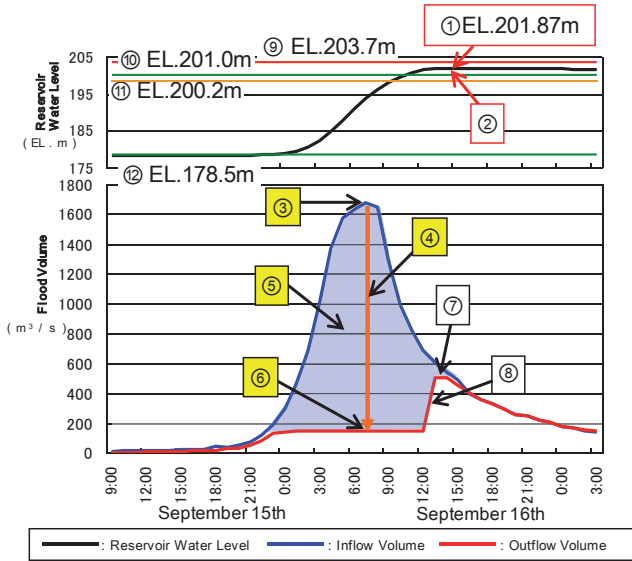
Fig. 10  
 Hiyoshi dam flood control diagram  
 Graphique de régulation de la crue du barrage d'Hiyoshi

However, since Katsura river downstream was in a dangerous state, prescribed flood control operations were maintained and about 90% of the maximum inflow volume (approximately 1,540 m<sup>3</sup>/s) was stored in the reservoir by special operations of delaying the start of ego as long as possible and flood waters was retained exceeding the s.w.l. of El. 201.0 m.

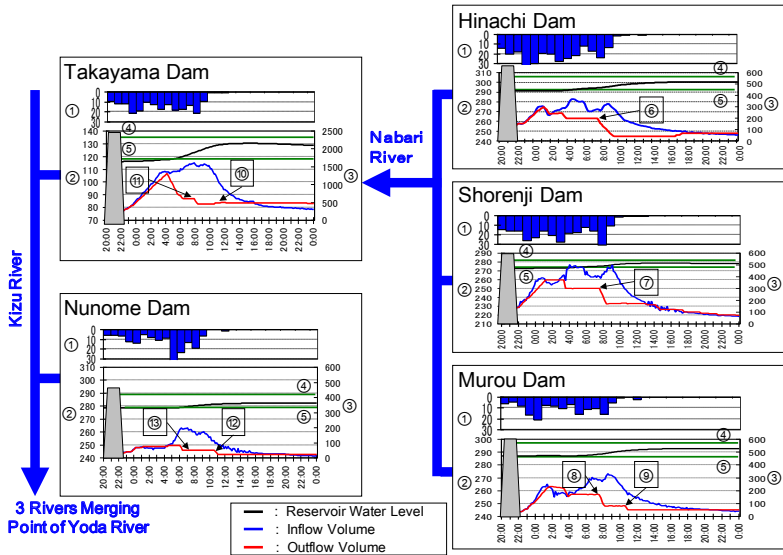
Fig. 11  
 Coordinated operations of Kizu river upstream dam group  
 Graphiques donnant l'augmentation du volume d'eau retenu par les 5 barrages de la rivière Kizu-Gawa

It was decided the 5 dams could be operated to increase their retention volume because accumulated rainfall in Kuzu river basin was smaller than it of the Katsura river and the Uji river basin, 5 dams carried out coordinated operation for lowering the water level where the 3 rivers merged as much as possible with monitoring and checking the residual volume for flood control in dam reservoirs. (Fig. 11)

During this operation, the Murou dam, Shorenji dam and Hinachi dam carried out operation of reducing discharge volume to lower the water level of downstream for increasing residual volume for flood control in the Takayama dam reservoir. By this operation, the Takayama dam also carried out operation of reducing discharge volume.

As a result, the 3 Nabari river dams retained 14,900,000 m<sup>3</sup> in the reservoirs, the Takayama dam stored a maximum of approximately 70% (approximately 1,130 m<sup>3</sup>/s) of the maximum inflow of 1,600 m<sup>3</sup>/s of the flood, and retained 23,700,000 m<sup>3</sup> in the reservoir and the Nunome dam stored a maximum of approximately 70% (approximately 150 m<sup>3</sup>/s) of the maximum inflow volume of 200 m<sup>3</sup>/s, and retained 2,700,000 m<sup>3</sup> in the reservoir. Retaining volume of total of the 5 dams was 3.4 times of prescribed flood control operations, it led to lower the water level of downstream of the 5 dams and the point where the 3 rivers merge.

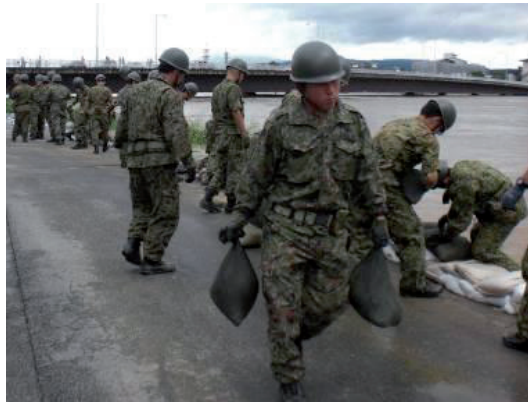
Fig. 12

Flood control activities of the self defense force  
*Activités de lutte contre les inondations par les forces d'autodéfense japonaises*

Near the confluent point of the Katsura river and the Kamo river, for approximately a maximum of 400m long and about a water depth of 10-20 cm, overflow was caused at the embankment, however through the diligent activities of flood fighting corps and the self defense force, sandbags were stacked and the worst case scenario of embankment collapse was prevented. (Fig. 12)
