MANAGEMENT OF THE RIVER ENVIRONMENT PRESERVATION AT HITOKURA DAM RESERVOIR

ABSTRACT

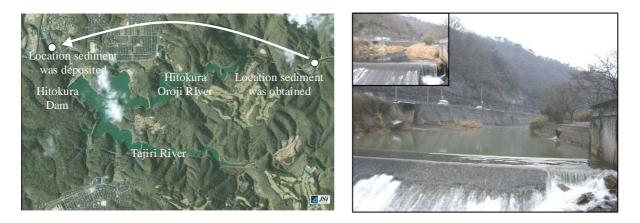
Photo 2. Excavation and Removal of Sediment at the Old Weir at the Upstream End of the Reservoir (Hitokura Oroji River) (left: location map, right: view of weir)

In 2006 and 2007, sediment accumulated at an old weir at the upstream end of the dam reservoir was used in flashing discharge performed. It was found that at the old weir, deposition of sediment and flourishing growth of land vegetation had divided the river bank forests from the surface of water, and separated the habitat of insects used as feed by fish from the water's edge. So the common reeds etc. flourishing along the waterside and the land vegetation along the river were dug up and removed to improve river environment upstream

of the dam. This measure improved river environment, river bank forest, and waterside at the same time as the large diameter stones that appeared during the excavation were piled up directly downstream of the left bank of the weir in order to secure a route for the movement of fish and benthos upstream of the weir (Photo 2).

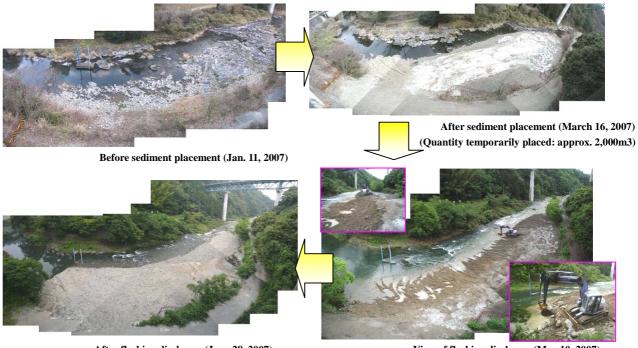
After flashing discharge (June 28, 2007)

View of flashing discharge (May 10, 2007)

Photo 3. View of Flashing Discharge in 2007

And since 2006, heavy equipment has been used during flashing discharge to forcefully agitate and cast the temporarily placed sediment, in order to ensure more efficient sediment bed load transport even small flow (Photo 3).

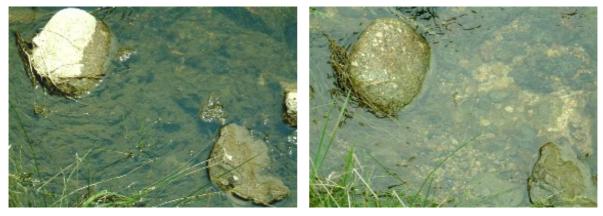
Photo 4. State of Algae Bed Load Transport Before and After Flashing Discharge (Before discharge (left): June 7, 2003, After Discharge (right); June 10, 2003))

Photo 4 and photo 5 show conditions of downstream of the dam before and after flashing discharge in June 2003 and in May 2007 respectively. It shows that the bed load transport effects have been found at locations where algae etc. are floating at normal time and algae has flourished for long time, and it was found that the transported bed load accumulated downstream.

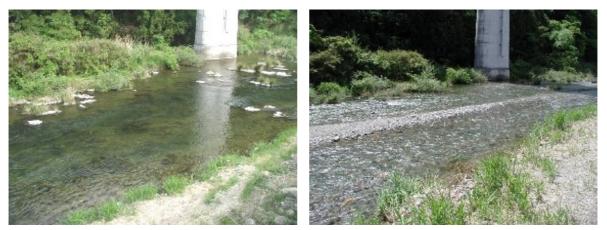
Photo 5. State of Downstream Riverbed Before and After Flashing Discharge (Before Discharge (left): May 9, 2007, After Discharge (right); May 11, 2007))

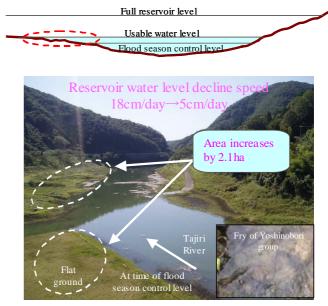
Fig. 5. Effects of Creating a Spawning Bed Inside the Reservoir

Fig. 4 shows flow during the flexible management trial at Uneno district that is between the dam and the confluence point with the main course of Ina River. This reveals that it was possible to constantly ensure necessary flow for fish at the Uneno district during the trial. According to period the trial of flexible operation based on the limited water level method carried out in 2006, it has confirmed that reducing reservoir water level reduction rate from 18cm/day to 5cm/day by July 15 has formed approximately 2.1ha of new spawning beds on the reservoir slopes that have a shoal topography in the Kunisaki district upstream from the reservoir, and that there are many kinds of fish including freshwater goby (Fig. 5).

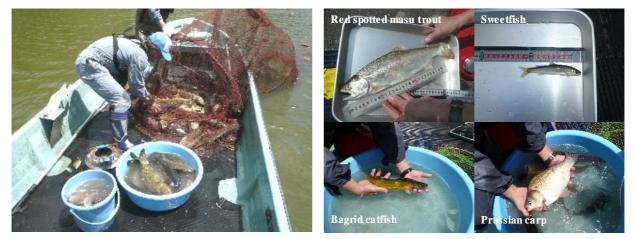
Photo 6. Views of Catching Fish and Measuring Native Species

The fish capture survey by using fixed nets which can utilize water level change was performed by installing a number of tunnel nets linked by wing nets near the upstream end of the reservoir to completely enclose the shallows upstream in the crossing direction. And then by the reservoir water level lowering a huge numbers of fish that have traveled downstream are holed and captured (Fig. 7). This method sharply minimized the impact of the fishing skills of surveyors, and at the same time it reduced damage to fish species by gill nets that severely damage fish, so that almost all captured fishes could be released (Photo 6).

Each of the captured fish was measured and weighed, then the native species were released and exotic species such as the largemouth bass, bluegill, and others were killed and disposed of. These measures have continued since 2005, and the result of the fish survey of 2007 (National Census on River Environment) has confirmed that the percentage of exotic fish has fallen to about 4%, and the recovery tendency of the native species was indicated.

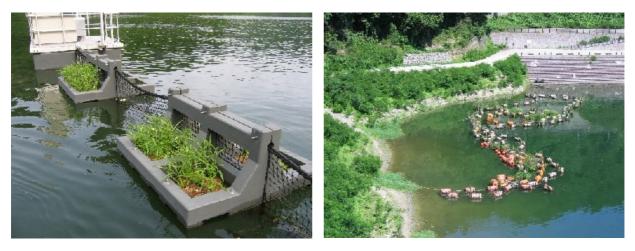
Photo 8. Vegetated Floating Island Type Boom and Floating Island Reusing an Old Boom

As the measure of other environmental preservation, the dam administrator is planning to cultivate vegetation using vegetated floating island type booms reconstructed in 2006. This project planned for future is the creation of habitat space for fish and other living organisms on floating islands as a measure to prevent eutrophication of the reservoir and to reuse old booms (Photo 8).
