**INTERNATIONAL COMMISSION ON LARGE DAMS**  
**76<sup>th</sup> ANNUAL MEETING**  
**SOFIA, BULGARIA, JUNE 2-6, 2008**  
**Symposium: “Operation, Rehabilitation and Up-grading of Dams”**

**A CLEAR WATER BYPASS PIPELINE SYSTEM MITIGATES TURBID  
WATER DISCHARGE FROM A DAM**

**Jun Kashiwagi<sup>1</sup>, Osamu Arino<sup>2</sup>**

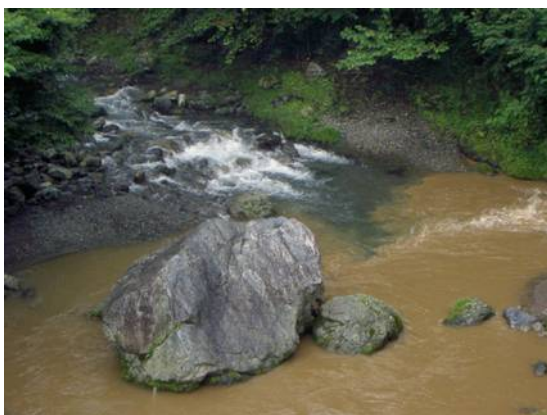
Fig.2 Turbid Inflow

The dam was completed in 1999 and soon experienced high turbidity of inflow due to intense rainfall from typhoons. Most of the entire catchment area was steep forested slopes, some poorly maintained, and heavy rain resulted in severe soil erosion.

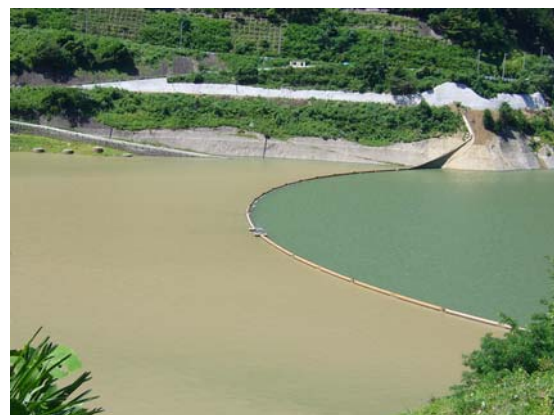
Fig.3 Floating Turbidity Curtain

Before the dam construction, the inflow of turbid water was thought to be manageable with a floating turbidity curtain and an intake tower with depth-selective withdrawal. However, the recession of forestry resulted in poor forest maintenance and unexpected inflow levels of highly turbid water. In addition, an increase in wildlife population damaged the forest and the ground surface.

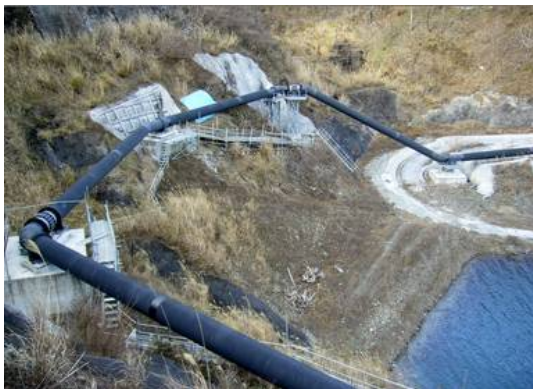
The most suitable type of pipe for each section was selected from steel pipe, fiber-reinforced plastic mortar pipe (FRPM) and polyethylene pipe. This was the first project in Japan to use polyethylene pipe in suspension as a permanent structure. The suspended section is fixed to the ground only at the ends. The material is flexible enough to follow changes in water level, and the middle of the suspended section stays 2 meters beneath the water surface to allow boats and flotsam to pass it over. Also, rotation joints adjacent to the fixed end points allow the pipe to swing up and down, avoiding internal stress in the pipe. We are sure that the suspended pipeline is a breakthrough as a way for a pipeline to cross water area at low cost.

Fig.7 Steel Pipe Section (1)

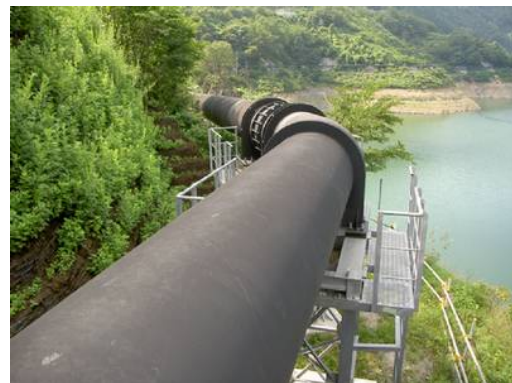
Fig.8 Steel Pipe Section (2)

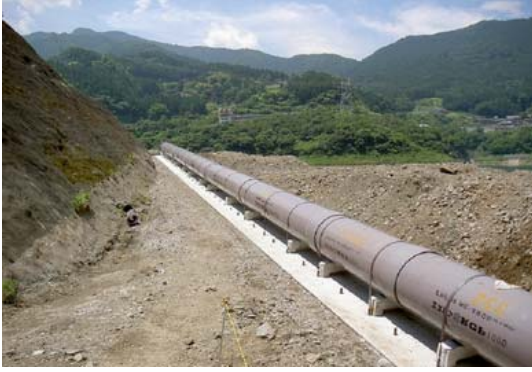
Fig.9 FRPM Pipe Section (1)  
(Under Construction)

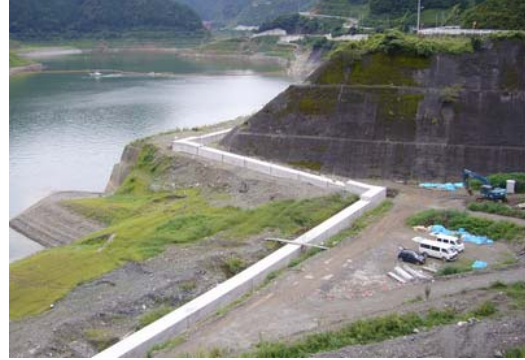
Fig.10 FRPM Pipe Section (2)  
(Completed with Concrete Cover)

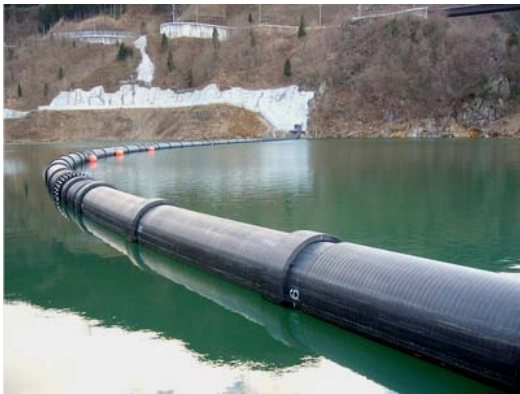
Fig.11 Suspended Pipe Section (1)  
(Before Submerging)

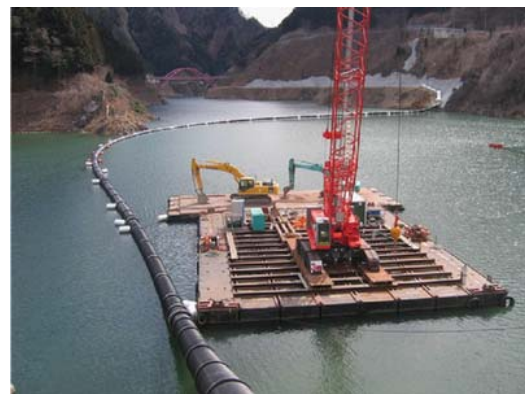
Fig.12 Suspended Pipe Section (2)  
(Construction Work)

We carried out the construction of the bypass system in harmony with the operation of the dam, getting consensus approval from all the organizations concerned. More than half of the pipeline route was inaccessible from existing roads. We transported materials such as pipes with a tug boat and pontoons and placed or assembled them with cranes fixed on the pontoons, controlling the reservoir water level so as to make the work possible.

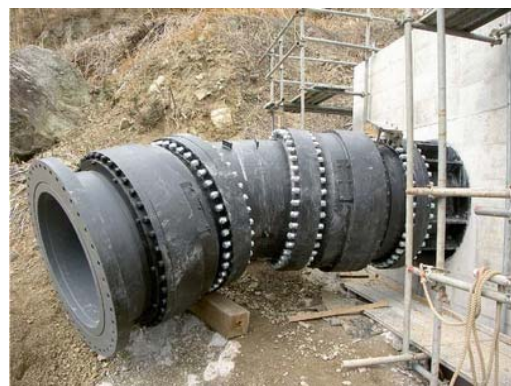
Fig.14 Suspended Pipe Section (4)  
(Rotation Joint)

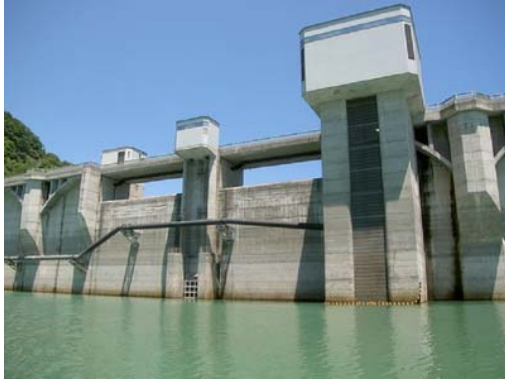
The outlet was located in a selective intake tower in the reservoir. The tower had been originally equipped with gates that allowed the separation of the water inside from reservoir water. Water from the bypass pipeline is poured directly into the inside of the tower, without mixing with turbid reservoir water.

Fig.15 Outlet (1)  
(Intake Tower)

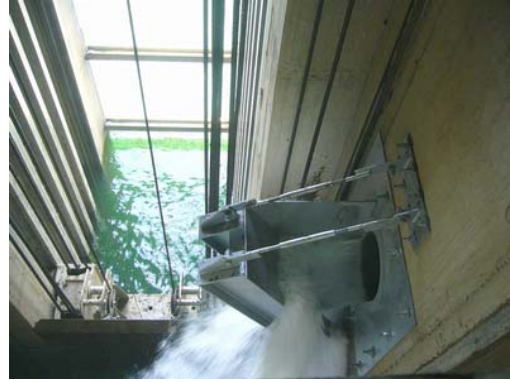
Fig.16 Outlet (2)  
(Inside the Intake Tower)

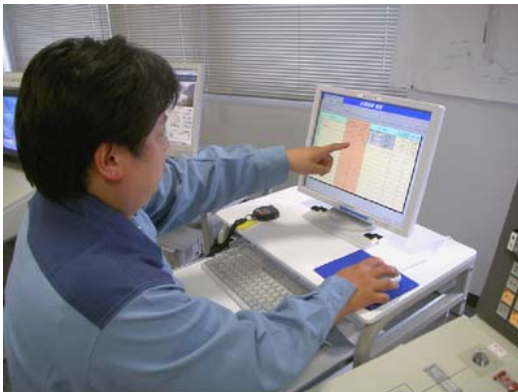
The outlet is equipped with a regulating valve. To ensure safe operation and to save human resources, the flow is remotely controlled from the operation room of the project office. Fundamental live data such as turbidity at the intake is periodically collected through a data telemetry system. Furthermore, the accumulated data can be checked on the Internet.

Fig.17 Remote Control System  
(Operation Room)

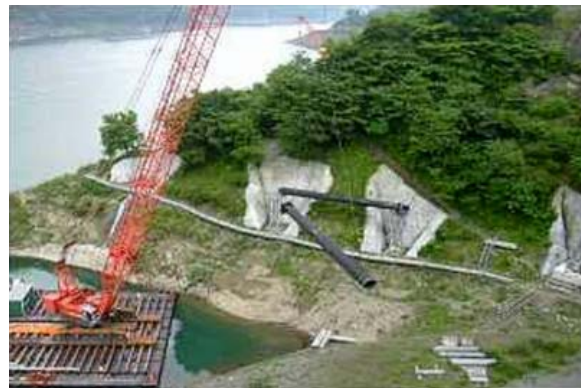
Fig.18 Construction Work  
(A Crane on the Pontoon)

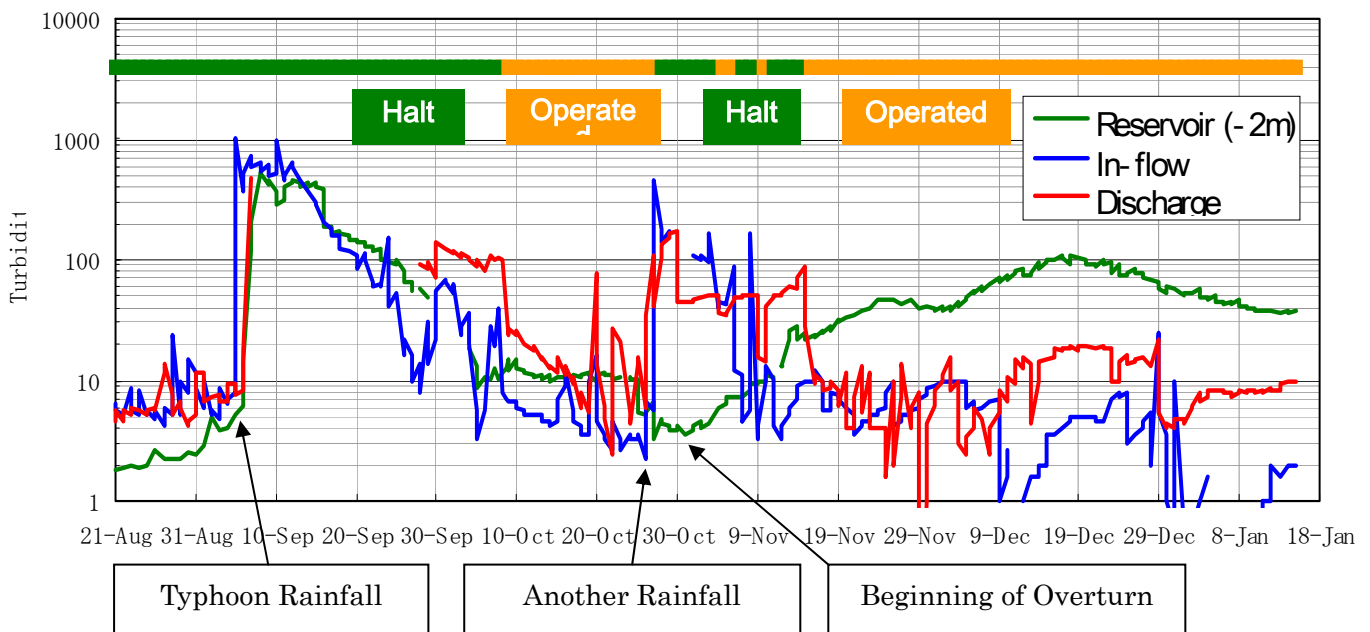
Fig.19 Inflow, Reservoir and Discharge Turbidity (NTU)

The bypass system was completed in March 2007 and the opportunity for practical operation soon arrived. In September 2007, the dam was hit by a huge typhoon that brought 583 mm of rain in only 64 hours. Inflow turbidity measured over 1000 NTU at the maximum. As a result, the turbidity of the reservoir rose to 538 NTU at the surface (-2 m depth) and discharge turbidity exceeded acceptable levels downstream.

The bypass system began to operate on October 8th, after the turbidity of the inflow fell sufficiently and sediment in the intake basin was removed. Then we turned operation on and off because another rainfall raised the turbidity of the inflow.

It took about a week to completely replace the turbid water in the intake tower and discharge pipe with a clean flow from the bypass system. After that, the discharge water showed low turbidity. The operation demonstrated the functionality of the clear water bypass pipeline system and the appropriateness of its design.

A month after the start of bypass operation, the autumn overturn of the reservoir began as the air temperature declined. This lifted suspended particles, which had gradually been settling in accordance with Stokes' Law, making the turbidity almost uniform from the bottom to the surface. Even after the overturn, the turbidity of discharged water was less than 20 NTU, while that of reservoir water was as much as 110 NTU.

Acceptable turbidity for the tap water purification plant and the industrial water purification plant downstream of the dam is 20 NTU. From the viewpoint of avoiding interference with purification processes or water use, it can be said that the clear water bypass pipeline worked successfully.

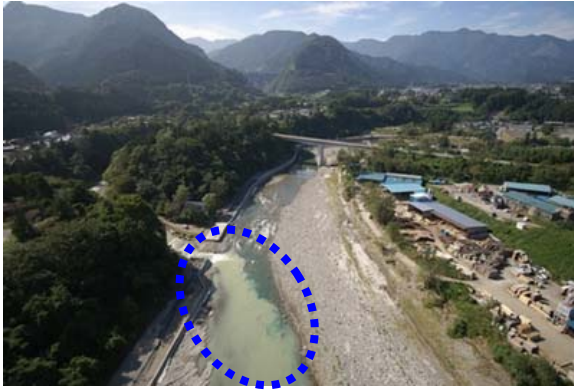
Fig.20 Before Operation (28 Sep. 07)  
(Turbid Water Flows into the Main River)

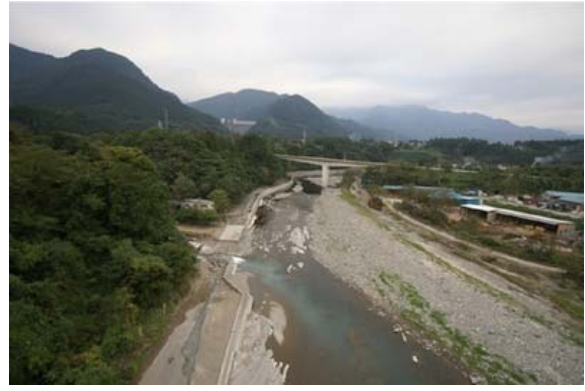
Fig.21 During Operation (11 Oct. 07)  
(Low Turbidity)

The turbidity of discharged water was dramatically reduced by operation of the clear water bypass pipeline system. It can be said that this system is effective when turbidity in the downstream river is increased by dam operation. In the case of the Urayama Dam, the construction cost of the bypass pipeline system was only 1.6 percent of that of the dam itself.
