<p>COMMISSION INTERNATIONALE DES GRANDS BARRAGES ----- LA 78^{EME} CONGRES DES GRANDS BARRAGES <i>Hanoi-Vietnam, may 2010</i></p>	
---	--

**REDEVELOPMENT OF THE HONGOUCHI-TEIBU DAM AS PART OF THE
NAGASAKI EMERGENCY FLOOD DAM PROJECT**

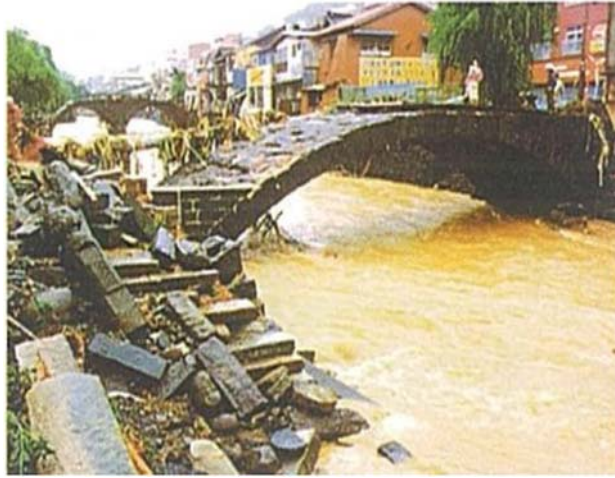
Photo 1

Flood Damage on the Nakashima River

Dégâts provoqués par les crues de la rivière Nakashima

On July 23, 1982, moist air flowed in from the southern seas along the stationary seasonal rain front, triggering intensive rainfall which dropped more than 300 mm of rain in three hours, mainly in Nagasaki City. The accumulated rainfall from the beginning to the end reached 572 mm. This unprecedented torrential rainfall caused the Nakashima River, Urakami River, and almost all other rivers flowing through the urban district of Nagasaki City (Photo 1) to overflow their banks, triggering scattered landslides and debris flow throughout the region. This torrential rain claimed 257 lives, submerged 25,680 buildings, and caused damage costing 211.9 billion yen, just in Nagasaki City. The Nakashima River and other rivers flowing through the city center are surrounded by urbanized neighborhoods, and in addition, are crossed by a group of stone bridges including the Megane Bridge, which is an important culture property. Therefore, it would be difficult to improve this river through large-scale course expansion. The approach proposed as a result was adding flood control functions to the water supply dams constructed in the Meiji Period.

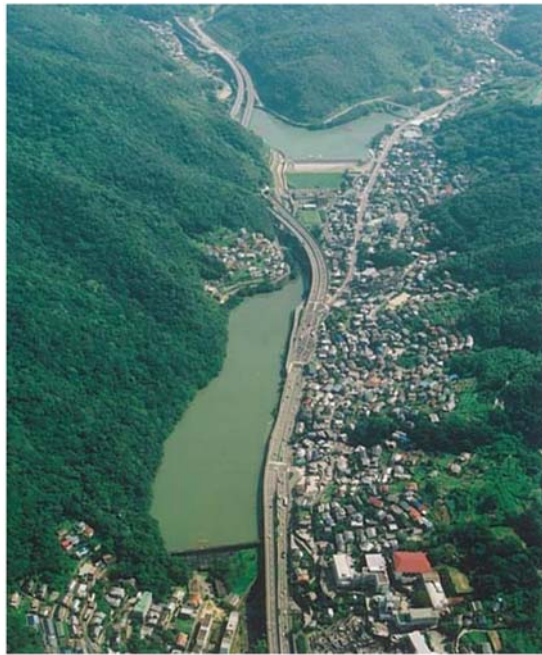
Photo 2
Hongouchi-kobu and -teibu Dam
Barrages de Hongouchi-Kobu (Partie haute) et de Hongouchi-Teibu (Partie basse)

The Hongouchi-teibu Dam is also an historically valuable dam which the Japan Society of Civil Engineers has designated as a modern civil-engineering legacy (Photo 2, Photo 3). Documents concerning the design and execution of this dam were almost entirely destroyed by bombing during World War II, so only a few remain. Boring has revealed that the dam body was covered with wedge-shaped blocks on its upstream side and concrete blocks on its downstream side, and that its interior was constructed with rubble concrete. No foundation grouting was executed. The maintenance bridge executed on the spillway is valuable as Japan's first reinforced concrete structure (Photo 4). A porous water intake system protruded in semi-cylindrical shape at the center of the upstream side of the dam body, and a bottom sluiceway passing through the dam body from its base was installed to introduce water through a pipeline. Through the process of this work, it was clarified that the intake use steel pipes and valves used were made in U.K. (Photo 5).

And as shown by Photo 2, in the area where urbanization had advanced around the dam site, private homes are concentrated close to the dam, so during the work, it has been necessary to pay close attention to noise, vibration, and dust, and at the same time, to execute the work under a restriction limiting the time execution is permitted to the period ending at 5:00 p.m.

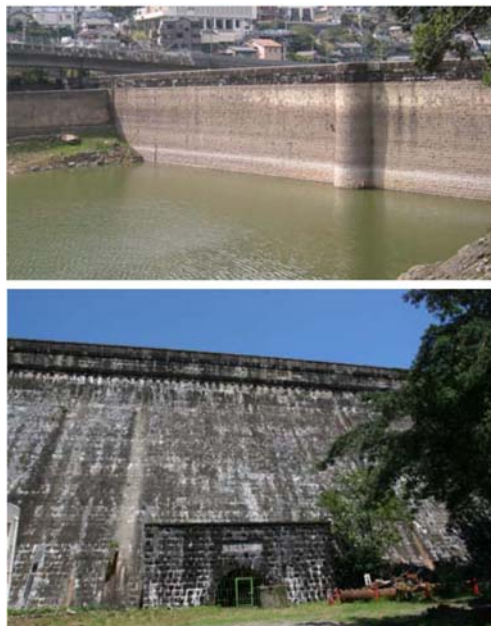
Photo 3
Upstream and Downstream Surface of the Hongouchi-teibu Dam
Surfaces en amont et en aval du Barrage de Hongouchi-Teibu (Partie basse)

The upstream side of the existing dam body is, as shown in Photo 3, covered with wedge-shaped stones, and the plan calls for a new dam body to be poured while leaving these in place. Wedge-shaped blocks are, as shown in Photo 6, about 30 cm on each side and with an extra 60 cm. The adhesive strength of the concrete poured on this surface was confirmed by performing direct tensile testing using a specimen made by applying concrete with the same blend as the newly constructed dam body on the wedge shaped stone obtained in cores taken from the existing dam body (Fig. 5). The results obtained adhesion strength of 0.32 N/mm² or more as shown in Table 2, so predicting a safety factor of 4, the adhesion strength was evaluated as 0.08 N/mm² or more.

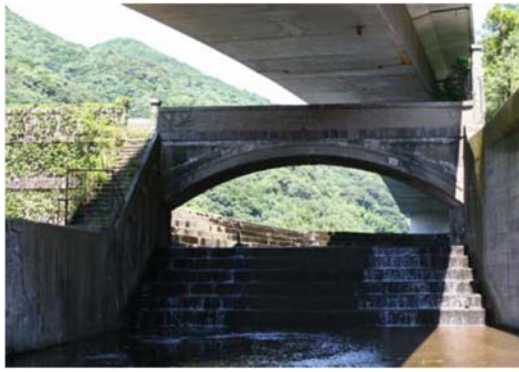
Photo 4

Maintenance Bridge of the Spillway (Japan's first RC bridge, 1903)
*Pont dédié à l'entretien de l'évacuateur de crues
(Premier pont RC construit au Japon en 1903)*

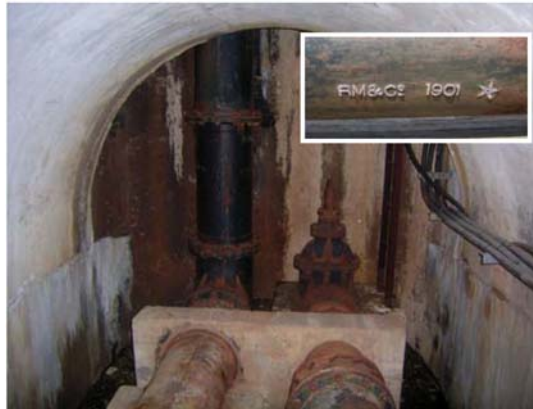
Photo 5

Water Intake Pipe (Made in U.K., 1901)
Canalisation d'entrée/admission d'eau (Fabriquée au Royaume-Uni en 1901)

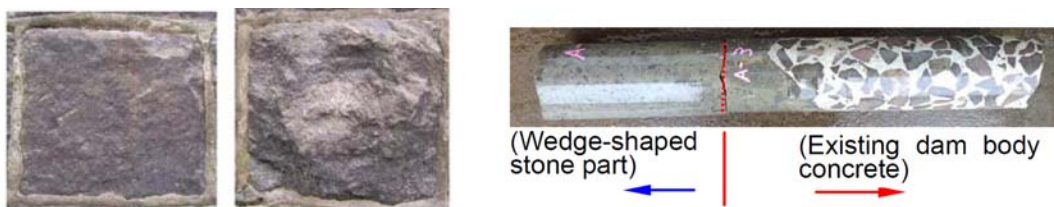
Photo 6

Surface of Wedge-shaped Block from Upstream Side of Existing Dam Body and Core Taken from Dam Body

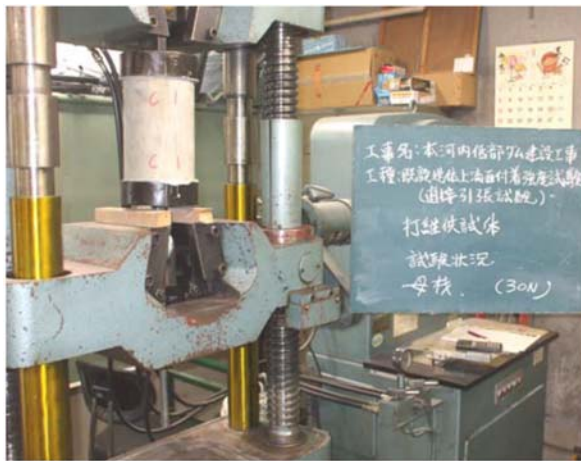
Fig. 5
Adhesion Strength Test (Direct Tensile Test)
Essai d'adhérence (Essai de traction directe)

| (1) Newly poured concrete | (1) <i>Nouveau béton coulé</i> |
| (2) Mortar | (2) <i>Mortier</i> |
| (3) Existing dam body | (3) <i>Corps du barrage existant</i> |

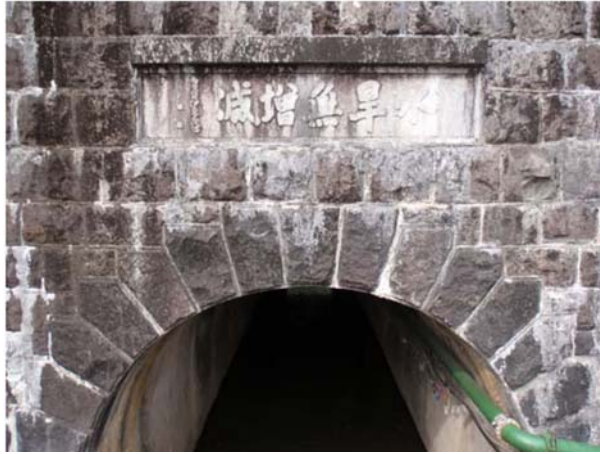
Photo 7

Plate on Downstream Surface of the Dam Body
Plaque apposée sur la surface en aval du corps du barrage
