<p>COMMISSION INTERNATIONALE DES GRANDS BARRAGES</p> <p>-----</p> <p>LA 78^{EME} CONGRES DES GRANDS BARRAGES <i>Hanoi-Vietnam, may 2010</i></p>	
---	--

ENVIRONMENTAL IMPROVEMENT EFFECT IN DOWNSTREAM CHANNEL BY SEDIMENT SUPPLY TEST

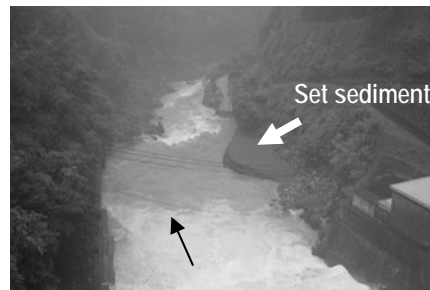
Fig. 3
Soil setting under flushing discharge (Flow at 90 m³/s)

A maximum 90 m³/s of discharge was planned in the test. The first test was performed in July 18 2008 when high inflow occurred. In the test, as in Fig. 3, 1.5 hour of 90 m³/s discharge (around 800,000 m³ of total discharge) transported about 70% of soil setting just below the dam (13,000 m³ out of

18,000 m³). However, traction of sediment was rarely found in the Jobu Bridge downstream.

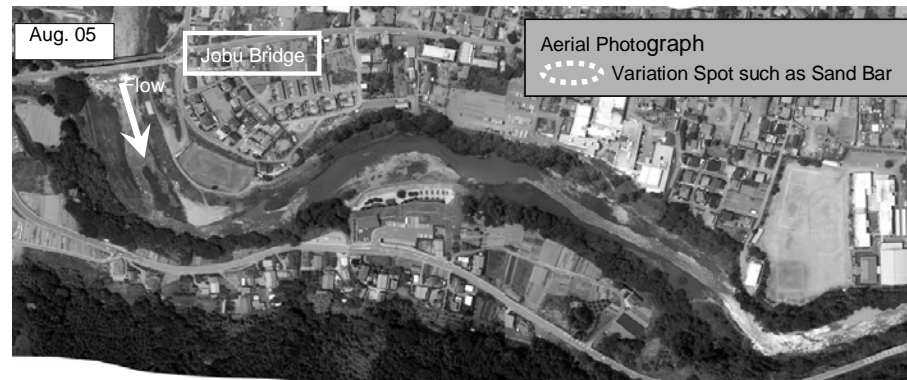
Fig. 7
Changes of planar shape in Section 2 (Jobu Bridge - Kanna River headworks)

Fig. 7 shows changes across ages in the downstream area of Jobu Bridge. There are significant signs of vegetation runoff after the severe flood in this area. Little disappearance of sand bar seems to result from sediment supply from tributary of the Sanba River even after the flood.

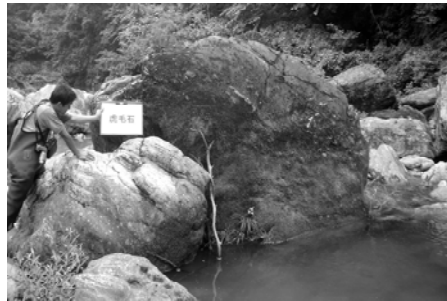
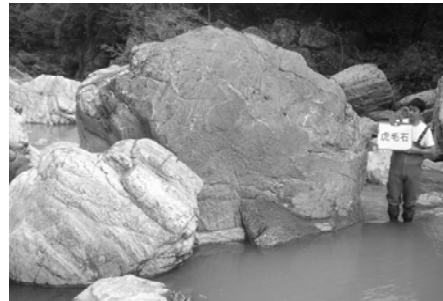
Fig. 10

Typical example of cleansing effect at Sanbaseki Gorge (Torage Stone)

As in Fig. 10, in Sanbaseki Gorge, flood caused by the typhoon produced cleansing effects from traction of sediment below the dam to confirm separation of attached algae, mosses, and vegetation. Such effects are awarded the highest rating in the sediment supply test partly because the local public comments that there have never been changes like this before the test.

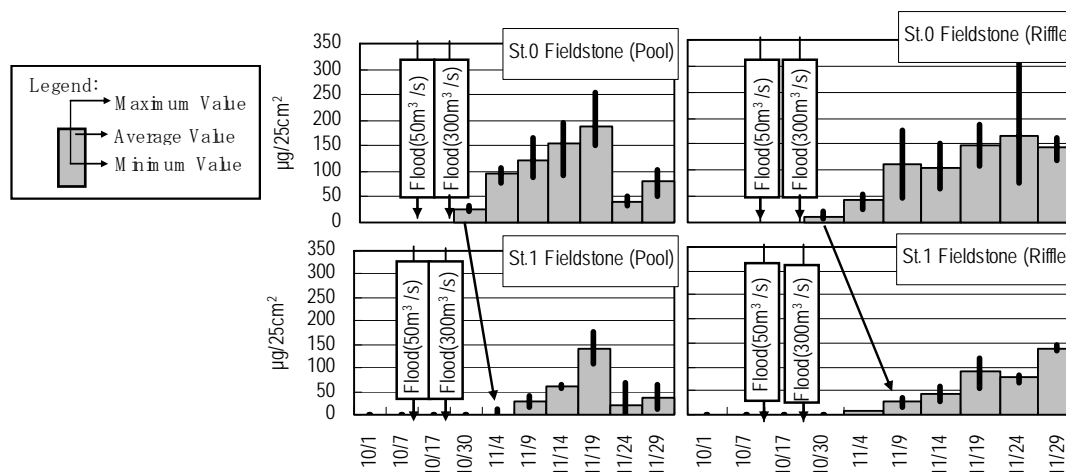
Fig. 11
Volume of "Chlorophyll-a" of attached algae at up/downstream of set sediment

Verification of level of cleansing effect from mixed sediment in flowing water was conducted. In the soil setting just below the dam, volume of 'chlorophyll a' which was attached to fieldstones in St. 0, upstream side, and St. 1, downstream side, was measured over time after the mesoscale flood. Environmental conditions of St. 0 and St. 1, adjacent to each other, could be regarded as the same except for the sites of soil setting. Fig. 11 shows the result. In addition, the reason for selection of 'chlorophyll a' as a measurement item was to exclude dead algae.

Attached algae were completely separated both in deep water and shallows at St. 0 while they were not absolutely separated at St. 1. This indicates a slower recovery speed at St. 1. Cleansing effects, resulted from mixed sediment in flowing water due to soil runoff, proved a little more effective in pools than in riffles because of high detachment effects of attached algae.

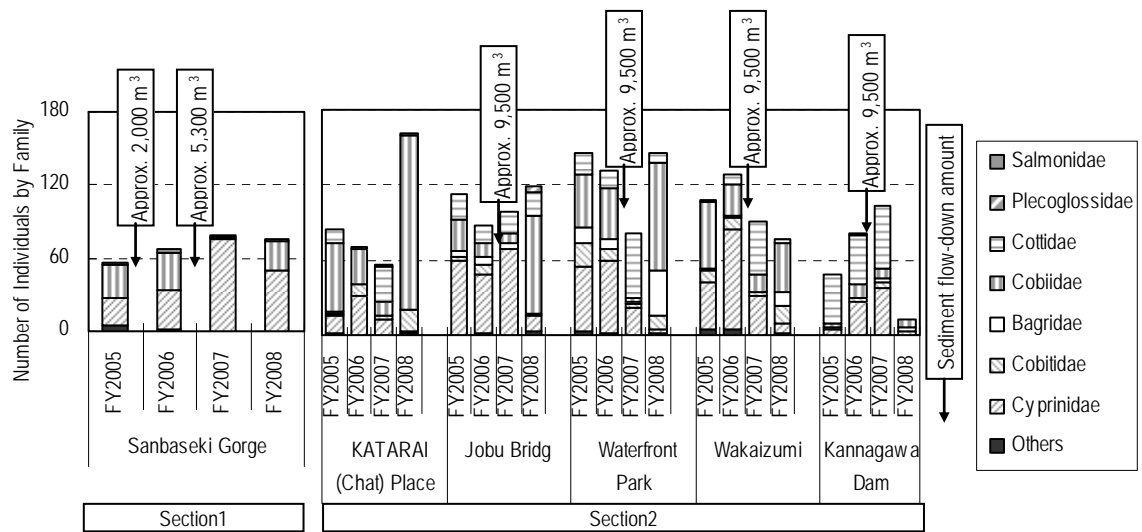
According to Fig. 15, *Tridentiger brevispinis* and *Rhinogobius* sp. OR of Family *Gobiidae* decreased only in 2007 during 2005 to 2008. The typhoon seems to carry away fishes in the river bed (benthonic fishes) at the time of survey, which was performed about 20 days after the typhoon. There were no significant changes otherwise.

Fig. 15 does not demonstrate such substantial changes in fishes even immediately after the typhoon as in Sanbaseki Gorge in 2007. In 2008, however, less *Triborodon hakonensis* and *Zacco platypus* of Cyprinidae Family and more *Rhinogobius* were seen. Apparently, the result of 2007 suggested less frequency of downstream inflow due to larger width of the river, which allowed fishes to evacuate within the river, and the result of 2008 demonstrated that replacement of bed material by the typhoon affected the habitat of fishes to reflect into the outcome of survey one year later. But, further survey is needed to specify the causes.

Fish species at Section 1 (Sanbaseki Gorge) and Section 2 (Shinsui Dam – Kanna-River headworks)
