Mitigation Measures against Low-frequency Sound Caused by Discharging Water from Amagase Dam

N. Morinaga

ABSTRACT:

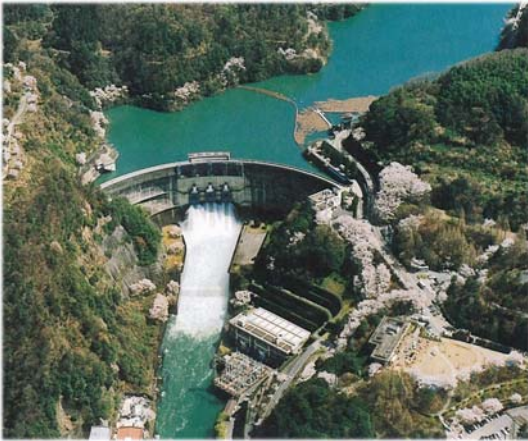
Figure 1. The whole view of Amagase Dam

Amagase Dam was completed on Uji River of Yodo River system in 1964. It is a concrete arch dam whose height is 73m. It is also known as a multi-purpose dam whose purposes are flood control, supply of city water, and generation of electricity. There is a center of the sightseeing spot, such as Byodo-in Temple and Ujigami Shrine, in Uji City at approximately 2km downstream of the dam. Neighbourhood of the dam is dotted with the residential regions. (Fig. 1)

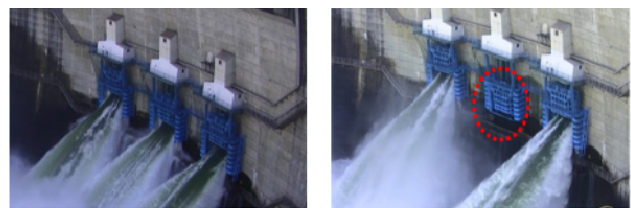
Figure 4. Examples of patterns of discharge

There are 3 main sluice gates in Amagase Dam (from the left bank side, 1st built, 2nd built, and 3rd built). Under the normal circumstances, these 3 sluice gates discharge the same amount of water. Measurements of low-frequency sound about the following patterns were conducted so that it could be verified that how the sound pressure level changes depending on the number of the sluice gates used. (Fig. 4)

- Pattern A: 3 sluice gates were used to discharge water (normally)
- Pattern B: 2 sluice gates were used to discharge water (1st built+3rd built)
- Pattern C: 2 sluice gates were used to discharge water (2nd built+3rd built)
- Pattern D: 2 sluice gates were used to discharge water (1st built+2nd built)

Pattern A
(Discharging water from 3 sluice gates)

Pattern B
(Discharging water from 2 sluice gates of 1st built and 2nd built)

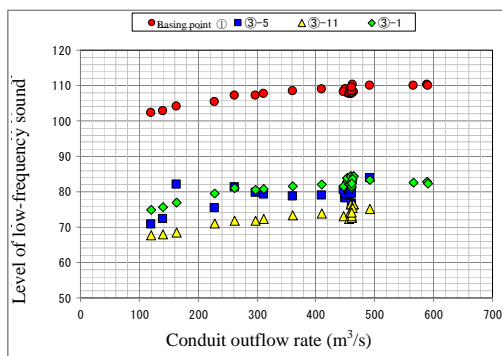
Figure 6. Relationship between discharged water volume and the level of the sound pressure (Basing point and right bank area)

Under the discharged water volume of approximately 400m³/s (total discharged water volume, including the discharged water volume with generation of electricity, is 581m³/s), the level of pressure of low-frequency sound increases as the discharged water volume increases. However, over the discharged water volume of 400m³/s, the level of pressure of low-frequency sound remains on the same level. (Figs.6 and7)

Compering it to the level of pressure of low-frequency sound at the basing point in the dam, the level of pressure of low-frequency sound in the right bank area decreases by approximately 20dB to 30dB regardless of discharged water volume. The pressure of low-frequency sound decreases by about 20dB in the left bank area as well.

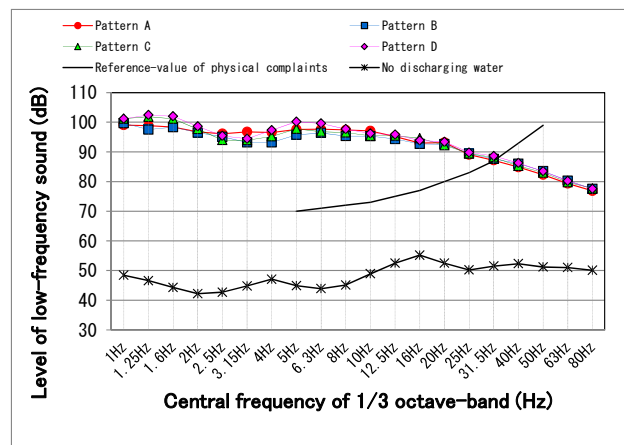
Figure 8. Relationship between frequency and the level of the sound pressure (Basing point)

The frequency at the measured spots in each area will be largely different depending on the different discharged water volume if the band frequency is less than 20Hz. If the band frequency is over 20Hz, the sound pressure level will tend to decrease. The sound pressure level between 20Hz to 80Hz is nearly equal to background noise level in the absence of water volume discharged by the main sluice gate, especially in the right bank area. Moreover, at the band of 1.25Hz, the sound pressure level is in the same range regardless the discharged water volume. (Figs8and9)

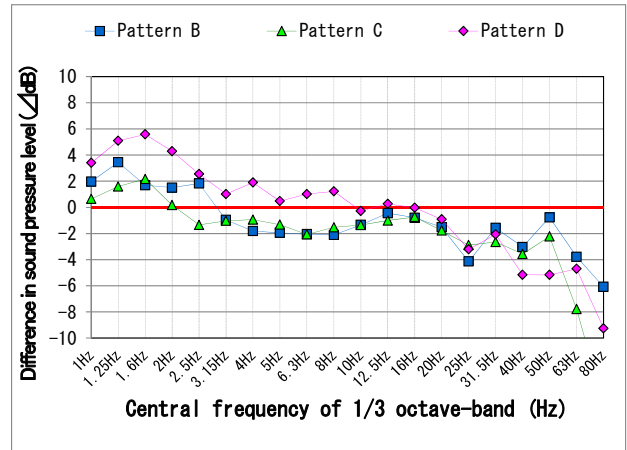
Figure 11. Relationship between patterns of discharged water and the level of the sound pressure (Right bank area)

Figure 10 to Figure 12 show the difference in the sound pressure level caused by the different pattern of discharged water by the main sluice gates, which assumes that discharging water through 3 main sluice gates is the normal pattern (Pattern A). (Difference in the sound pressure level = Pattern A – Each pattern)

In each spot, discharging water through 2 main sluice gates (Pattern B) is most likely to decrease the level of low-frequency sound. Band 3.15Hz to 8Hz, especially, tends to decrease. At the basing point, the maximum decrease of about 4 dB was observed.

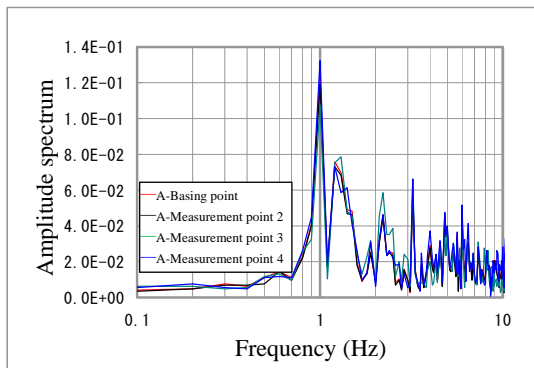
Figure 14. Results of FFT analysis

Furthermore, as the result of the FFT analysis about the measurement result of basing point, several dominant frequencies were found. Figure 14 shows the result of FFT analysis and the dominant frequencies. Higher amplitude was detected at 1Hz, 2.2Hz, 4.8Hz, and 6Hz. As Figure 15 shows, the time difference between the measured waveform in certain spots was analyzed. Table 1 shows its result. According to the result of the analysis, it was revealed that the source of low-frequency sound was probably different depending on the different frequencies. Under 1 Hz, the sound travels from multidirections, including the lower reaches or the left bank side, so it can be considered that all-round stilling basin is the source of the low-frequency sound. Also, 2.2Hz reaches the spot A-3 faster, so it can be considered that low-frequency sound is generated from resonance with the space created by the arch dam. Moreover, 4.8Hz and 6Hz is the fastest to reach the spot A-1, so it can be considered that the source of low-frequency sound is near the waterfall.

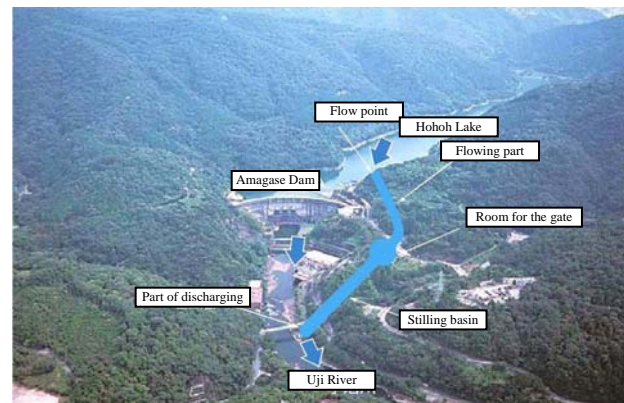
Figure 17. Plan of reinforcement of discharging systems

A new discharging system of tunnel style will be constructed in the left bank side to enhance the ability of

discharging of Amagase Dam. Redevelopment project of the dam is being gone forwarded. (Fig. 17) It is being examined whether there is possibility that the new discharging system of tunnel style generate low-frequency sound or not by conducting model experiment. The way of discharging water and reducing the flow of discharged water in the new system is different from that of current one. It is considered that low-frequency sound will be generated differently even if the new discharging system generates low-frequency sound. The affected area and distribution of the frequency will be very different. It is confirmed that generation of low-frequency sound from the main sluice gate can be mitigated under water volume of $4\text{m}^3/\text{s}$. After finishing the construction of the new tunnel discharging system, it will be possible to mitigate the generation of low-frequency sound by distributing appropriately the role of discharging water among two systems except for some occasions, such as the case of flooding that needs to be taken the full advantage of the both discharging systems
