## **Problems of Bedrock Exposure and a Trial to Recover Gravel-beds Below a Dam in Mountain Rivers**

**S. Kobayashi, M. Masumoto & J. Miwa**

*Public Works Research Institute, Tsukuba, Japan  
skoba55@pwri.go.jp*

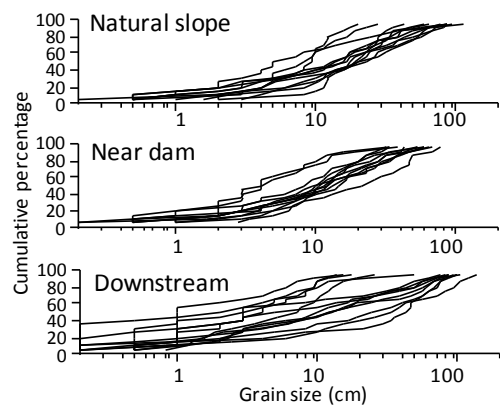
Figure 3. Cummulative grain size curve

We found that 10-40 cm materials, which are the middle size of the whole size range, were scarce in the downstream section (Kobayashi et al. 2009). Bed materials were surveyed by a random sampling of 100 materials based on line-intercept method for 38 reaches in the natural slope and near dam section, both of which were the upstream of Kurobe dam, and the downstream section. In the upstream sections, the grain size distribution was S-shaped with a most dominance of 10-40cm materials for most of the reaches, as shown in Fig. 3. In contrast, although the distribution varied among the reaches in the downstream section, the dominance of 10-40 cm materials was observed for few reaches. At the whole section, the percentage of 10-40 cm materials was 41-45% in the upstream sections, while only 22% in the downstream sections. The shortage of 10-40 cm materials was much evident for the main bed materials consisting riffle beds, as shown in Fig. 4.

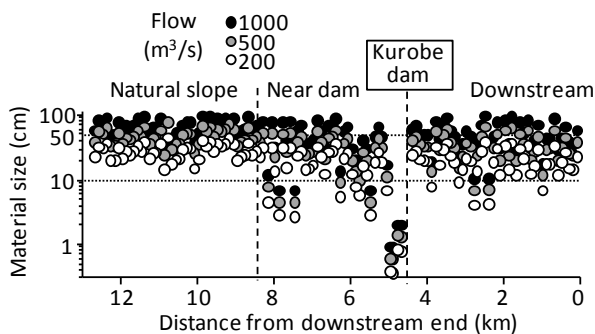
Figure 5. Movable bed materials during floods

The shortage of 10-40cm materials in the downstream is likely due to retention of these materials at immediately upstream of the Kurobe Dam. The movable bed material size during floods was simply estimated from channel width and gradient using known equations of flow resistance and critical shear stress for particle motion, as shown in Fig. 5. Large materials that exceed 50 cm are movable in many of the reaches both in the upstream and downstream during floods of  $500 \text{ m}^3 \text{ s}^{-1}$ , which occur with an interval of 4-5 y, and  $1000 \text{ m}^3 \text{ s}^{-1}$ , which occur with an interval of 8-10 y. Smaller materials such as 10 cm materials are movable by  $200 \text{ m}^3 \text{ s}^{-1}$ , which occur with an interval of 1-2 y. However, movable materials were <10 cm even during floods of  $1000 \text{ m}^3 \text{ s}^{-1}$  at reaches immediately upstream of the Kurobe dam with channel width of >130 m and channel gradient of <1/1000. Although the estimation was simple, our field surveys of particle movement using a radio tracer tracking technique during floods showed that the major material size in transport was roughly consistent with the previous estimation (Kobayashi et al. 2010). Therefore, although large amount of sediment is still transported downstream through the Kurobe dam, the sediment appears to consist mostly of materials with <10cm in size.

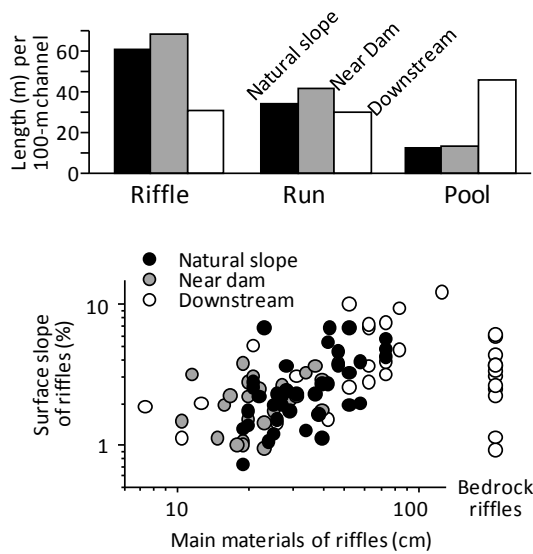
**Figure 7.** Total length of riffles/pools (upper) and relation between bed material size and slope of riffles (lower)

Our study suggests that sediment reduction and subsequent bedrock exposure have significant effects on invertebrate community by at least two ways. First, decrease of 10-30 cm materials and increase of bedrock as habitats within reaches potentially cause a dominance of limited species mainly blackflies, while depress total invertebrate biomass. Second, a shortening of riffle length within the reaches, which is associated with sediment reduction, can also depress invertebrate biomass. The total length of riffles per 100-m channel reach was half in the downstream than in the upstream sections, while the total length of pools was four times in the former than the latter, as shown in Fig. 7. This is because in the downstream section, riffles with 10-40 cm materials, which were moderately steep and long, were few, while riffles with >50 cm materials and bedrocks, which were steep and short, were dominant, as shown in Fig. 7. As a consequence of shorter riffles and longer pools in the reaches, the biomass of total invertebrates and especially of taxa with grazers and filterers are estimated to be 2 to 6 times smaller in the downstream section than in the upstream sections.

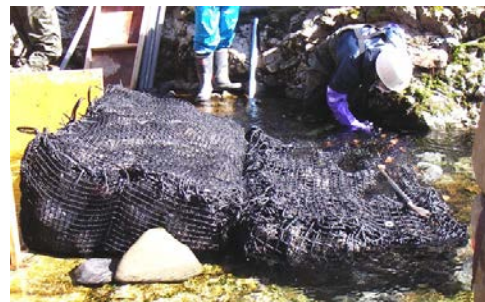
**Figure 8.** Geotextile bags filled with stones (upper), and the location where the bags were set up (lower)

Geotextile fabric is far lighter than steels, but it shows certain strength against physical impacts and ultraviolet rays, and also it is flexible. We used box-type geotextile mesh bags, which are made from non-joint polyethylene mesh, with mesh size of 25 mm, total net size of 2m length, 1m width, 0.5m high, and the mesh was double-layered, as shown in Fig. 8. Each bag can be filled with stones of 1 m<sup>3</sup> or 1500 kg. Two bags were piled up before filling stones in order to reduce the risk of breaking. We filled 5-15 cm materials, which were collected from nearby bank areas, in the bags. Totally 12 bag units, with each unit consist of 2 bags, were set up at locations where the bed slope was inverse at the mid-channel to reduce possibility of their movement and to increase their effects on transported sediment as much as possible, as shown in Fig. 8. Among the 12 units, 3 or 6 units were connected to make the cluster bigger, while these units were not fixed to bedrock.

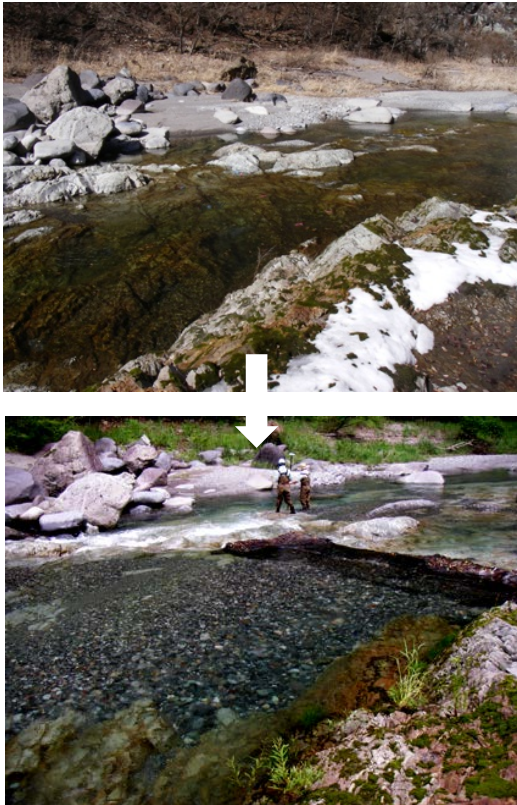
**Figure 9.** Change of bed after a flood

Floods of 100-200 m<sup>3</sup> s<sup>-1</sup> occurred a few times in 2010 and 2011. The bedrock-exposed reach was covered by pebbles and gravels at upstream areas of the installed bags after these floods, as shown in Fig. 9. Although some bags were moved 8-10 m downstream by the first flood, they contributed to the deposition of pebbles and gravels at the downstream side of the bags. Deposited sediment was primary <5 cm materials, while it is evident that 10-20 cm materials were also in transport during these floods. Since no damage was found for all the bags, it is suggested that these bags can be used for sediment deposition and retention at least for the flood of this magnitude.

However, by a flood of 500 m<sup>3</sup> s<sup>-1</sup>, some bags were moved to and settled near the bags that were moved by the previous flood, some other bags were disappeared, and bedrocks was re-exposed for most of the area. The sediment deposit behind the moved bags was remained. The net of the bags was broken especially for upstream- and up-side. We found that some huge boulders with 50-100 cm in diameter newly appeared nearby the study reach. Collision of such boulders to net is likely to have broken the net. Although we had 1000 m<sup>3</sup> s<sup>-1</sup> flood two weeks after the 500 m<sup>3</sup> s<sup>-1</sup> flood, no further changes were observed for the bags and sediment deposition.
