Deep Catastrophic Landslides and Landslide dams in Japan

Tadanori Ishizuka & Nobutomo Osanai
Public Works Research Institute, Ibaraki, Japan
t-ishiduka@pwri.go.jp

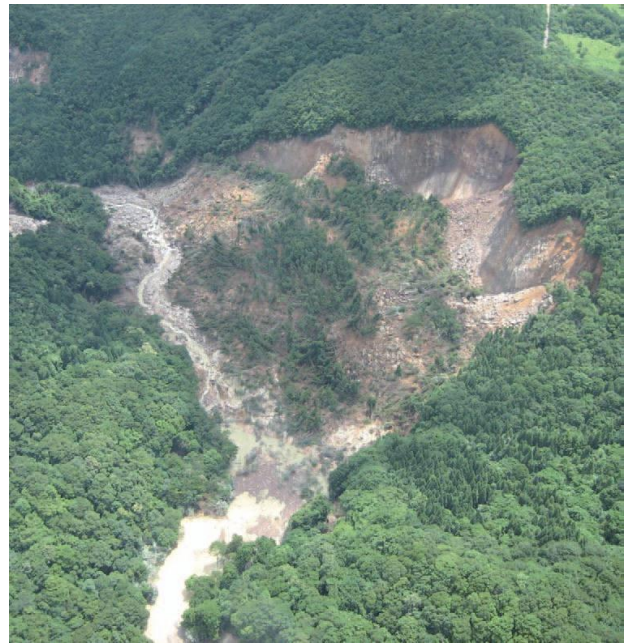
Figure 2. A photo of the landslide dam formed in Numakura-sawa
(Taken on July. 10, 2008)

Numakura-sawa is located at the 5km upper reach of the Kurikoma dam in the Sanhasama basin (Fig. 1). A large scale landslide occurred in a mountain slope of the right bank and dammed up a stream. The photo of landslide dam is shown in Fig. 2. The gradient of a collapsed slope was approximately 35 degree, the width and the height of the landslide were approximately 400-600m and 90m. The longitudinal profile of the landslide dam taken by aerial laser survey (conducted on June 16) is shown in Fig. 3. It is before overflow on June 21. The width and the length of the landslide dam were about 150m and 550m respectively. The relative height of the dam was approximately 42m and the horizontal distance from the top to the downstream end was about 400m. The average gradient of the downstream slope was about 6 degrees. It is thought that the riverbed rose approximately 26m at the apex point of the landslide dam. The longitudinal gradient of the riverbed before the formation of the landslide dam was about 1/24 (2.4 degrees).

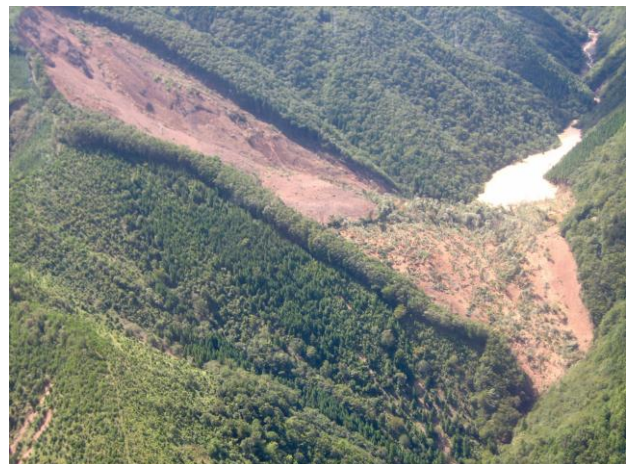
Figure 6. A photo of the landslide dam formed in Nagatono
(Taken on Sept. 5, 2011)

Among these, the five dams were so large and dangerous to overflow and outbreak. (Fig. 6 and 7) The urgent investigation based on the law enforced on May 1, 2010 was applied by the MLIT for those five dams. The objective of the law is as follows; to provide the necessary information on a hazard prone area and the time of hazard occurrence to a local government for residents' evacuation, and to clarify the role of the national and prefectural government on emergent action which requires advanced technical knowledge and skill.

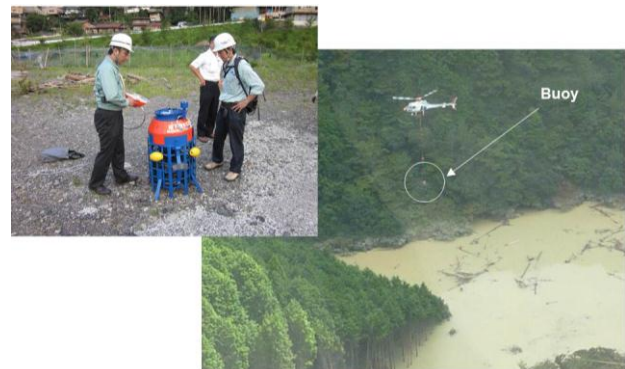
Figure 11. An aerielly-conveyable floating water level gauge

mountain area, surrounding geographic feature is very steep and a road does not exist in many cases. Traffic may be obstructed due to slope collapse. Therefore, the transportation of equipment and communication is very difficult and it is necessary to solve such a problem for measurement. The Public Works Research Institute had developed an aerielly-conveyable floating water level gauge for the above objective (Itou et al., 2009).

The water level observation buoys were dropped from the air, and installed for four landslide dams (Akatani, Nagatono, Kuridaira, Iya) (Fig. 11). The measurement result is shown in Fig. 12 (in Akatani). From the predawn on September 22, water level became high gradually and decreased rapidly on the same day after 10:00. It was guessed overflow and erosion started on the landslide dam. It was confirmed by helicopter survey that overflow and erosion had occurred actually (Fig. 13).
