Missing Water at the Aratozawa Dam due to the Iwate-Miyagi Nairiku Earthquake in 2008

ABSTRACT:

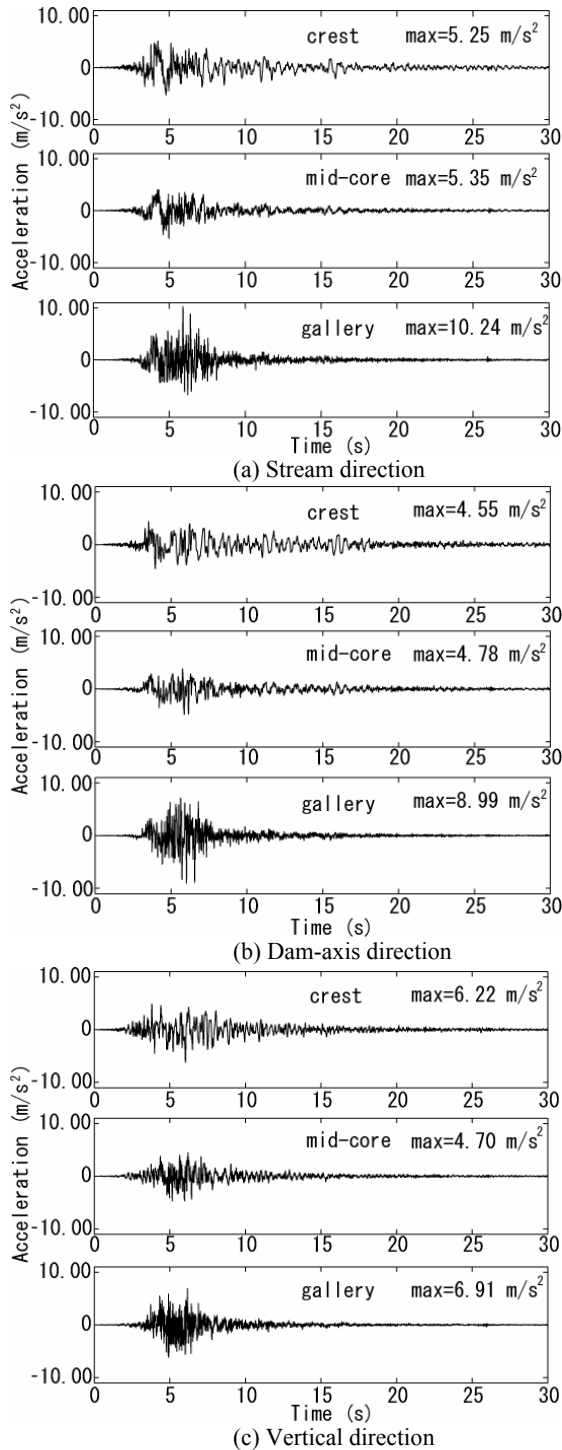
Figure 3. Time histories of three-component strong motion acceleration of the main shock observed at three locations shown in Fig. 2.

Three component strong motion accelerometers are installed at three locations, i.e., the dam crest, the mid-core and the bottom gallery (see Fig. 2). During the main shock, strong motion accelerometers installed at the Aratozawa dam registered a peak acceleration of 10.24 m/s² at the bottom gallery. As shown in Fig. 3 and Table 1, in each direction, the peak acceleration at the bottom gallery was the largest. This seems unusual, since

earthquake acceleration at a crest is usually the largest due to the amplification effect of the dam body. But this attenuation in acceleration is attributed to the nonlinear characteristics of soil materials. Actually, peak periods in spectral ratios between the crest and the gallery were significantly longer during the main shock than those in other smaller earthquakes (Ohmachi and Tahara, 2011).

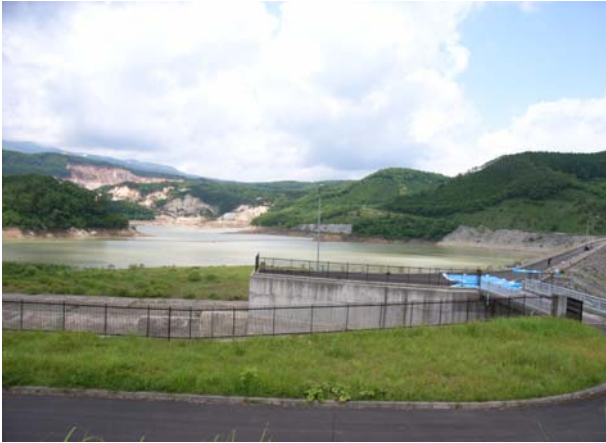
Figure 4. The Aratozawa dam (right) and extensive landslides that occurred upstream of the dam (left)

At the time of the main shock, the reservoir water level was at EL.268.48 m, while the high water level is at EL.274.4 m (see Fig. 7). As shown in Fig. 4, extensive landslides with a total volume of about 67 million m³ occurred upstream of the dam, and a substantial part of that volume collapsed into the reservoir, resulting in a sudden rise of 2.4 m in the reservoir water level. This rise in the water level was equivalent to an increase in storage water volume of 1.5 million m³.

In field investigations conducted immediately after the main shock, surface ruptures were observed at around northern and southern rims of the Aratozawa dam reservoir (Toda et al., 2010). Those at the north rim were close to the massive landslides shown in Fig. 4, and those at the south rim were found on the road running on the right bank side of the dam. Based on several ground breaks, a fault trace in the reservoir bottom crossing from the north to the south was estimated, even though it was not certain.

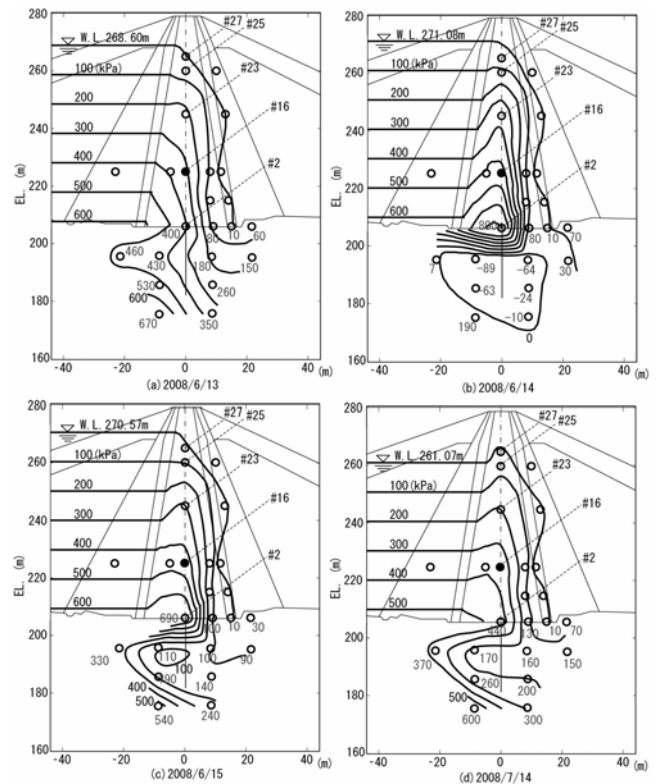
Pore water pressure has been measured to record daily at 9:00 a.m. at the Aratozawa dam. The pore water pressure distribution in a vertical section of the central part of the dam was estimated from readings of the meters before and after the main shock, as shown in Fig. 6 where small circles indicate locations of the meters and a simple distribution is assumed on the upstream side. The vertical section is the cross section A-A' where the seismometers are installed (see Fig. 2). The numbers in the foundation indicate the pressure readings in terms of kPa.

In the core zone of the dam, the pore water pressure of June 13, 2008 (denoted by 2008/6/13) was distributed in the typical pattern of a normal steady state condition, although the estimated phreatic line was not as smooth as expected, maybe due to some mechanical errors included in the readings. On June 14, seventeen minutes after the main shock, the distribution pattern had remarkably changed to exhibit a sudden build-up of excess pore water pressure in the core zone especially at the lower part of the zone. Figure 7 shows a series of the daily readings of the pore water pressure meter #16 whose location is indicated by a solid circle in Fig. 6. It can be seen that after the main shock, with a continuous drawdown of the reservoir water level, the pore water pressure showed a monotonous decrease. Seemingly, after June 24, 2008, the decrease in the pore water pressure in the core zone was mainly governed by the drawdown of the reservoir water level.

Figure 6. Distribution of pore water pressure in the clay core and foundation. Small circles indicate locations of pore water pressure meters in the core and foundation.

Meanwhile in the dam foundation, Fig. 6 indicates that, immediately after the main shock, in contrast to the excess pore water pressure in the core zone, the negative pore water pressure was produced, especially in the vicinity of the grout curtain. The negative pressure almost disappeared by June 15, one day after the main shock. On June 17, three days after the main shock, the pore water pressure distribution in the foundation almost approached the normal steady pattern observed before the main shock.

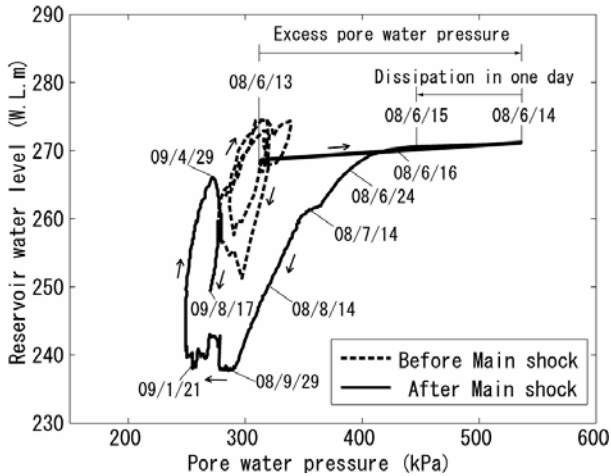
Figure 7. Time history of pore water pressure in the clay core at meter #16 plotted against reservoir water level

As shown in Fig. 7, when the reservoir water level was lowered below EL.240m after the main shock as a part of the post-earthquake inspection, most part of the reservoir bottom was exposed to the air. As long as the visual inspection was concerned, neither the estimated fault traces nor ground holes and breaks from which the above-mentioned missing water was thought to be absorbed into the dam foundation was found anywhere. Thus, for the time being, the whereabouts of the missing

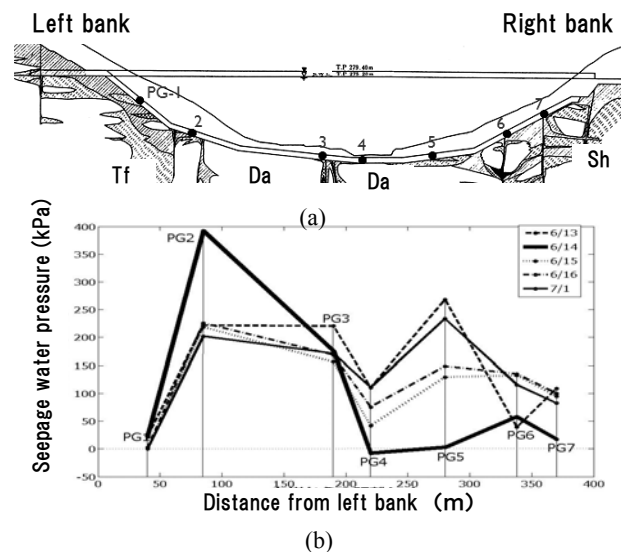
Figure 10. (a) Vertical section along the bottom gallery, and (b) distribution of seepage water pressure along the gallery

As shown in Fig. 10 (a), seepage water pressure meters PG-1 through 7 are installed at 7 points on the downstream side along the bottom gallery of the dam, and their daily readings were recorded at 9:00 a.m. The daily readings of the meters on June 13, 14, 15, 16, and July 1 are shown in Fig. 10 (b). Apparently, immediately after the main shock, the seepage water pressure showed a sudden decrease on the right half side of the dam, while it showed a sudden increase on the left half side. In half a month after the main shock, as a whole, the decreased or increased readings of the seepage water pressure almost returned to those observed before the main shock.

As far as the daily readings of the pore water pressure and seepage water pressure are concerned, it seems reasonable to think that the missing water was absorbed into the dam foundation, especially on the right half side of the dam. A geological profile along the gallery (Oh-ishi, 1975) is roughly shown in Fig. 10 (a). The bedrock in the dam foundation consists mainly of hard dacite (denoted by Da) of the rock class $C_H \sim B$. On the left bank side, solid tuff (Tf) of the class $C_M \sim C_H$ is underlain with somewhat soft layers of shale (Sh) and tuff of the class C_M . On the right bank side, hard dacite is underlain with somewhat soft layers of shale and tuff of the class $C_M \sim C_H$. As shown in Fig. 10 (a), some parts of vertical joints on the right bank side are weathered to the class C or D denoted by dark hatches.

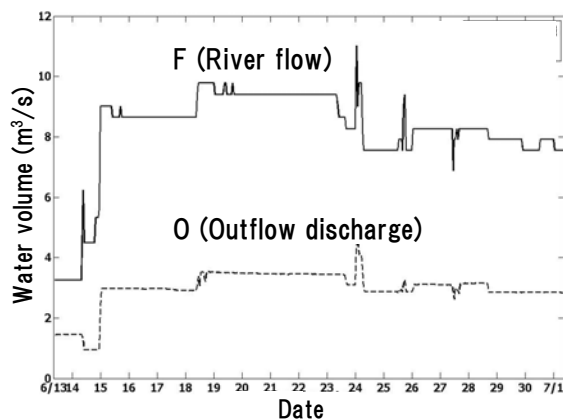
Figure 11. Time histories of the downstream river flow at the Monji station and outflow discharge.

The time histories of the river flow F and outflow discharge O are shown in Fig. 11 during June 13 and July 1, 2008, with solid and broken lines, respectively. The difference between the two lines F and O in Fig. 11 is considered as the catchment C , and the difference shows a sudden increase after the main shock, maybe partly because of a slight change in the slope of the ground surface due to near-field effects of the earthquake. It should be noted in Fig. 11 that, in contrast to other days, on June 14 and 15, the river flow F had less correlation with the outflow discharge O , suggesting that a part of the missing water arrived at the Monji station.

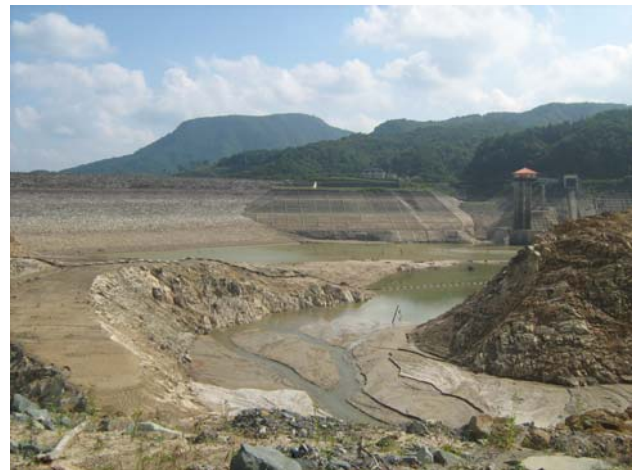
Figure 12. Upstream view of the right side of the Aratozawa dam and reservoir bottom when the reservoir water level was lowered in September, 2008.
