Recovery Works from Landslide Dams Caused by Typhoon Talas 2011

This article summarizes the landslide dams and the recovery works.

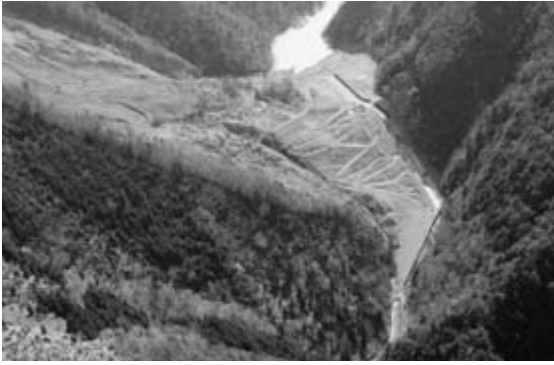
Figure 10. Recovery works at Nagatono site

The spillway construction has been operated under the safety-first principle. Firstly drainage pumps started running to lower the reservoir's water level to reduce overflow risk not to interrupt earthwork on the dam. After securing enough working area, the soil excavation and the gabion work were completed within the shortest work period(Fig.10 , Fig.11).

Construction machines and drainage pumps were airlifted by a helicopter for these emergency recovery works, because some landslide dams locate at unapproachable mountainous area by road.

In order to prevent overtop erosion from the large-scale reservoir at Akadani, Nagatono and Kuridaira, MLIT Kinki has urgently constructed a temporally spillway protected by gabion mattress on the dam body, which is designed to ensure the safety against a 2-year return period rainfall.
