Prediction of Concrete Frost Damage of The Nagawado Dam Based on The Standardized Freezing and Thawing Cycle Method

Reina Doi & Takahide Kurose

Tokyo Electric Power Co Inc, Tokyo, Japan

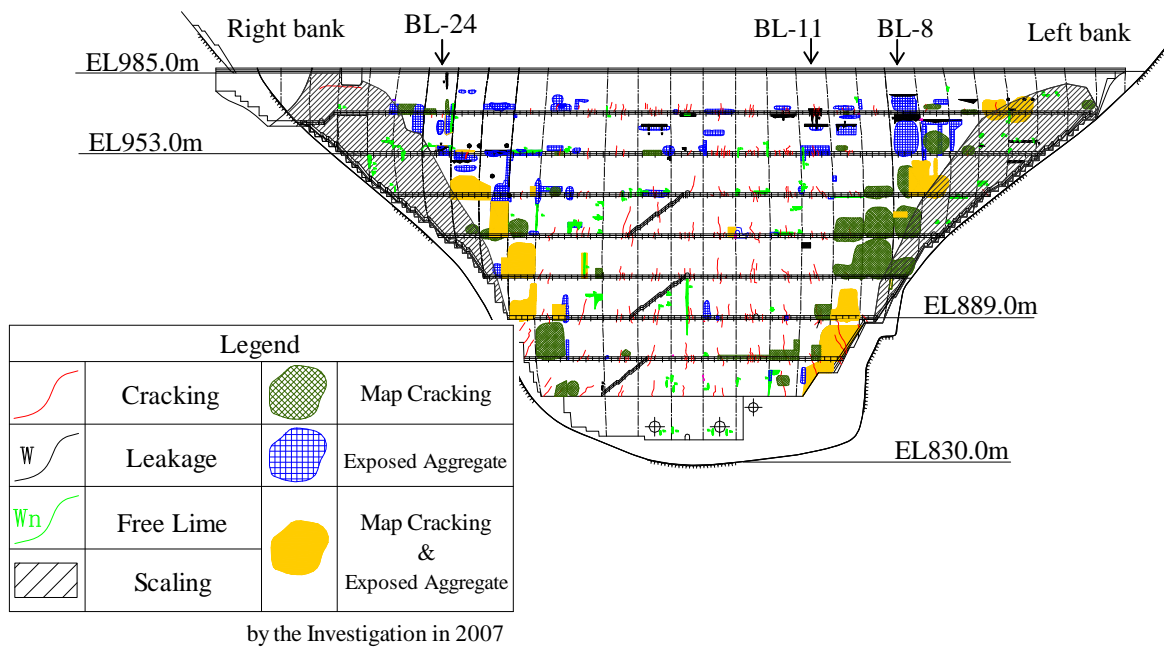
The dam is inspected monthly and engineers take high resolution photos of the dam from control points during the inspection. The concrete damage map was drawn from the photos in order to evaluate the deterioration progress as shown in Fig.1. The deteriorations are more distinct in the following areas.

- The dam concrete around the abutments where it is exposed to rain or snow.
- The dam concrete where water leaks are observed.

Figure 1. Damage map of the downstream surface of the Nagawado dam

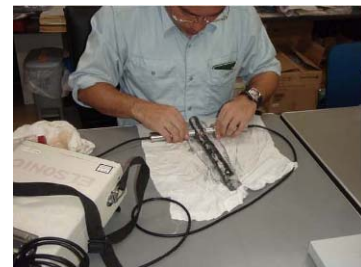
Photo 3. Measurement of ultrasonic wave propagation velocity

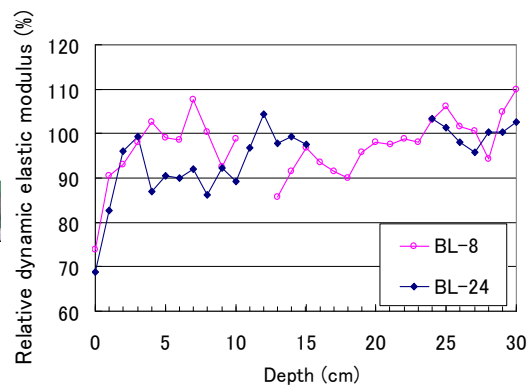
Relative values of the dynamic elastic modulus were calculated to the non-degraded unit. The relative values are smaller at the surface. The relative values at the dam surface are 74 % and 69 % in the BL-8 and the BL-24 respectively. The relative values are more than 80 % at 1 cm depth and a deeper part as shown in Fig.2. Those values exceed a criterion generally adopted for the concrete soundness against the frost damage, 60-80 %. This indicates the deterioration is minor and limited to the surface.

Figure 2. Distribution of relative dynamic elastic modulus

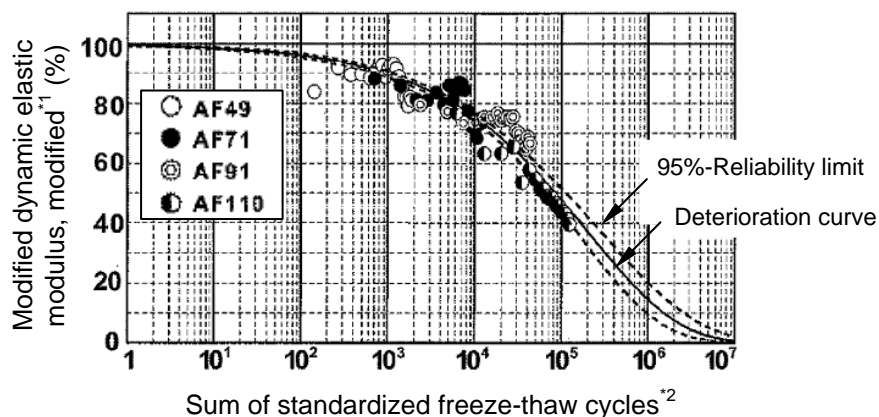
The previous study by Ishii evaluated the deterioration curve of the Nagawado dam concrete as shown in Fig.3. In the previous study, the deterioration curve was identified by the accelerated laboratory tests and field exposure tests over 20 years. Test pieces/blocks were made of various mix concrete proportions including the Nagawado dam concrete design. The study concluded that the frost damage could be evaluated by the deterioration curve and the freezing and thawing cycles which should be converted into the standardized form.

¹ Modified dynamic elastic modulus was calculated as a relative value to the concrete strength with the subsequent strength increase.

² The standardized freezing and thawing cycles were calculated based on W/C+F=49%, -6 degree C. of min.

Figure 3. Deterioration curve by laboratory test pieces

In this study, the method was applied to predict the dam concrete deterioration due to the frost damage. The deterioration curve, however, should be reviewed for accurate prediction with the following reasons. The deterioration curve by the previous study was based on the acceleration laboratory tests and field exposure tests. As to the field exposure tests, the concrete blocks were located in the reservoir area of the downstream dam. The concrete blocks were exposed to the reservoir environment, which was submerged sometimes in a year. Such exposed environment is different from the condition of the dam downstream surface and may affect the deterioration curve. Also, the previous study used resonant vibration method to measure the dynamic elastic modulus. The method is to evaluate the modulus of the mass block, while the modulus may be different by the concrete depth. And, the degrade surface may have smaller modulus. It indicates that the deterioration of the internal concrete may be overestimated in case the previous deterioration curve is adopted.

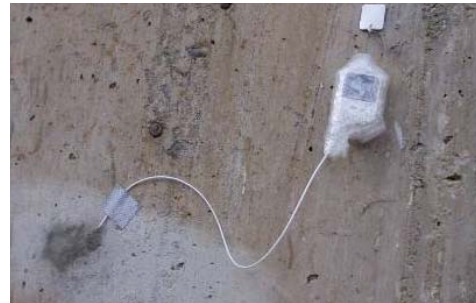
Photo 5. Thermometer

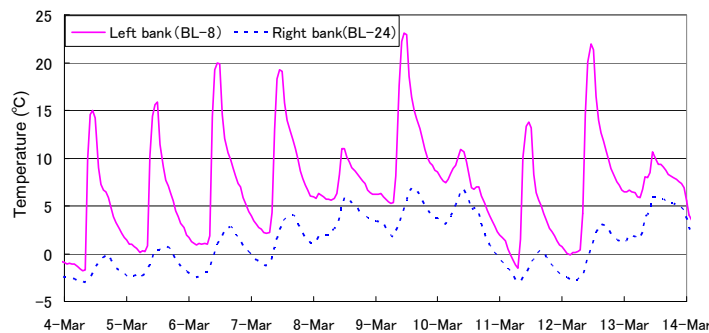
According to the monitoring records, the mean ambient temperature was below 0 degree Celsius from December to February. The new thermometer at 1cm depth at the left side monitored more freezing and thawing cycles during these months. The left side was exposed to sun in the daytime, which caused more frequent thawing in the daytime and freezing at night. In March, the mean ambient temperature became 0 degree Celsius or over. Less freezing and thawing cycles were monitored at the left side in March, since the concrete temperature at the left side was usually 0 degree Celsius or over all day. The sun condition gave differences of the concrete temperature between the left and right side of

the dam as shown in Fig.4. The difference became larger on sunny day, and the maximum difference was observed in March.

Figure 4. Monitoring the concrete temperature at 1cm depth

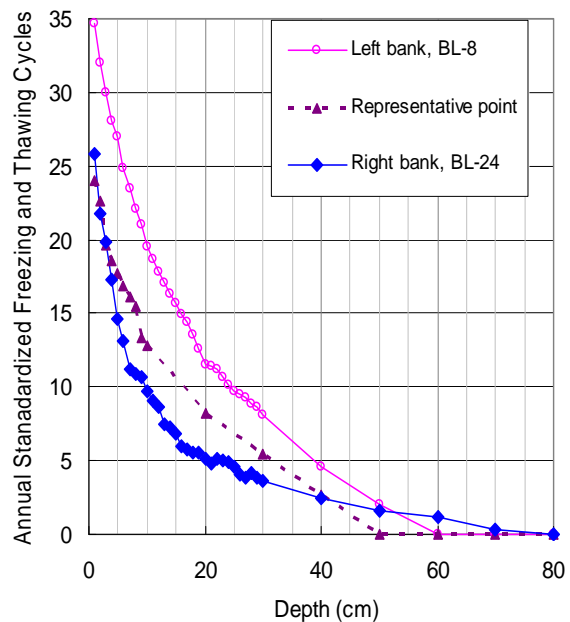
According to the period from December 2012 to March 2013, the thermal distribution at the BL-8, BL-24, BL-11 and the representative point are available by the analyses. Ratio of the standardized freezing and thawing cycles at each block to the representative point was identified by comparison. The annual cycles at the BL-8, BL-24 and the BL-11 were examined applying the identified ratios to the representative point. The standardized freezing and thawing cycles for each location were obtained as shown in Fig.7.

The more freezing and thawing cycles were monitored at the left side where the dam is exposed to more solar radiation in the daytime in winter. The number of the standardized freezing and thawing cycles were evaluated to be 35 cycles annually at 1cm depth at the BL-8. According to the BL-24 and the BL-11, the number of the cycles were smaller. Such difference is caused by the solar radiation conditions by places due to the dam site topography and the dome-arch shape. The number of the cycles and the frost depth at the BL-11 is far smaller due to its solar radiation condition.

Figure 7. Annual standardized freezing and thawing cycles, BL-8, BL-24

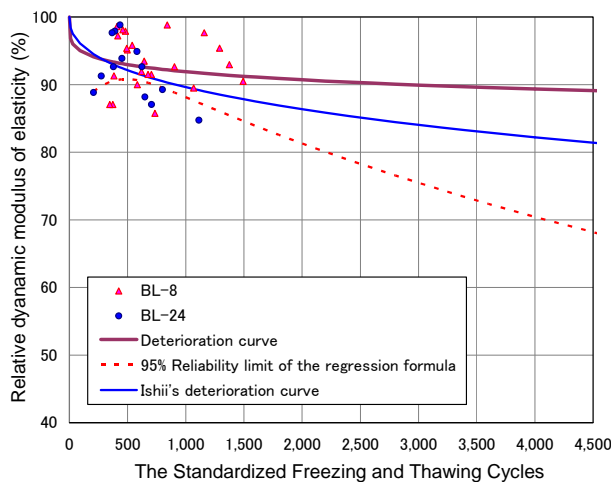
In this study, the deterioration curve was reviewed based on the measured dynamic elastic modulus of the cores and the thermal conduction analysis. Fig.8 shows the data considered to identify the deterioration curve. The measured dynamic elastic modulus shows degradation trend, although the data includes dispersion. The dispersion may be caused by the influence of the coarse aggregates in the cores. Eq.2 expresses the reviewed deterioration curve for the Nagawado dam concrete. The constant coefficients were identified by a regression analysis. The 95%-reliability limit interval curve was also proposed as a conservative view point.

Figure 8. Relative dynamic modulus of elasticity vs. the standardized freezing & thawing cycles

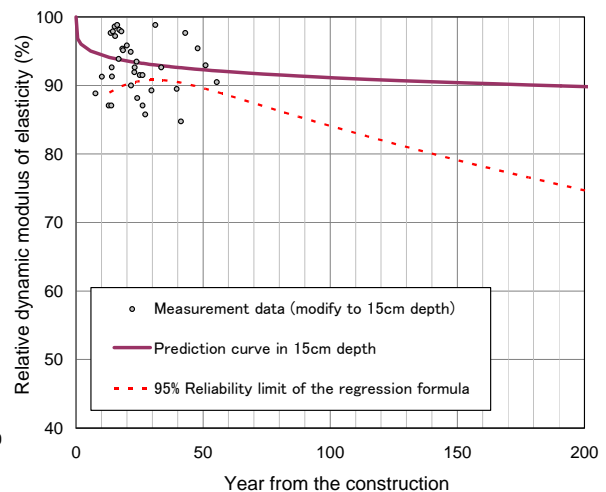
Fig.9 shows prediction of the deterioration at 15 cm depth due to the frost damage. The relative dynamic elastic modulus will maintain approximately 90 % in 200 years according to the prediction curve. Even 95%-reliability limit interval considered, the relative dynamic elastic modulus will be more than 80 % in approximately 150 years. It was concluded that the dam concrete will be sound and stable in the long term.

Figure 9. Prediction of the relative dynamic modulus of elasticity at 15cm depth at the BL-8
