INTERNATIONAL SYMPOSIUM ON
DAMS IN A GLOBAL ENVIRONMENTAL CHALLENGES
Bali, Indonesia, June 1ST – 6TH, 2014

**Rational, Organized, and Successful Emergency
Operation against Disaster
– Case of the Historic Earthquake in Japan –**

S. Takagi, H. Izume, K. Someya and H. Ootaka

Japan Water Agency, Saitama, Japan
satoru_takagi@water.go.jp

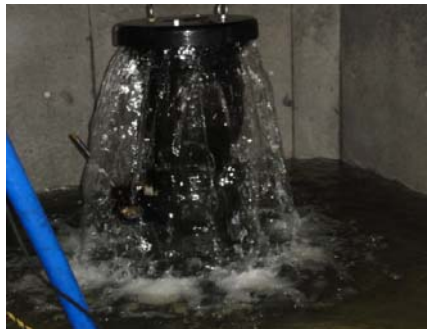
Finally, facility damages by the quake were observed at 8 projects located in Ibaraki and Chiba Prefecture of the Tone River and Ara River Basin. Most of the damages were subsidence caused by the liquefaction and water leakage of pipeline system in canal project sites. However, damage by the tsunami and the human damage did not occur. And also there was no damage in dam facilities. Followings are major damages observed at the damaged project sites.

Photo 1. Damage of the air valve

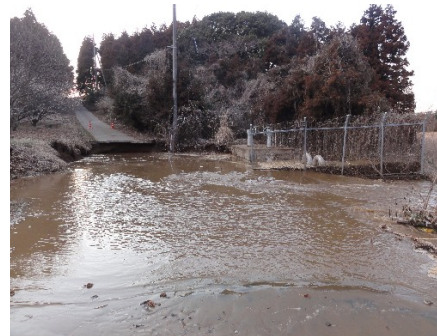
Photo 2. Water leakage from pipeline systems

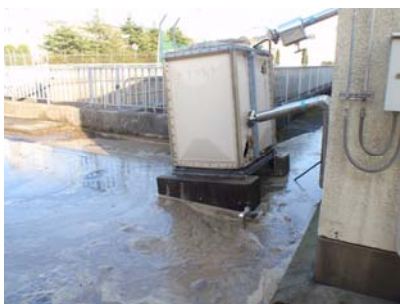
Photo 3. Subsidence caused by liquefaction

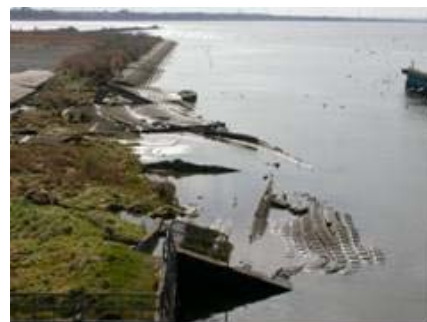
Photo 4. Damaged bank protection

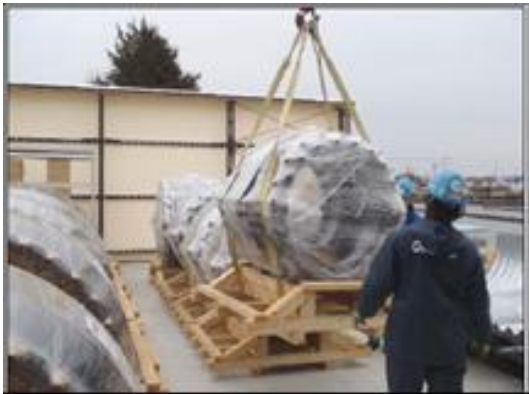
Photo 6. Conveying materials of stocked

JWA have stocks of various materials and machineries as a part of preparedness activities against disaster. At The 2011 Tohoku Earthquake, the materials for water leakage repair which were stored at Tone Canal office beforehand were sent to Hokusou Canal project site where the pipelines were damaged and contributed to facilitate urgent recovery. In addition, a pumper truck (1m³/s class) was sent to a pump station in Tousou Canal System to help deliver water to purification plant in case of electricity failure which was planned by electricity company because emergency generator was broken by the earthquake and there is no energy to send water to the plant if electricity stopped (see photo 6.7).

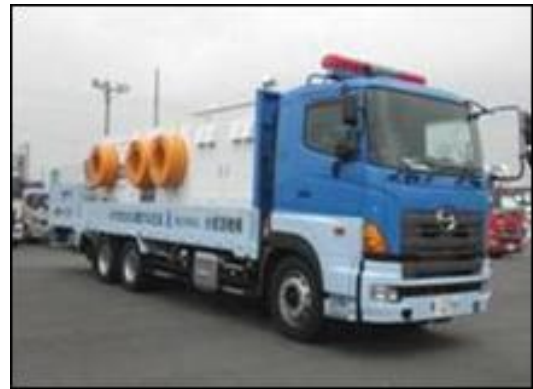
Photo 7. Pumper truck

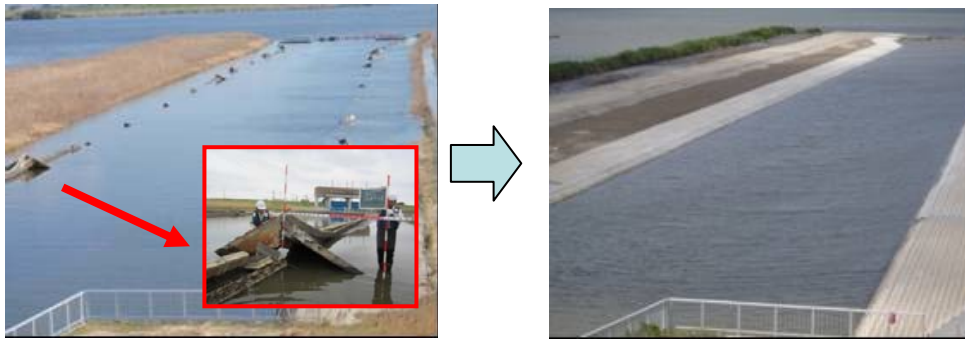
Photo 8. Disaster recovery (left) damaged bank protection (right) after recovery

Finally, JWA completed the disaster recovery works, in full scale, by the end of March, 2013 (see photo 8).
