## **Cracking on Embankment Dams due to Recent Large Earthquakes and Direct and Splitting Tensile Strength Tests for Core Material**

**H. SATO & Y. ENOMURA**

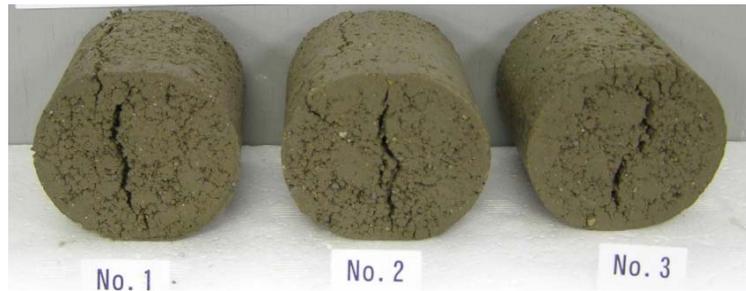
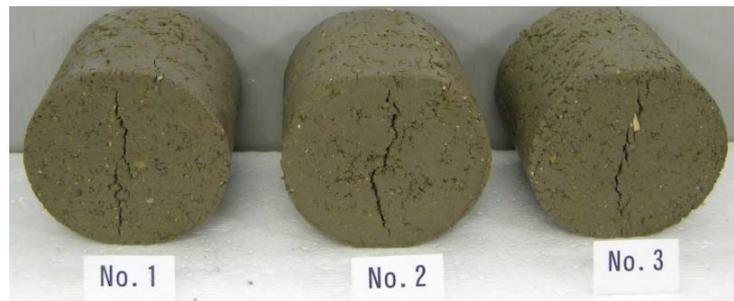
Figures 7 and 8 show the specimens after the tests. Although the specimens after the tests are, as shown in the photos, considered to be slightly affected by the loading plate, cracks formed vertically in almost the center of the specimens in every case.

**Figure 7.** Specimens after the splitting tensile tests (D=95%)

**Figure 8.** Specimens after the splitting tensile tests (D=100%)
