## Construction of a tunnel spillway at large water depth

Ken Takahata<sup>1,a</sup>, Ryoichi Yoshioka<sup>1,b</sup>, Akihiro Konagai<sup>2,c</sup>

<sup>1</sup>*Shikoku Branch, Shimizu Corporation, Ehime, Japan*

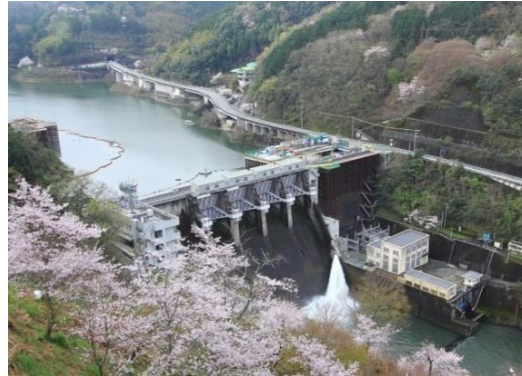
Figure 1. Kanogawa Dam

Kanogawa Dam is located in the upper reaches of the Hijikawa River with a river basin area of 1,210km<sup>2</sup> and a length of 103 km that flows in the northwest of Shikoku in south western Japan. The dam was completed in 1959 to control floods and generate hydropower (Figure 1).

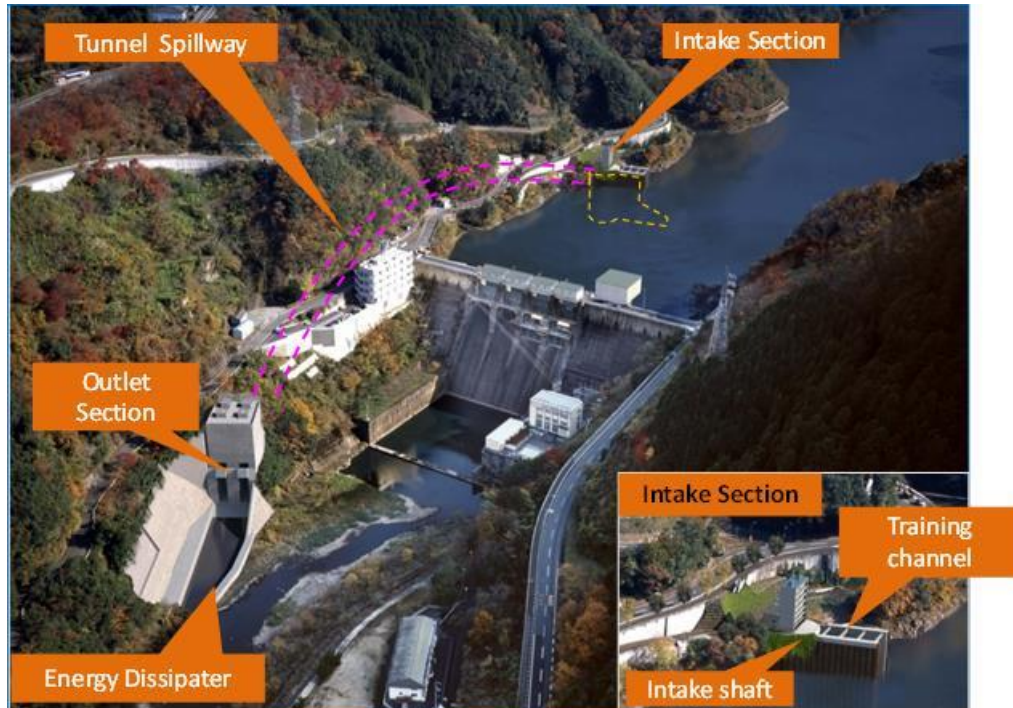
Figure 3. Overview of tunnel spillway

The tunnel spillway constructed on the right bank at the dam site consists of a training channel (47 m long) located at the upstream end, an intake shaft (inside diameter 17 m), a tunnel (about 457 m long, 11.5 m in inside diameter), an outlet and an energy dissipater (Figures 3, 4 and 5). The shaft in the reservoir was constructed by driving a total of 34 steel pipe sheet piles (1,500 mm in diameter, L = 44.0 m) to form a circle (in plan) having an inside diameter of 17 m, and excavating the area thus enclosed down to an elevation of 50 m while installing supports (Figure 6).

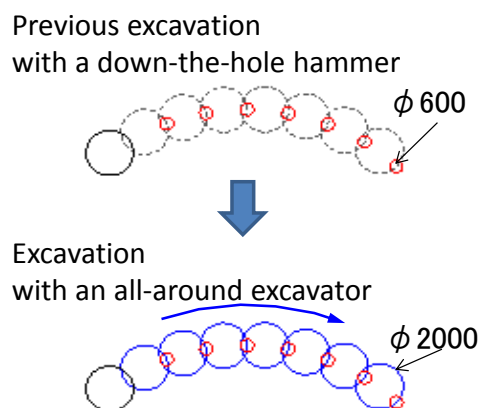
**Figure 10. Rock excavation procedure**

The geology at the shaft site consists of an alternation of sandstone and shale, mainly containing Semi Hard and Hard bedrocks. Instead of driving steel pipe sheet piles directly into the bedrock, a series of circular holes of 2,000 mm in diameter and 35 m in average depth were drilled with a full-perimeter rotary drill in a circular pattern. Then, a steel pipe sheet pile of 1,500 mm in diameter was constructed each holes thus created (see Figure 9). At the time, the method of drilling a hole 2,000 mm in diameter and more than 30 m in depth in rock by using a full-perimeter rotary drill was almost unprecedented. There was concern, therefore, about the possibility of seizure of the drill during the drilling operation. It was decided, therefore, to drill smaller holes, 600 mm in diameter, in advance in the still-undrilled region along the 2,000 mm hole perimeter with a down-the-hole hammer (see Figure 10).

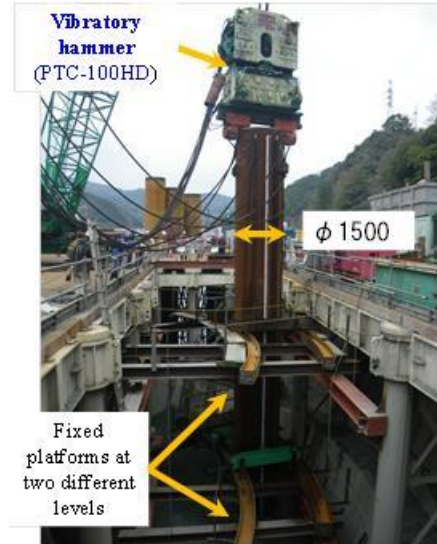
Figure 11. Erection of steel pipe sheet piles using a vibratory hammer

When placing steel pipe sheet piles, verticality was achieved by installing two guide platforms at two levels (see Figure 11). The inclination of the pile being driven was frequently measured with two electro-optical distance meters. The verticality of the steel pipe sheet piles thus driven was measured upon completion of piling with an ultrasonic measuring instrument, and the measurement results verified that the piling work was carried out with high accuracy.

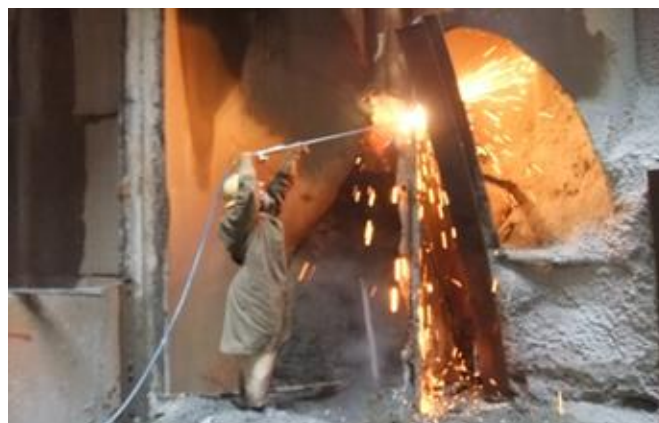
Figure 16. Cutting with the oxygen lance

In order to prevent the failure of crusher-runs on the rear surface of the steel pipe, steel sheet piles along the tunnel circumference were cut near the portal excavation using oxygen lance each time excavation advanced (a length of 1.0 m) (See Figure 16). The objective was to leave as many steel pipes as possible and minimize the exposure of the crusher-runs and earth behind the steel sheet piles.

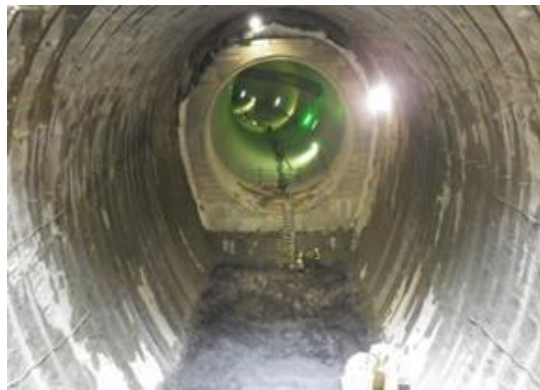
**Figure 17. Completion of excavation at the bottom slab**

Construction was carried out while checking on whether seepage from steel pipe sheet pile joints was increasing or not and whether there was abnormal flooding from the connecting tunnel. Figure 17 shows the connecting tunnel, viewed from the intake shaft, upon completion of the excavation down to the invert.
