Construction of a tunnel spillway at large water depth

ABSTRACT

1.1 Location and specification of Kanogawa Dam

1.2 Overview of new tunnel spillway

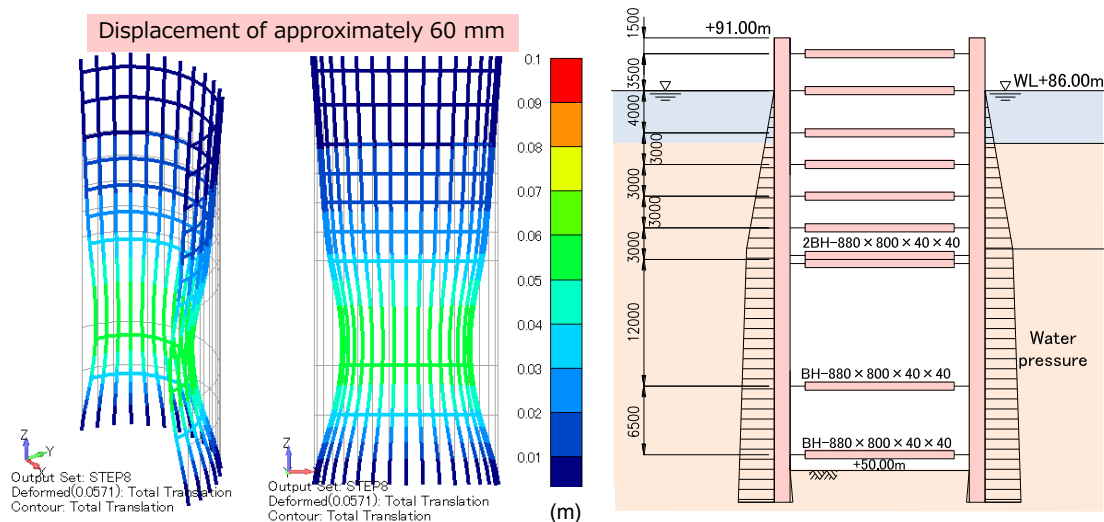
**Figure 13. Results of analysis
 (displacement of steel pipe sheet piles upon completion of excavation)**

There was concern that the deformation of the lower part of the steel pipe sheet pile wall due to internal excavation might create gaps around the circumference of the steel pipe sheet pile wall, causing the formation of water channels connecting to the reservoir so as to induce large-scale flooding during excavation. It was therefore necessary to accurately determine the deformation and behaviour of steel pipe sheet piles, and three-dimensional FEM analysis was performed in advance. The maximum displacement upon completion of excavation was calculated to be approximately 60 mm in the region above the eighth level of supports (see Figure 13).

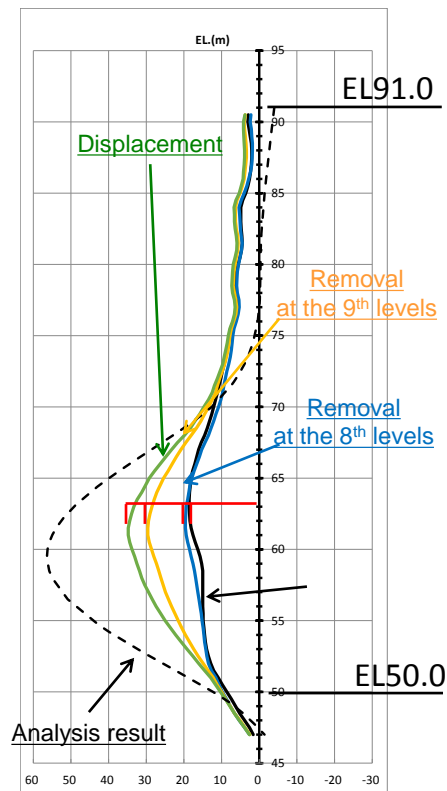
Figure 15. Measured deformation of steel pipe sheet pile

Figure 15 shows the measured deformations of a steel pipe sheet pile. It was verified that deformation was approximately 20 mm while excavation took place in the shaft, 10 mm when ring supports were removed at levels 8 and 9 and 5 mm when the steel pipe sheet piles were cut. A total inward deformation of 35 mm was verified.

The measured total deformation was smaller than the value in the preliminary analysis, and cutting open the steel pipe sheet pile wall had a smaller effect than in the analysis. The difference is ascribable to the following: (i) The reservoir level during construction was approximately at elevations 75 to 80 m, lower than that under the conditions assumed in the analysis and the external force due to water pressure was smaller than expected: (ii) Injecting cement slurry behind the steel pipe sheet pile wall after the removal of supports increased ground stiffness: and (iii) Connecting the steel pipe sheet piles on the training channel side to the intake shaft reduced deformation toward the inside of the shaft.
